AL-ASHRAFIYYAH MOSQUE AND MADRASAH IN TA'IZZ

Conservation intervention (2008-2015)

The subject of this volume is the work of restoration of the paintings, stuccoworks and woodwork, and the structural consolidation of the al-Ashrafiyyah Mosque and Madrasah in Ta'izz (Yemen, 13th-14th century), carried out by the Istituto Veneto per i Beni Culturali (IVBC, 2008–2015) thanks to the support of the Social Fund for Development (SFD – Culture Heritage Unit). It follows the previous volume *The Great Mosque of Ṣan'ā'. Conservation intervention (2005–2015)*, published in June 2022.

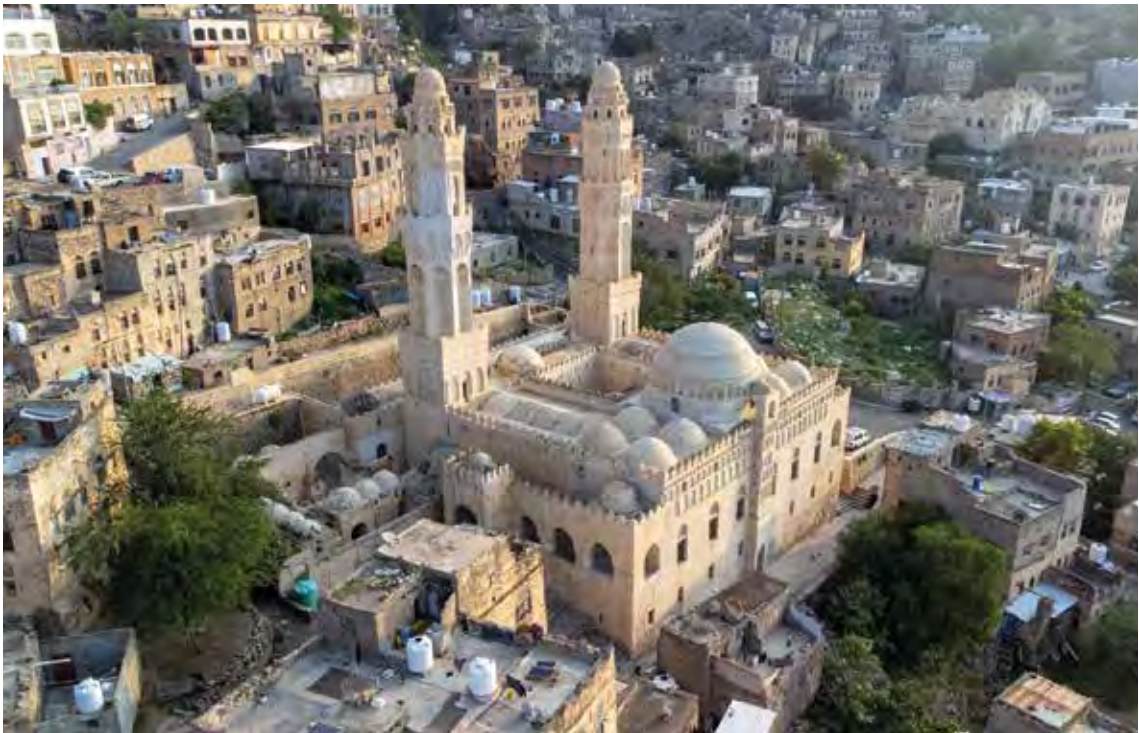
Fig. 1. Overview of al-Ashrafiyyah Mosque and Madrasah in Ta'izz.

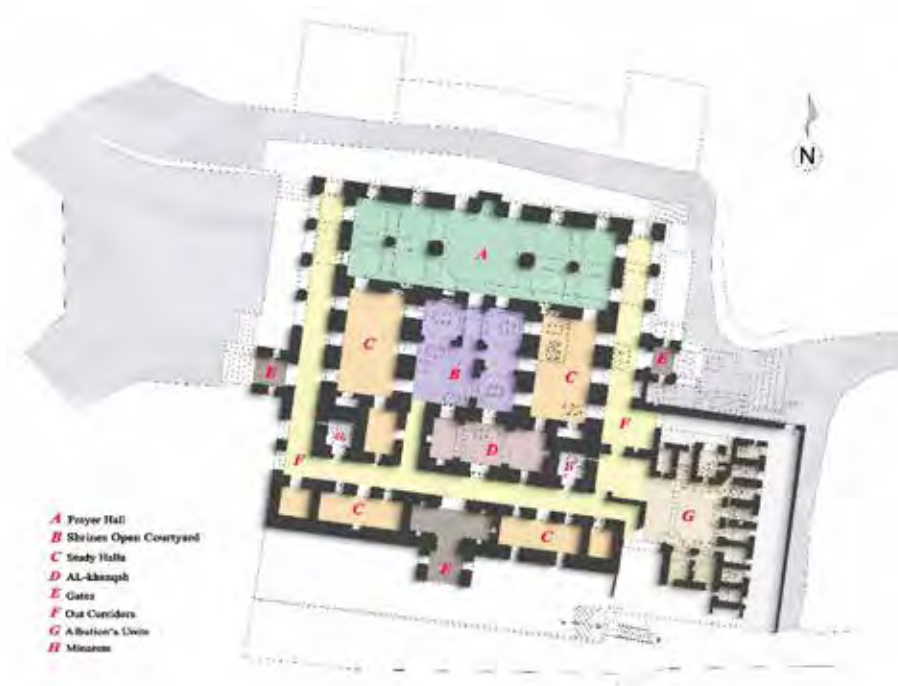
Fig. 3. First floor plan of al-Ashrafiyyah Mosque and Madrasah in Ta'izz.

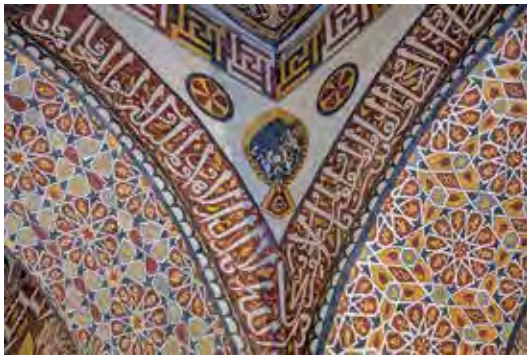
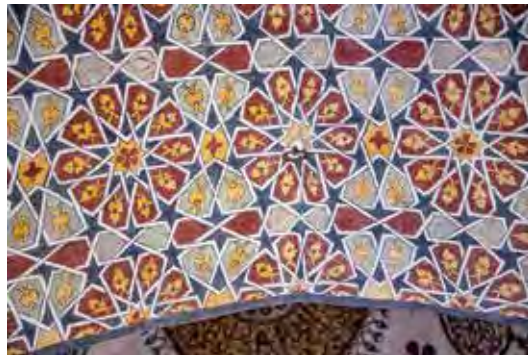
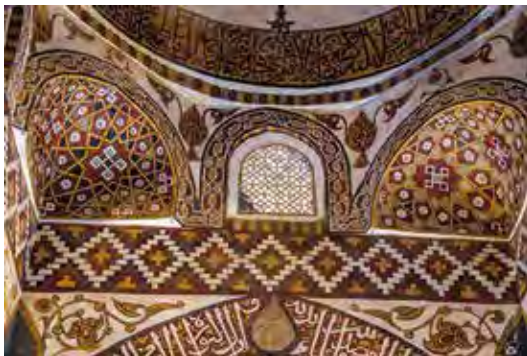
Figs. 5, 6 and 7. The five-pointed rose, star plates and other motives on arches and niches of the prayer hall.

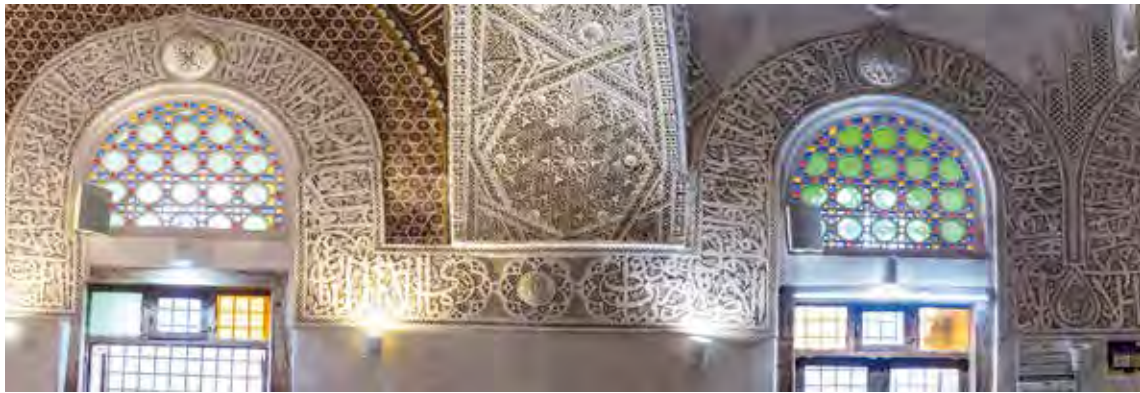
Fig. 8. Gypsum decoration of Qur'anic inscription.

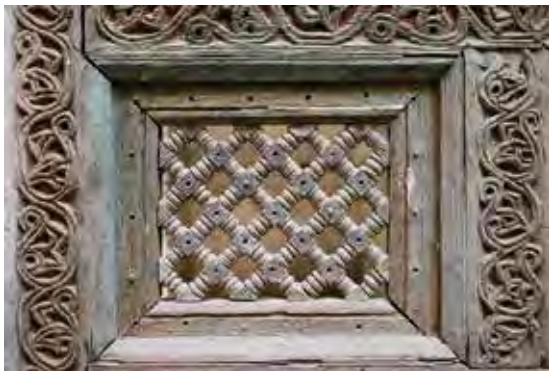
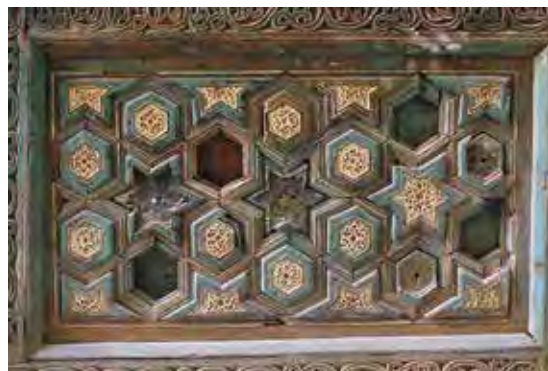
Figs. 9 and 10. Arabesque works at the kiosks of the shrines.

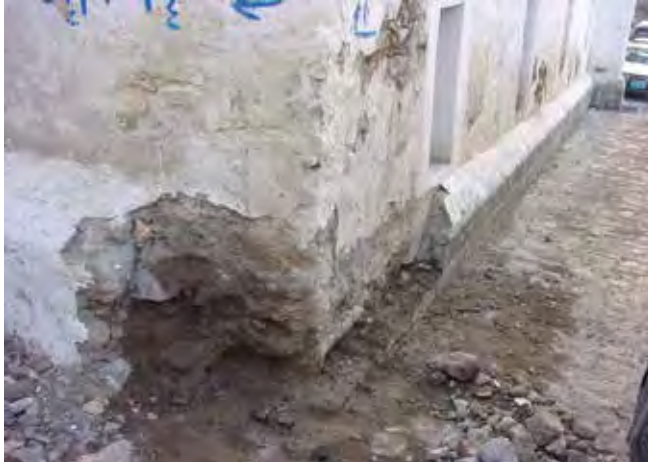
Fig. 12. Repair of the plinth at the north-eastern corner of the main building.

- Replacing the water and sewerage network in and around the building.
- Restoration and strengthening of the northern and eastern plinths.

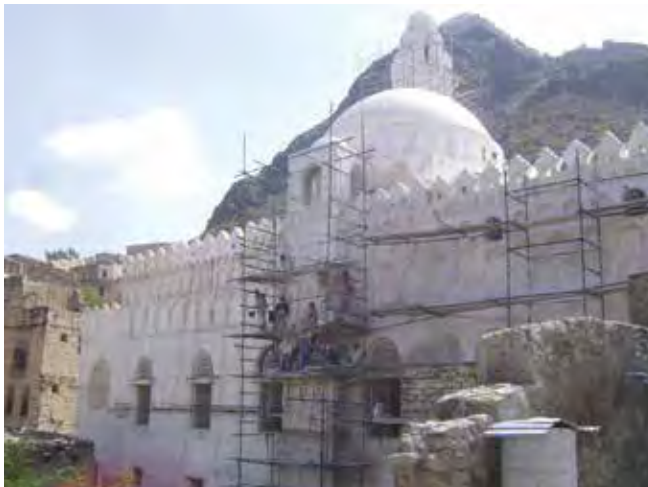
Fig. 13. Restoration work of the façade.

- Removal of reinforced concrete beams in the open hall court yard.
- Replacing the damaged wooden beams with timber of the same type for the ceilings, walls and staircases of the two minarets from inside, starting in the eastern and then western areas, by a professional master with transferring his experience to an assistant.
- Replacing the damaged stones with the same type of original stones in all façades of the southern entrance.

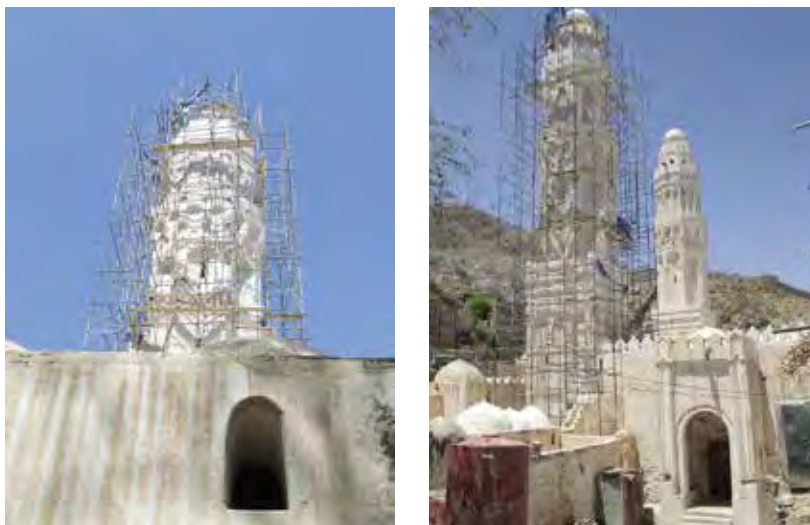
Figs. 14 and 15. Eastern minaret restoration works.

- Restoration of the façades of the western minaret from the damaged and accumulated layers of light, replacing the damaged wooden lintels in the main body of the minaret from the outside, and replacing the damaged railing from the outside.

- Replacing the damaged wooden lintels in the doors and walls of the western basement and re-slitting the walls and edges of the doors and windows.
- Removing the layers of lime accumulated on the eastern minaret, replacing the damaged lintels and wooden beams, and restoring the damaged bar.

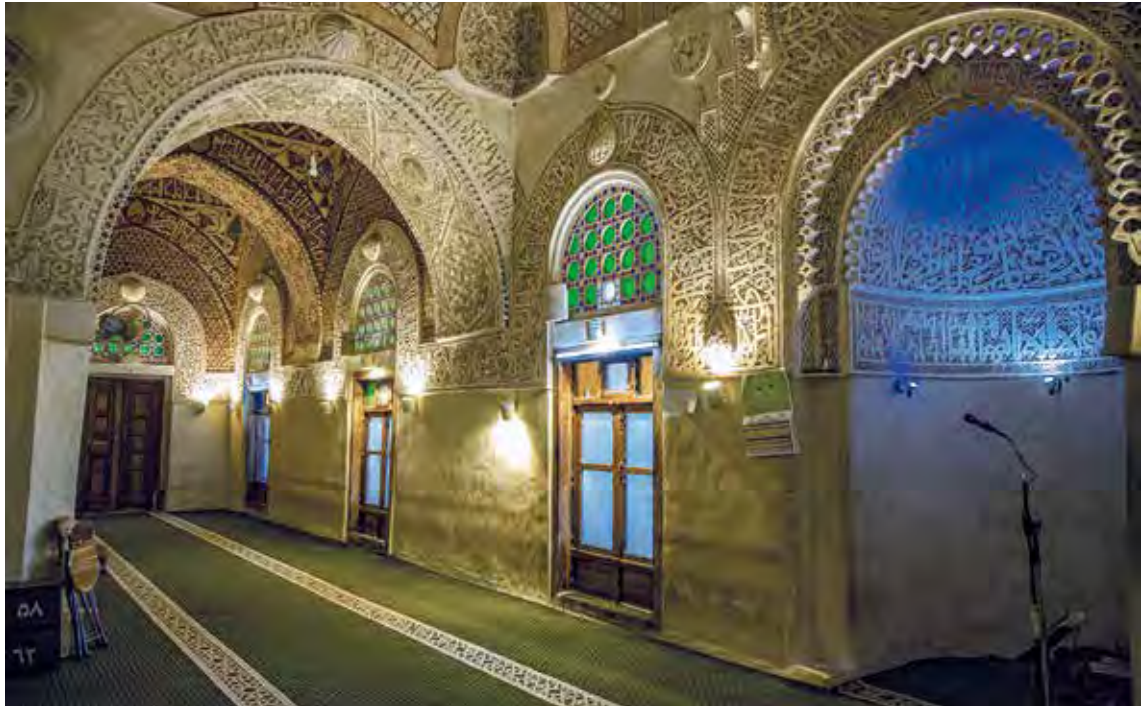
Fig. 16. New lighting and audio system.

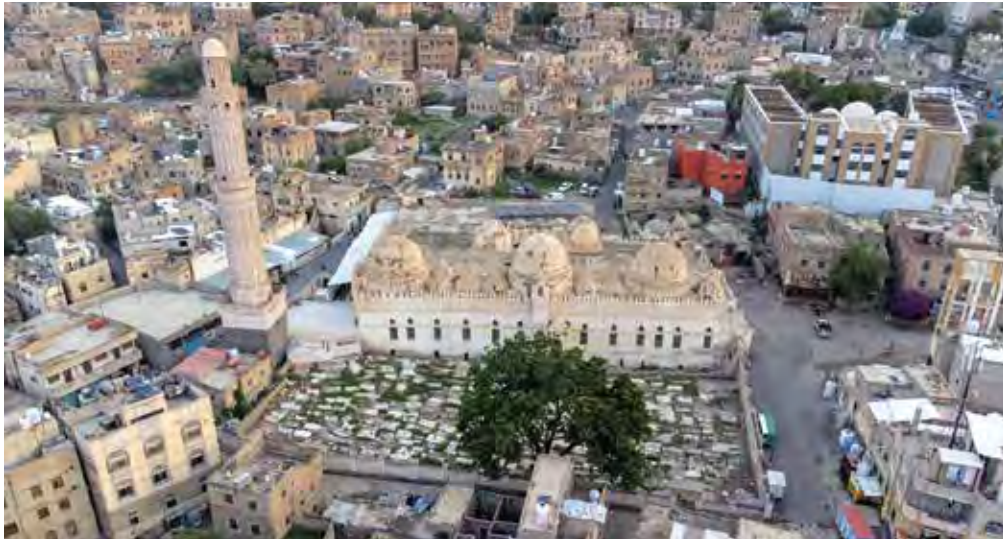
Fig. 17. Eye bird view of al-Muzaffar Mosque – Ta'izz.

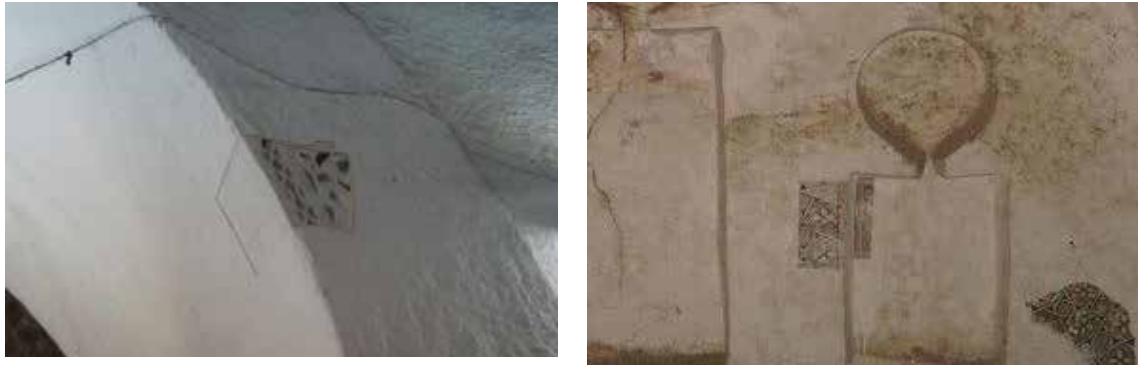
Figs. 19 and 20. First inspection of the mural paintings in al-Muẓaffar Mosque – Ta'izz.

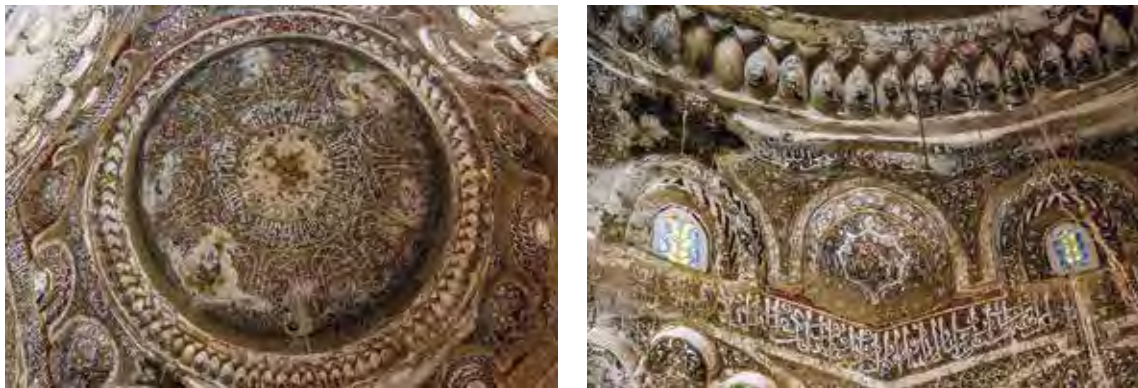
Figs. 21 and 22. Deteriorated mural paintings in al-Muẓaffar Mosque – Ta'izz.

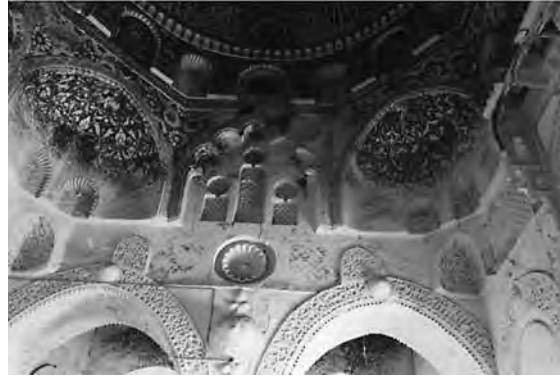
Fig. 2. Photo of the inside of the main dome, taken in 1974.

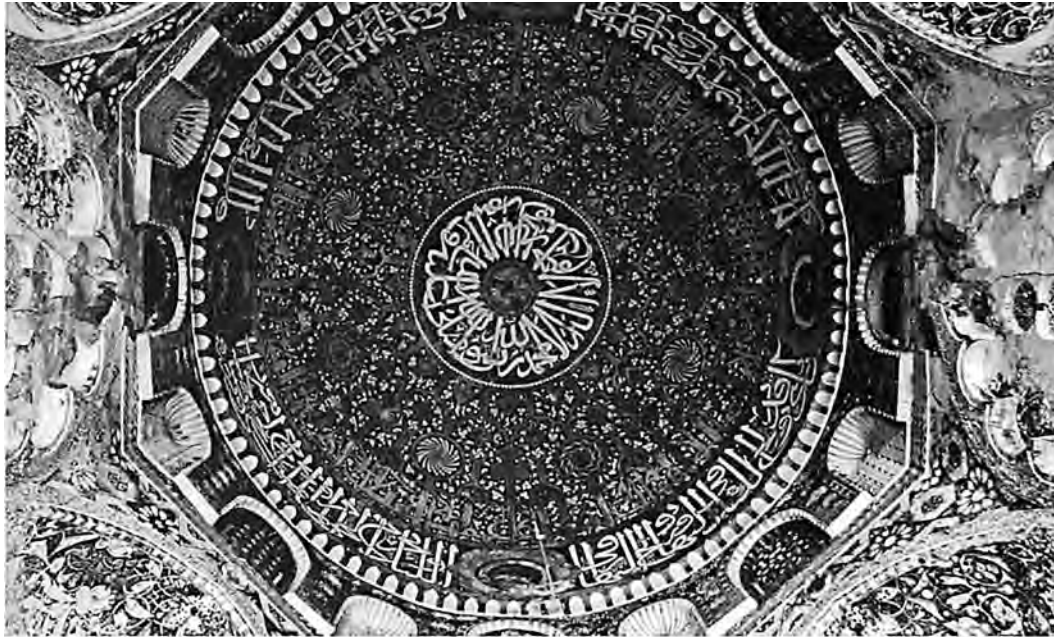
Plate 1. The painted great dome of the Ashrafiyyah.

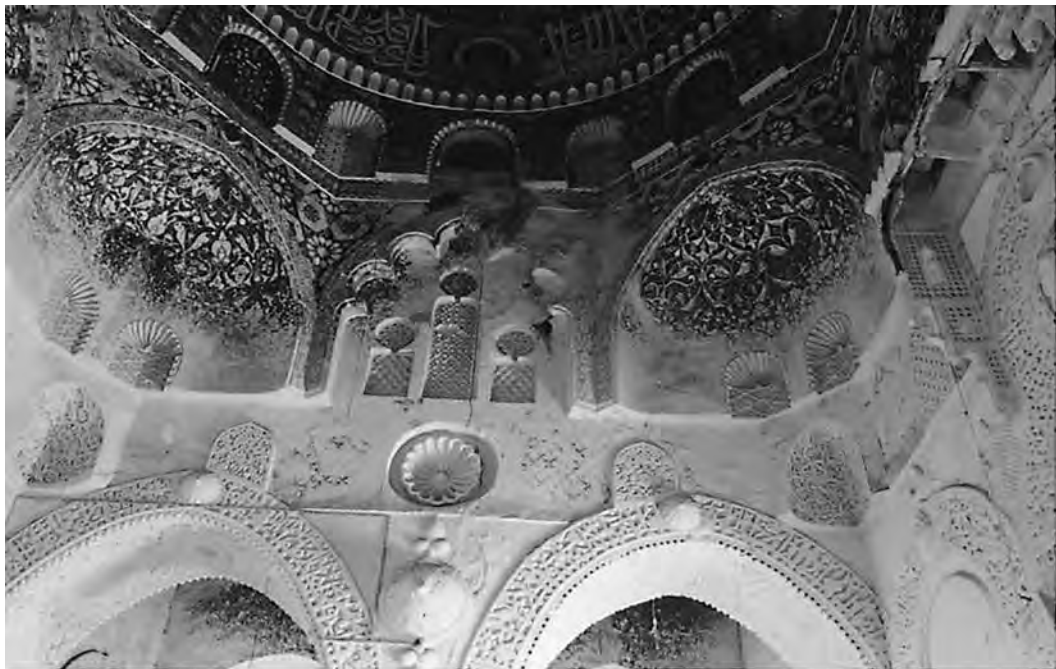
Plate 2. The springing and drum of the great dome of the Ashrafiyyah.

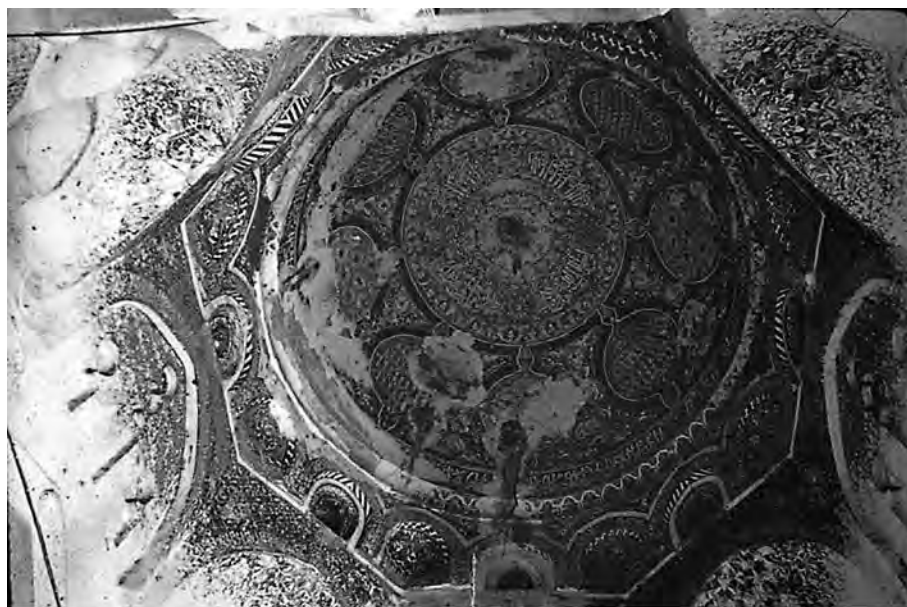
Plate 4. The painted decoration on the large eastern dome of the Muẓaffar mosque, Ta'izz.

These will be only briefly considered for comparison purposes. The dome chosen is the eastern one. Here a floral arabesque surrounded the central boss, itself already obscured by damp penetration in 1972 when the photograph reproduced here was taken (Plate 4). Outside of this a free monumental Qur'anic inscription is divided into four sections by rondels, each again containing a floral arabesque pattern. A further floral arabesque pattern encircles the dome to frame the central pattern.

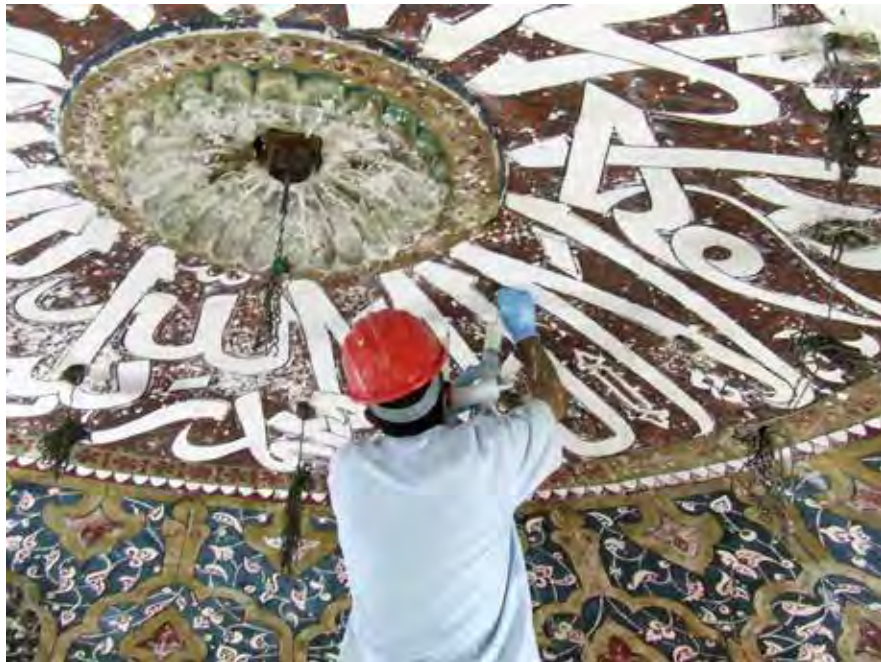
Fig. 4. This picture enables us to appraise the size of the letters of the inscriptions on the summit of the dome in the prayer hall (1e), at a height of 15 meters.

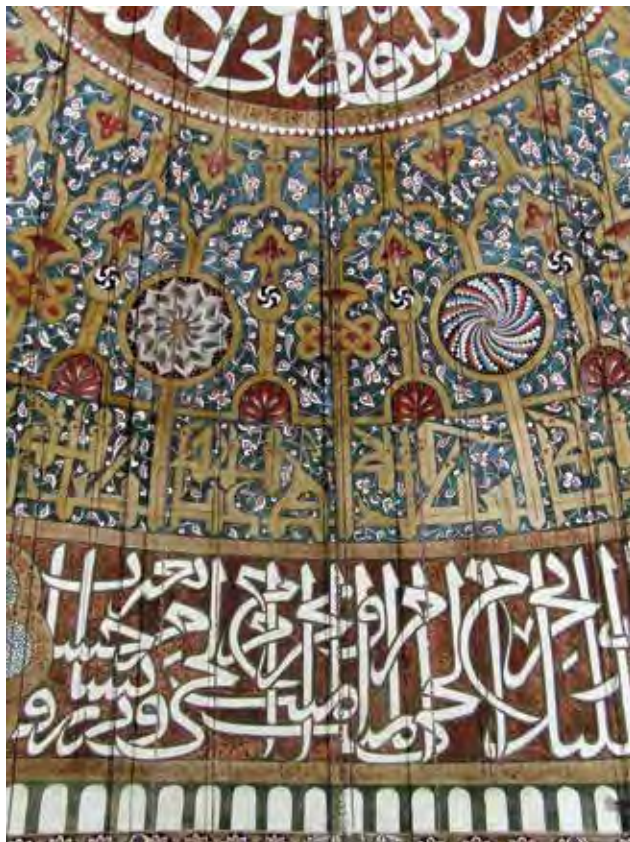
Fig. 5. Parts of inscriptions in a vertical section of the dome of the prayer hall (1e).

There are three levels of script: 1. In the upper inscription we can see the *basmalah* in *thuluth* script; 2. In the central part we can make out gilded letters in Kufik; 3. In the lower band there is a fragment of the *sūrah* Āl ‘Imrān, Q 3: 27 (see below the complete text of the inscriptions).

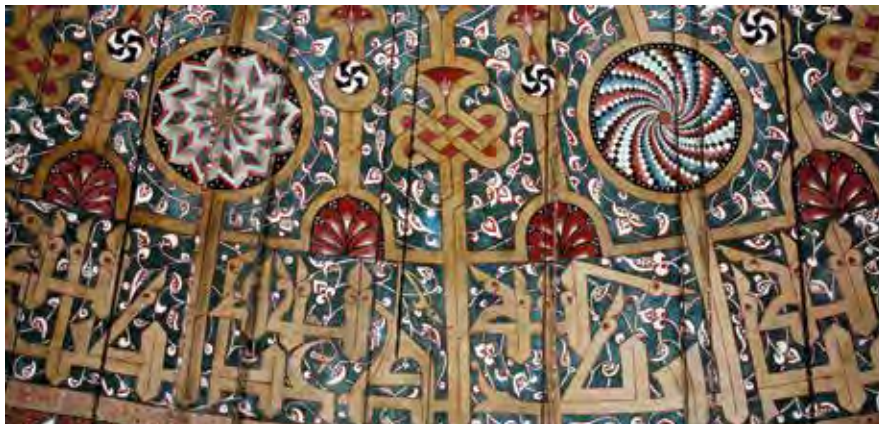
Fig. 6. Text in Kufic script, in a field decorated with floral and geometrical motifs.

The script quotes religious expressions in a highly stylized eastern Kufic. The vertical line of the *lām* is greatly elongated, woven into or surrounding rosettes or spirals: *li-l-* (لل)

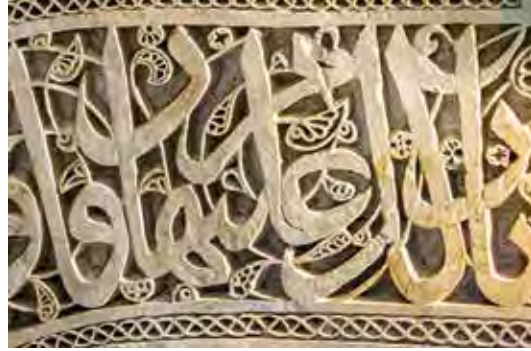
Fig. 9. Example of *thuluth* script carved into the plaster.

Detail of the inscription encircling the *mihrāb*. We see evidence of the expert engraving of the letters in the plaster and decorative elements (*zakhārif jiṣṣiyyah*) in the spaces between them, within a frame (Q 55: 26)

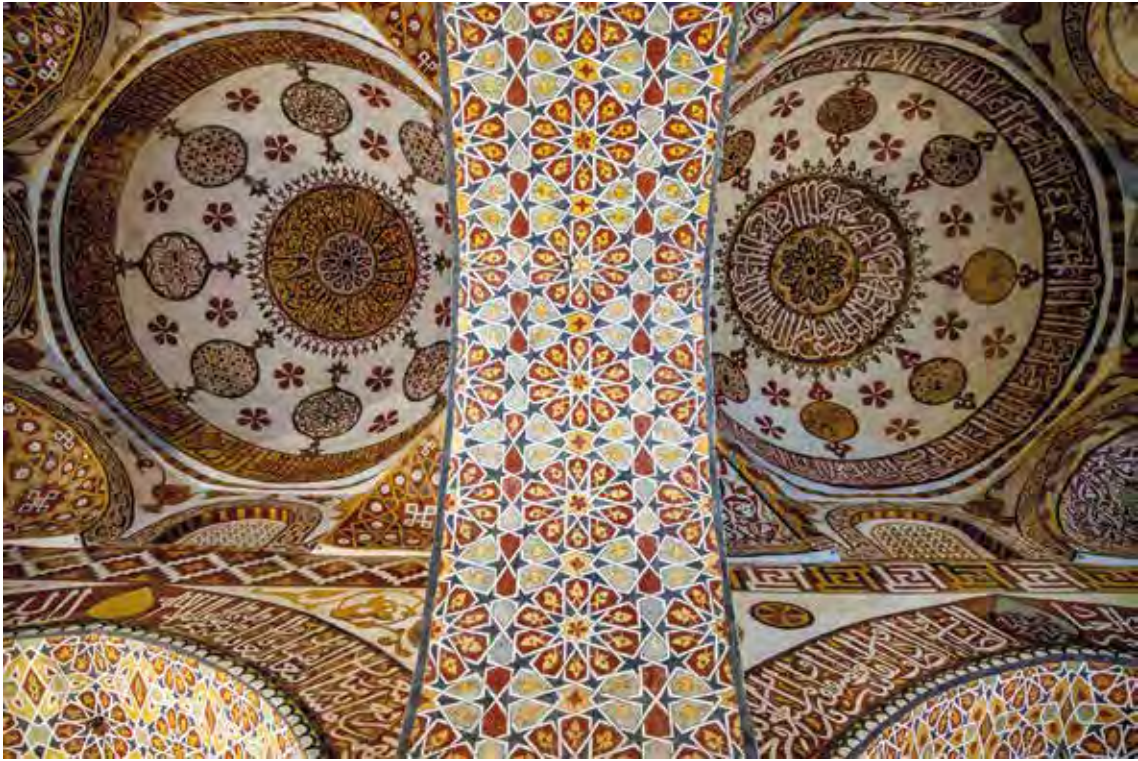
Fig. 10. Domes **1f** and **1g** (photograph by Majed Alahmadi, 2022).

In Figure 9 we can observe two lateral domes (indicated on the plan as **1f** and **1g**) with the arrangement of the inscriptions in monumental *thuluth* on the summit and along the arches. Among the decorative elements, we discern red or white Rasulid rosettes with five (sometimes six) petals; circular designs with appendices along the vertical axis (called by various names: *shams* ‘sun’, *naranj* ‘orange’; and locally *rummān* ‘pomegranate’); arabesques based on a geometrical structure. A second inscription in *thuluth* characters encircles the domes at the bottom. On the walls we see (on the right) a band with the name ‘Alī repeated and (on the left), a decorative motif, while around the great doors there are Qur’anic inscriptions.

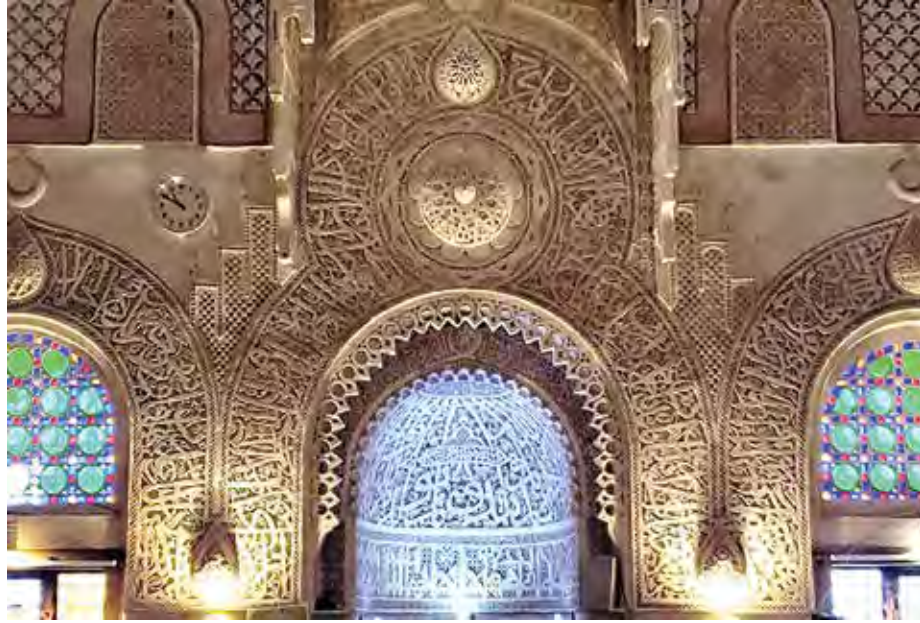
The prayer hall is the central part of the building. The niche of the *miḥrāb* is located on the north wall and is surrounded by a long Qur'anic inscription in *thuluth* characters carved

in the plaster, with the entire Sūrah al-Raḥmān (55: The Lord of Mercy).⁶⁰ The central portion of the inscription is presented, on the basis of the available photography.

Fig. 17. The Qur'anic inscription around the *mihrāb*.

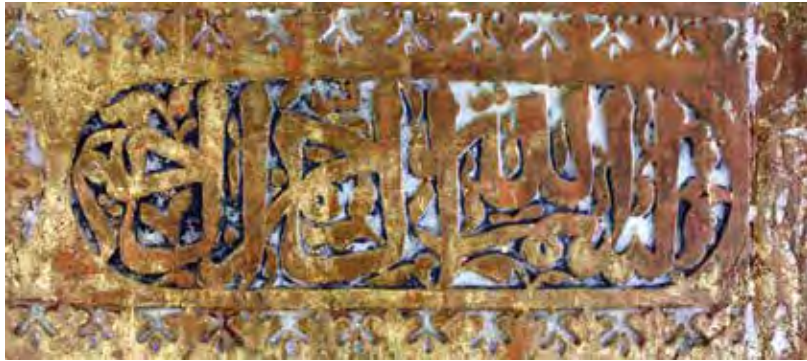
Fig. 32. The *basmalah*.

At the bottom we can see mosque lamps (*thurayyāt*) as decorative elements. The lamp could evoke the verses of the Light (Q 24: 35-36).

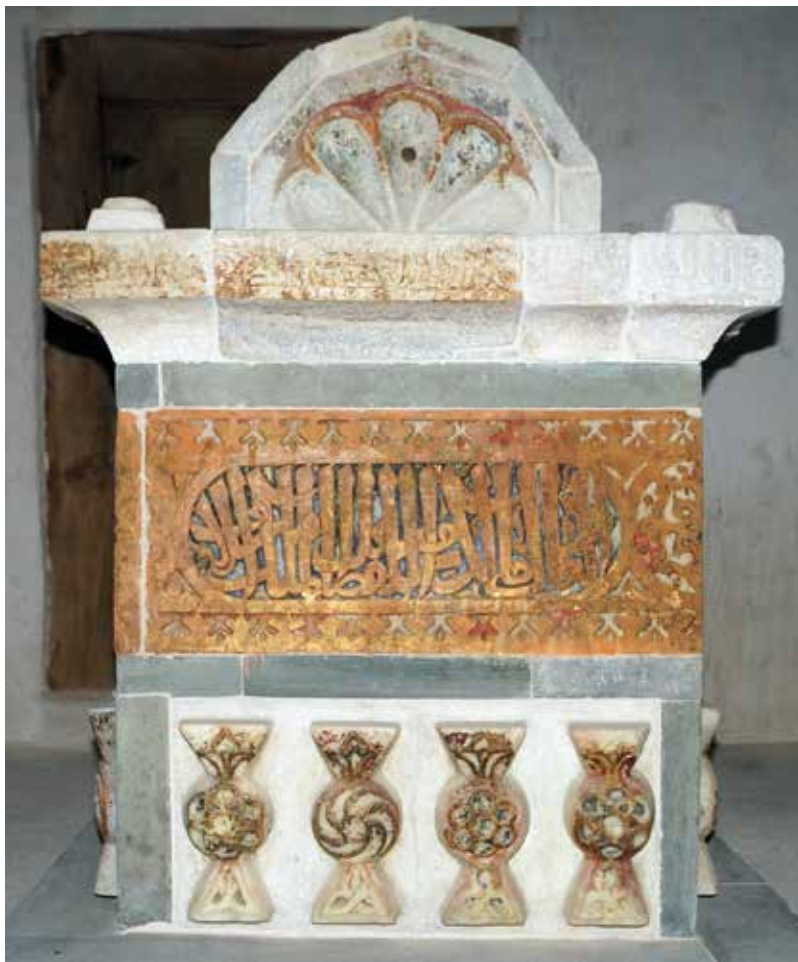
Fig. 33. North side of the cenotaph with the name of sultan al-Malik al-Ashraf.

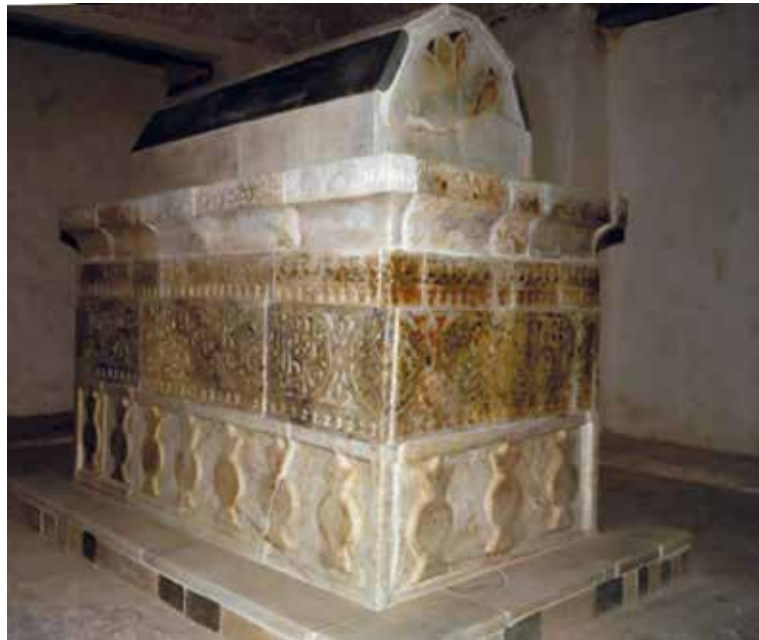
Fig. 34. Cenotaph of al-Malik al-Nāṣir Aḥmad.

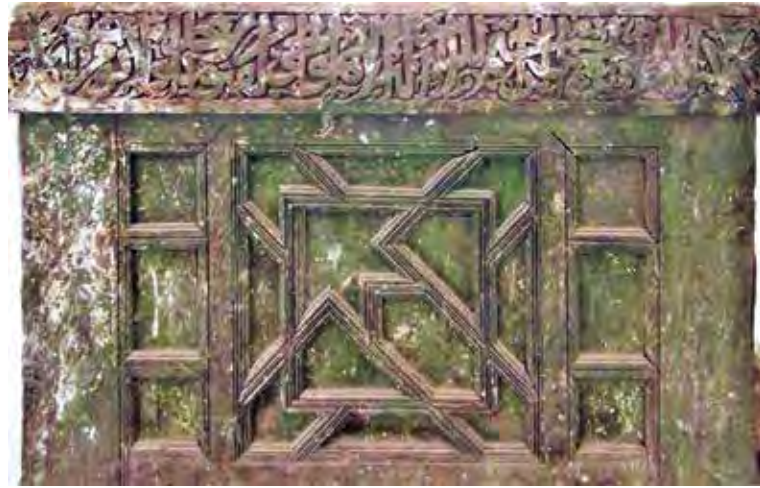
Fig. 35. Cenotaph in wood.

The cenotaph was found in a very poor state of conservation and lacking the entire upper portion. What remained of the original inscription is limited to the *basmalah* and the beginning of the Verse of the Throne of Surah al-Baqarah (Q 2: 255).⁶⁸ No name of the deceased.⁶⁹

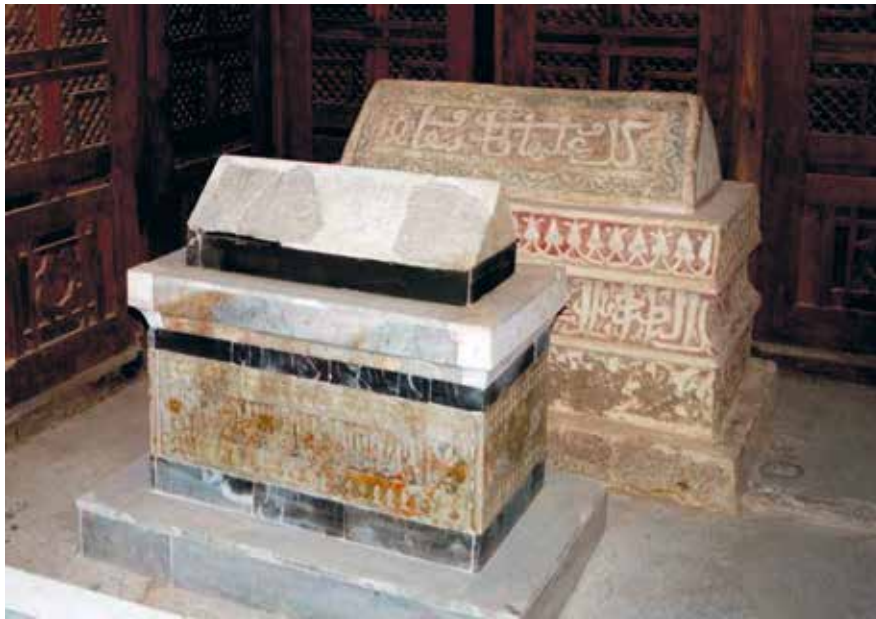
Fig. 36. Cenotaphs of Ḥasan, son of al-Malik al-Ashraf, and of al-Malik al-Nāṣir Aḥmad.

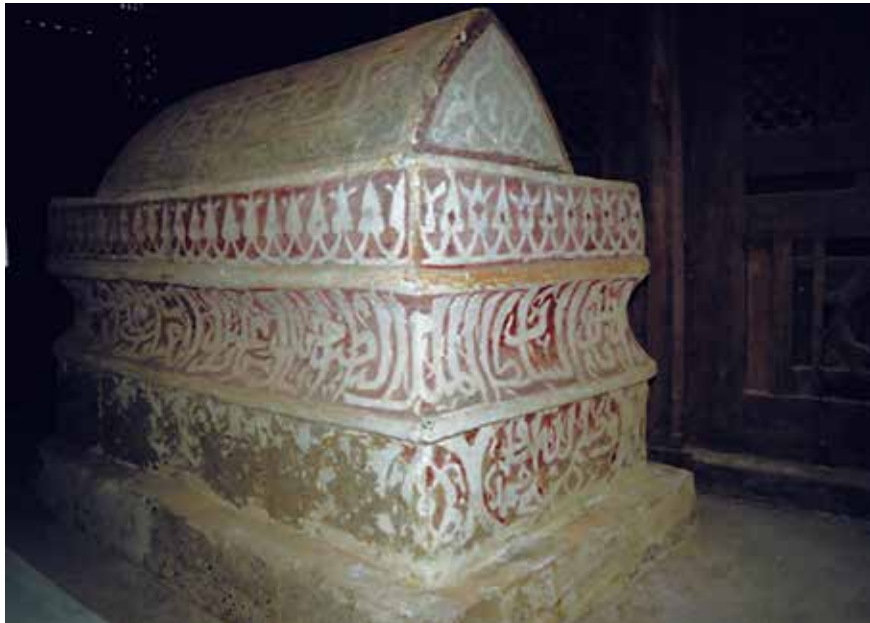
Fig. 37. Cenotaph of (the son of ?) al-Malik al-Nāṣir Aḥmad.

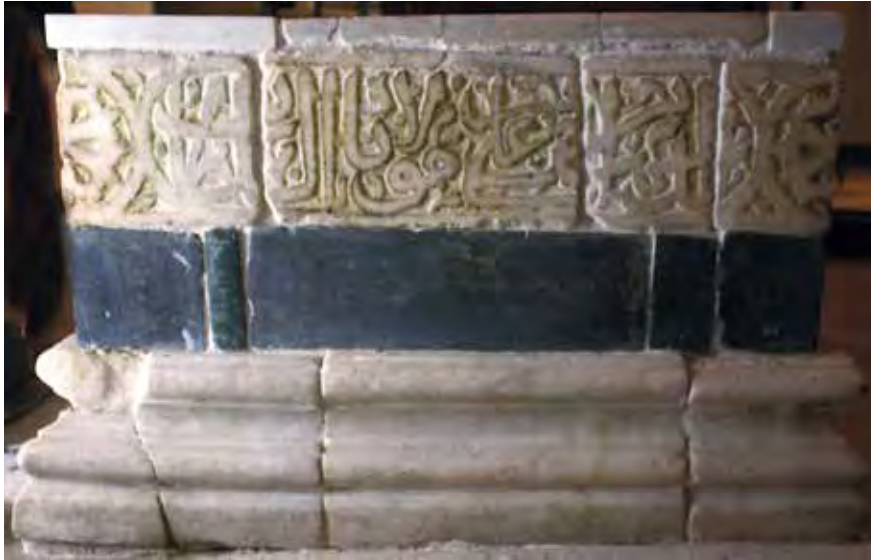
Fig. 38. Cenotaph of al-Malik al-Mujāhid (‘Alī).

Nothing but the base remains of the original cenotaph. With the restoration, it was possible to rejoin the parts, integrating the missing ones (see Section 3 – Chapter 2, Figs. 85-98). There is still some doubt as to the reading and interpretation. It was perhaps dedicated to al-Malik al-Mujāhid ‘Alī, son the the sultan al-Malik al-Nāṣir and grandson of al-Malik al-Ashraf.⁷²

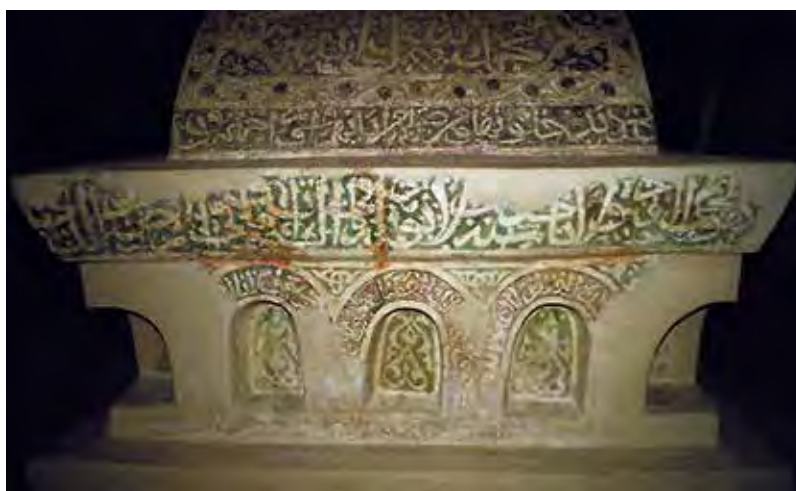
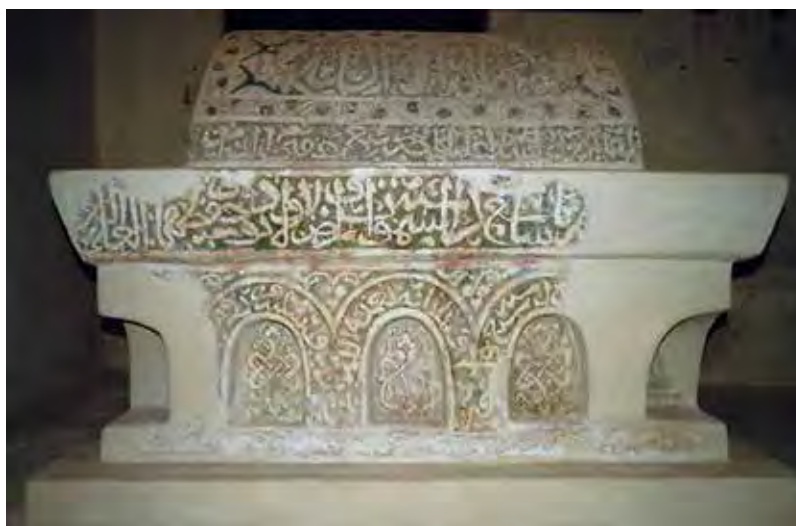
The cenotaph is located in the southeast corner of the Library, at some distance from the other three, which are grouped inside a wooden structure. The restoration made it possible to read parts of the inscriptions. On the top are the *shahādah* and on the north side the *qiblah* la. Two Qur’anic verses are written along the faces of the monument: Q 13: 23-24 and 2: 255, the “verse of the Throne”. The lower portion, in smaller scripts, is more difficult to read.⁷³

Figs. 39-40. Cenotaph of al-Malik al-Mufaḍḍal (?).

This cenotaph required a laborious process of restoration (see Section 3, Chapter 2, Figs. 107-131). The script presents a number of gaps.

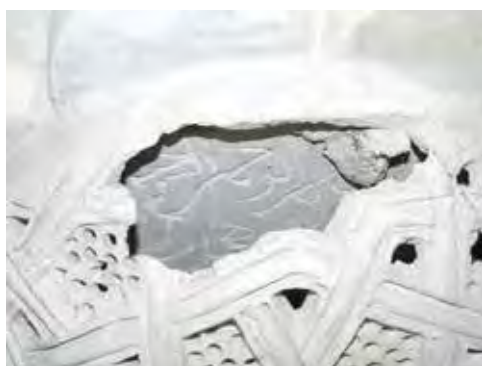
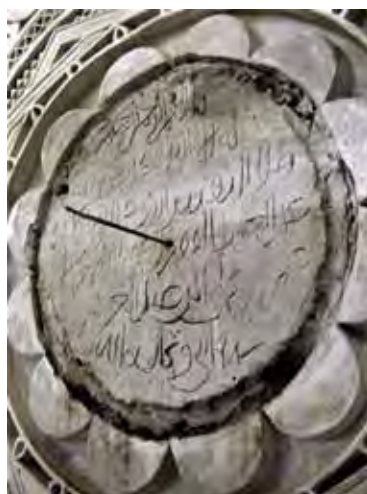
Figs. 41-42. The inscription which came to light during the restoration work.

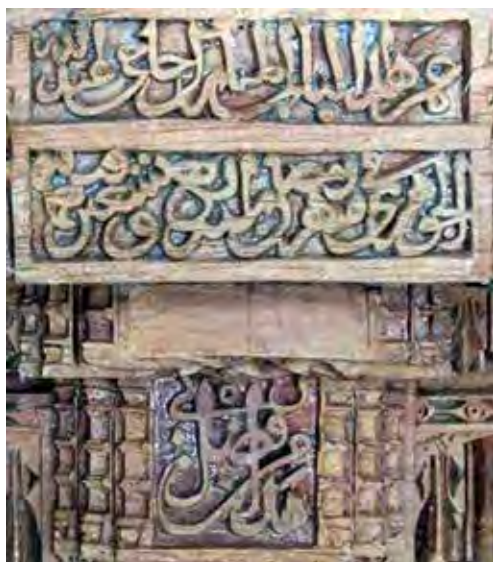
The artisan who built the western door of al-Ashrafiyyah Mosque and Madrasah complex carved a celebratory panel above the lintel on the outside of the southern door. It contains the name Ḥājī ‘Abd Allāh al-Jawharī, and the date 894. The script, in *naskhī* characters, is confused in the final part, apparently due to an erroneous division of the spaces. This date probably indicates the completion of the works done to expand the Madrasah, works that had begun almost a century earlier.

Fig. 43. Inscription over the southern door on the outside of the south wall.

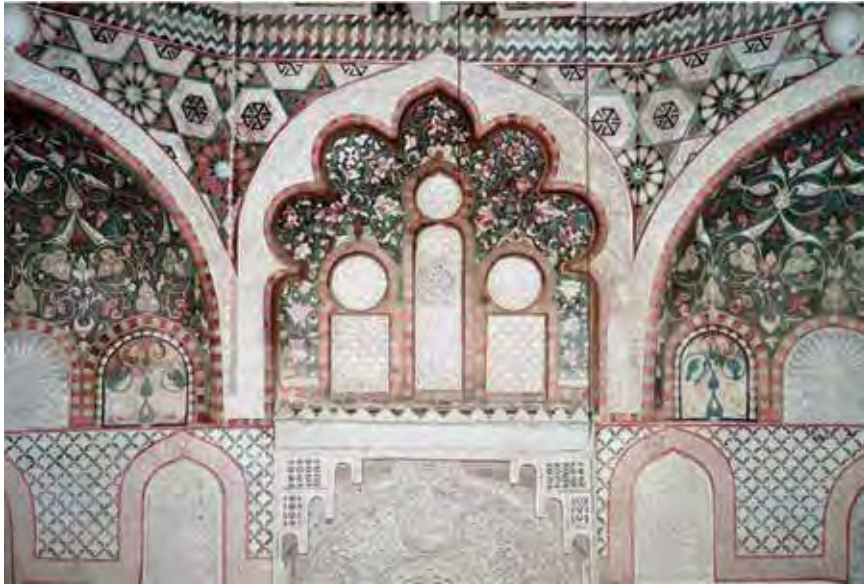
Fig. 4. Main dome, second register, octagonal tambour, details. Kiosk in stucco over the *miḥrāb*, ogival pentalobate window and, in the corners, niches with ogival arches.

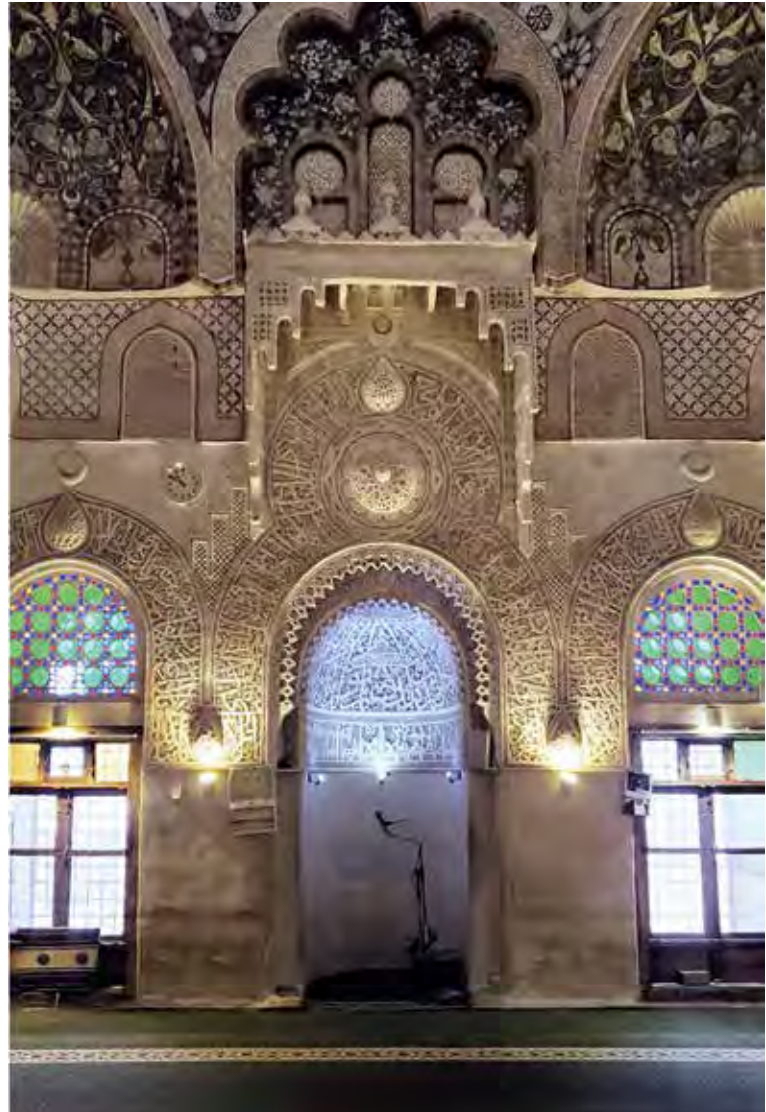
Fig. 6b. General view of the *mihrāb*. Photo taken in January 2021 by the Yemeni artist Nezar Moqbel.

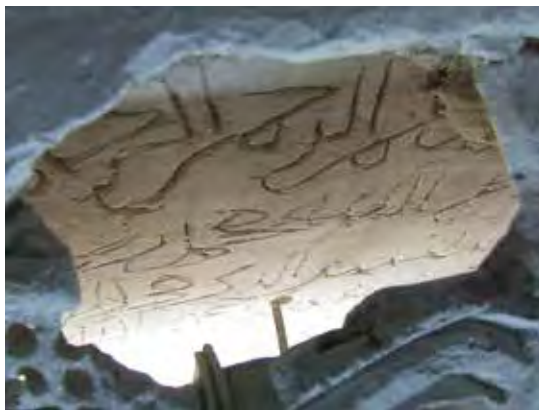
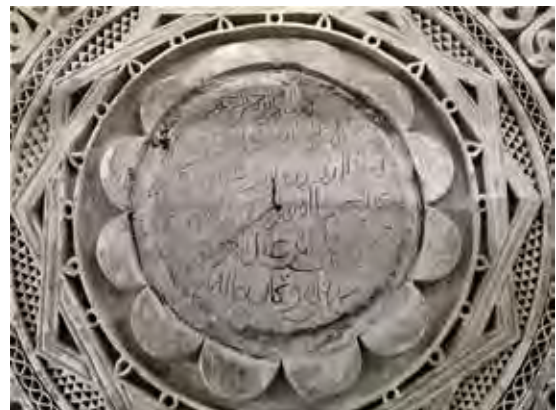
Figs. 6c and 6d. Detail of the writing found etched on the plaster behind a carved boulle.

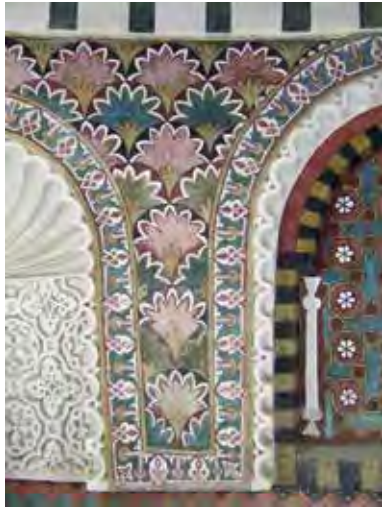
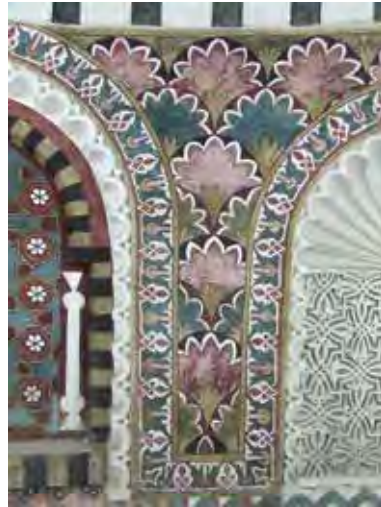
Figs. 7 and 8. Main dome, third register, octagonal tambour. Floral decorations between the windows and the niches in perforated plaster.

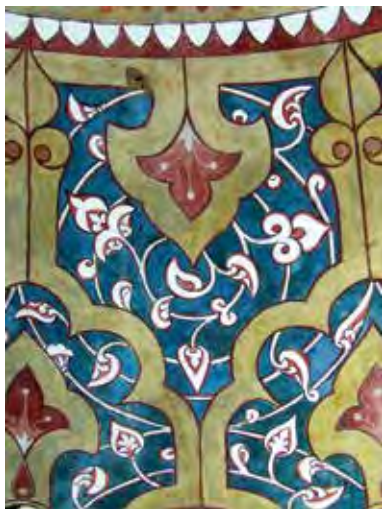
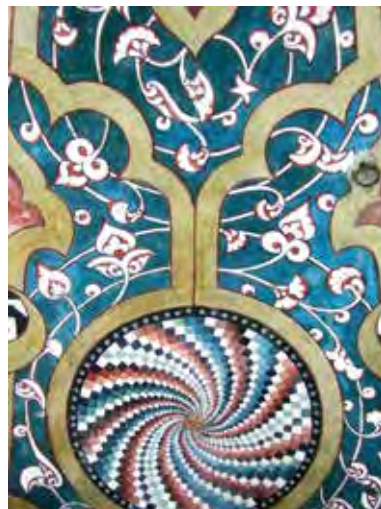
Figs. 9 and 10. Hemispheric dome. Detail of pergola.

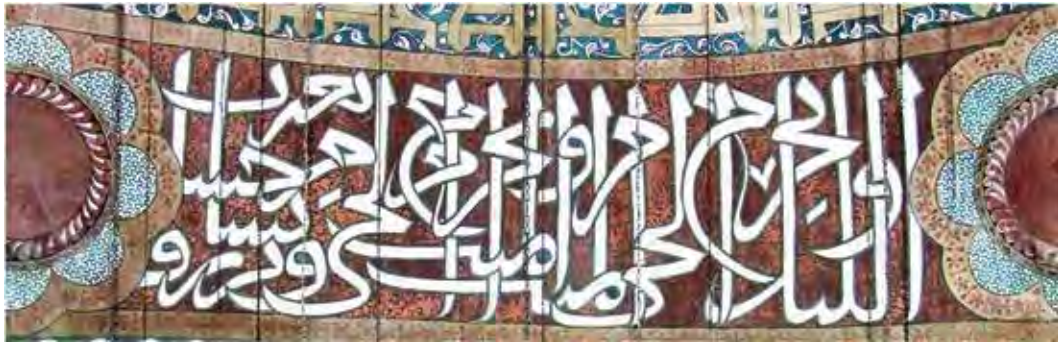
Fig. 11. Hemispheric dome: first section with broad calligraphic band, which stands out against a carpet of red floral designs. Qu'ran 3: 27.

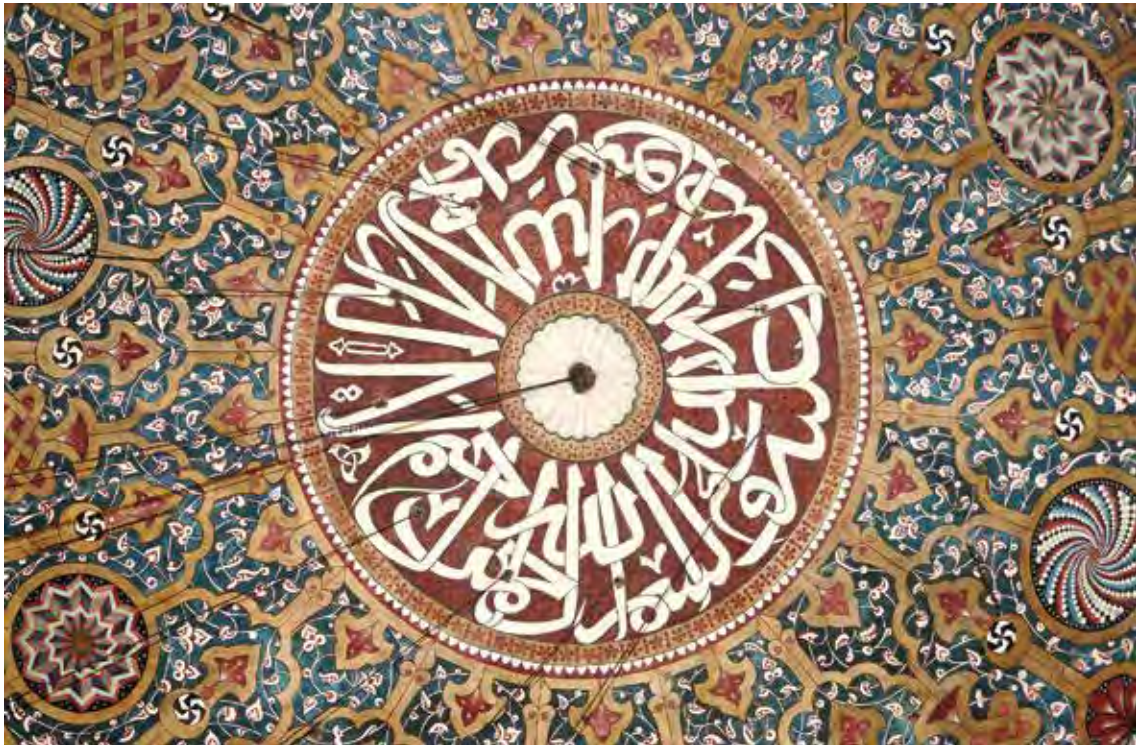
Fig. 12. Apex of the hemispheric dome with the *basmalah* and the *shahādah* in *thuluth* calligraphy.
