AL-ASHRAFIYYAH MOSQUE AND MADRASAH IN TA'IZZ

Conservation intervention (2008-2015)

The subject of this volume is the work of restoration of the paintings, stuccoworks and woodwork, and the structural consolidation of the al-Ashrafiyyah Mosque and Madrasah in Ta'izz (Yemen, 13th-14th century), carried out by the Istituto Veneto per i Beni Culturali (IVBC, 2008–2015) thanks to the support of the Social Fund for Development (SFD – Culture Heritage Unit). It follows the previous volume *The Great Mosque of Ṣan'ā'. Conservation intervention (2005–2015)*, published in June 2022.

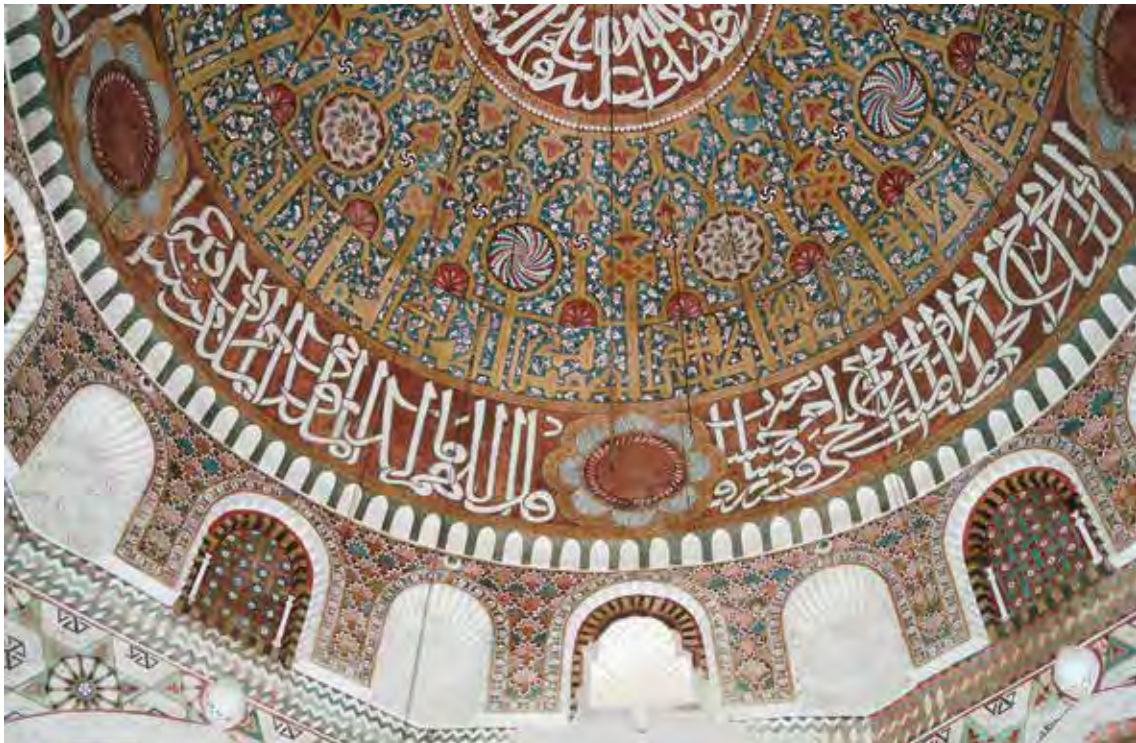
Fig. 13. Octagonal tambour and hemispheric dome, general view. Qu'ran 3: 26-27.

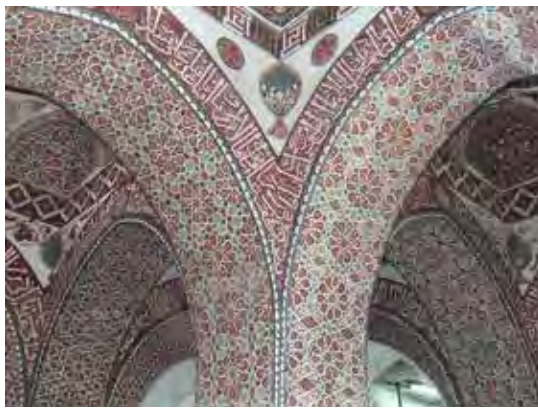
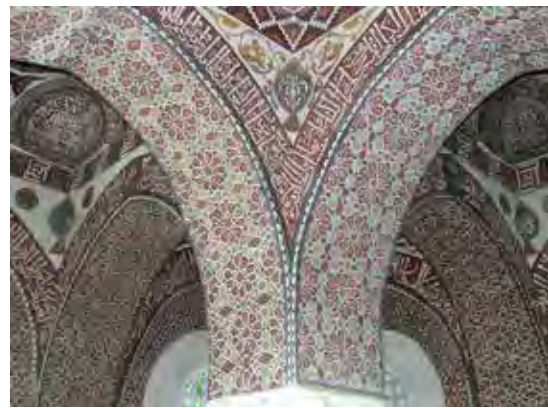
Figs. 14 and 15. Small domes, general view of east sector.

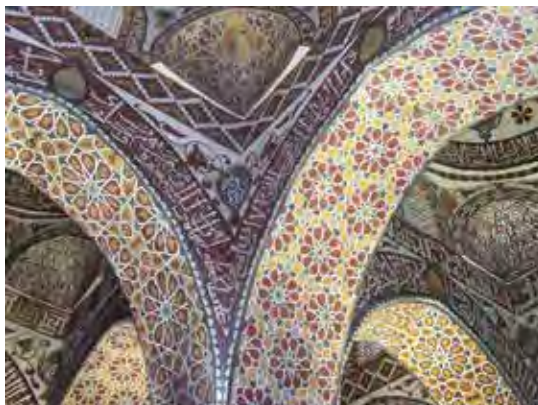
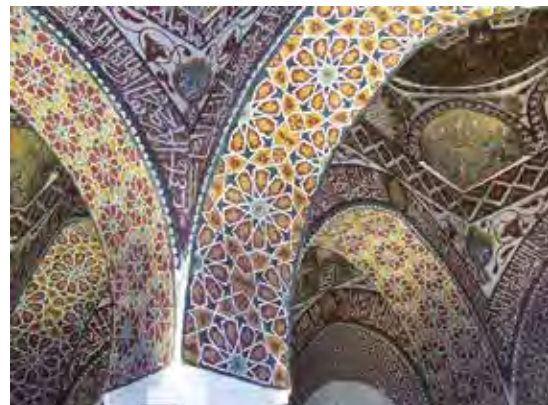
Figs. 16 and 17. Small domes, general view of west sector.

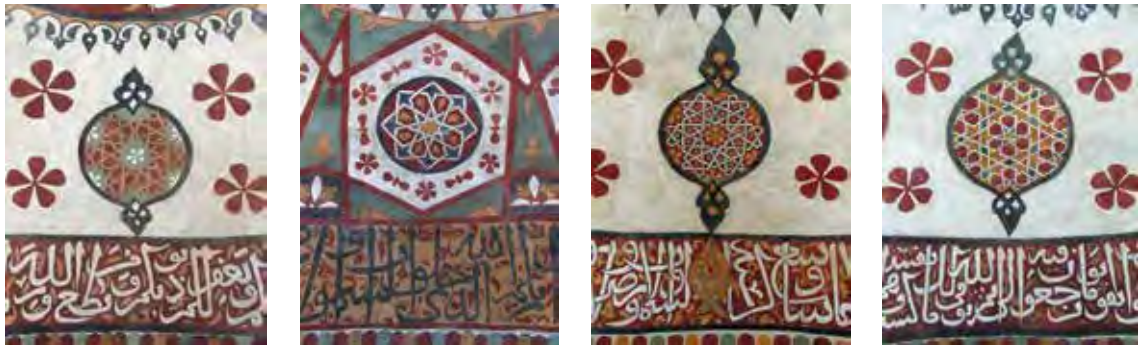
Figs. 21a, b, c, d. Small domes, types of decorations of the hemisphere.

The central part, placed between the two inscriptions, is the most characterized portion of the dome and is organized into two main types of decoration.

The first features rounded designs that echo the shape of the pomegranate, on a white background, separated by red flowers with five petals, symbols of the Rasulid dynasty. The second contains eight hexagons on a green background, inscribed with circles whose decorations are reminiscent of those used in the decorative pomegranate designs.

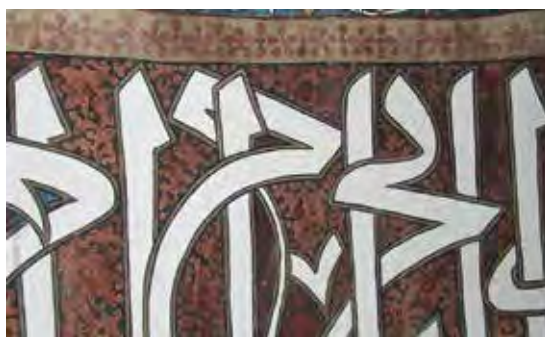
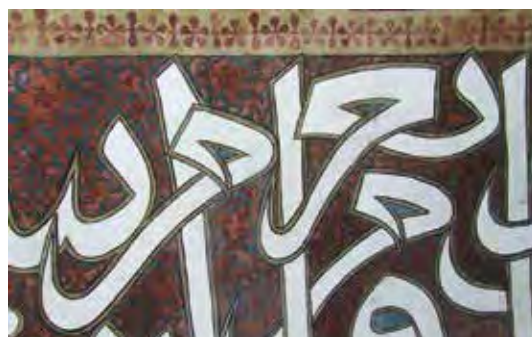
Figs. 22 and 23. North dome interior. First ring with *thuluth* calligraphic band, details.

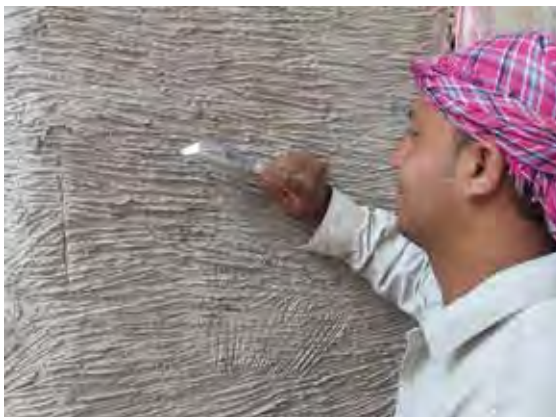
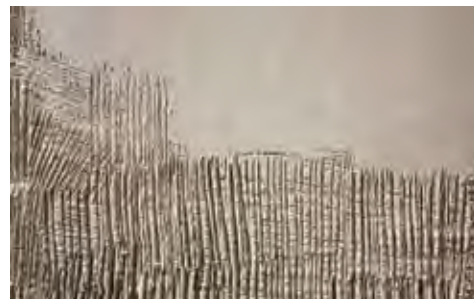
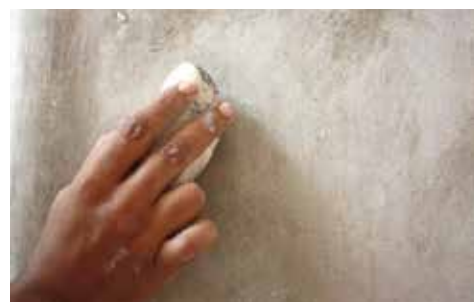
Figs. 27, 28 and 29. Example of last application with fine plaster, pounded with the sharp edge of a stone and smoothed with a flat stone during reconstruction of the *qadād* finish on the outer walls of al-Ashrafiyyah Mosque and Madrasah.

The work of application of the exterior coating goes on for days. With the layers still wet, continuing to spray water, the last coat of fine plaster is finished by smoothing with the flat side of a stone, until the surface becomes extremely smooth and hard as marble.

Beyond the description of the scientific studies and laboratory tests, it is possible to show how the tradition of this technique of coating with *qadād* plaster has continued through the centuries arriving at our own time, taking as example the works of resurfacing the plaster done at the mosque. The three coats of plaster are applied one over the other in close sequence on the masonry, and it is continuously pounded with the sharp edge of a stone during application. After the first rough coat has been applied but is still wet, a second coat of medium granulometry is applied, followed by a third of finer quality, constantly pounded until the mortars are penetrated completely one in the other.

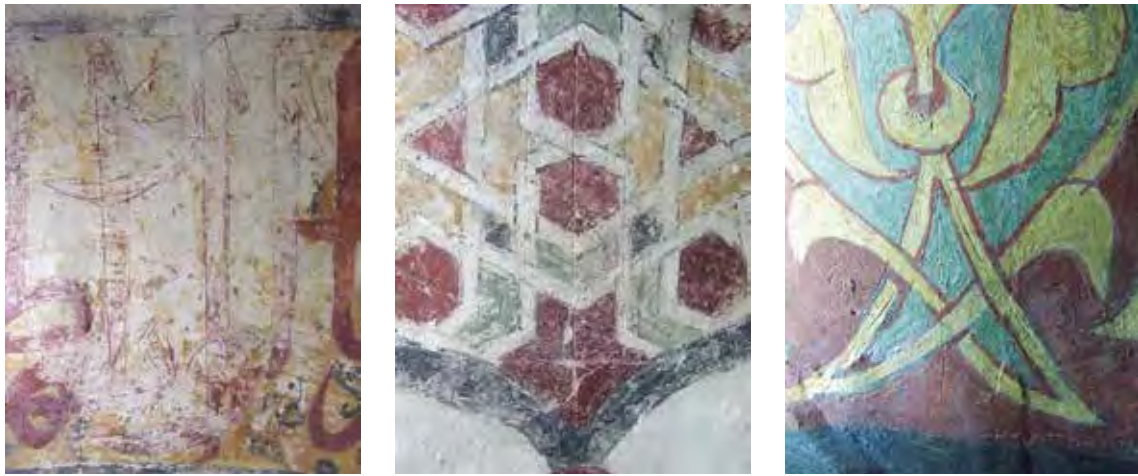
Figs. 30, 31 and 32. Close-up of preparatory design etched in the mortar.

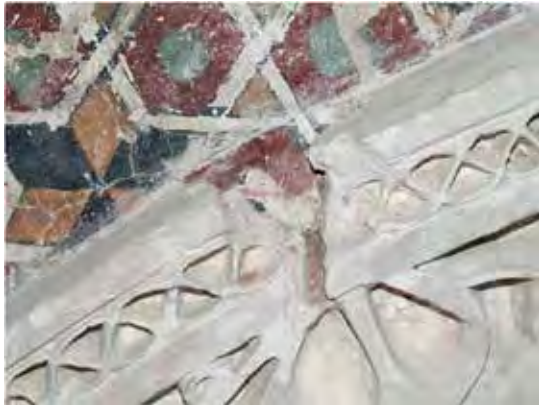
Fig. 33. Stuccowork decoration on mural painting.

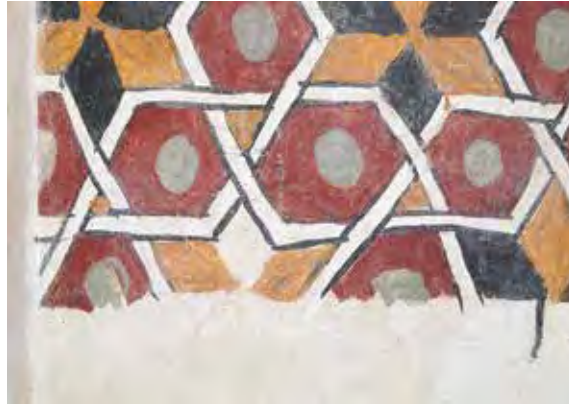
Fig. 34. Detail of application of fresco painting on plaster.

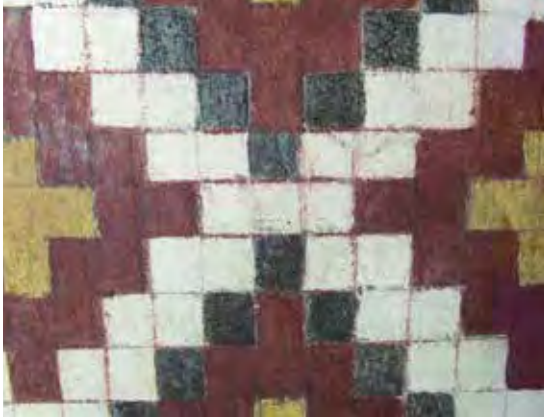
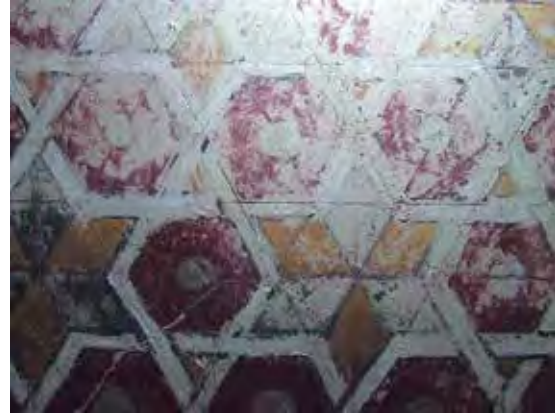
Figs. 35 and 36. Small domes: detail of repeated design made using paint-soaked cord and finished by etching.

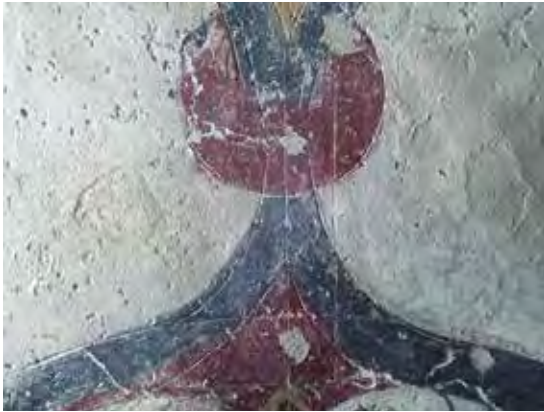
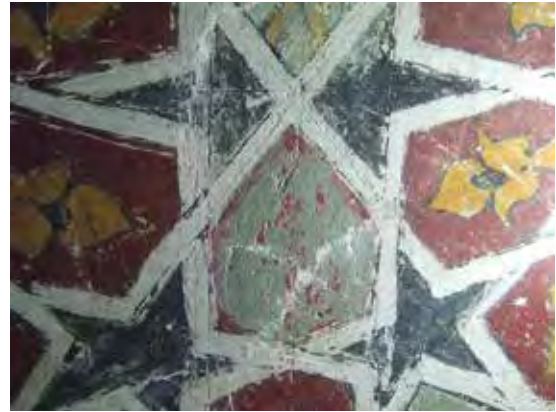
Figs. 37 and 38. Dome 1f and under-arch 1f-g. Close-up of details of preparatory design or etching. On the right we can see evidence of a correction, the green on red.

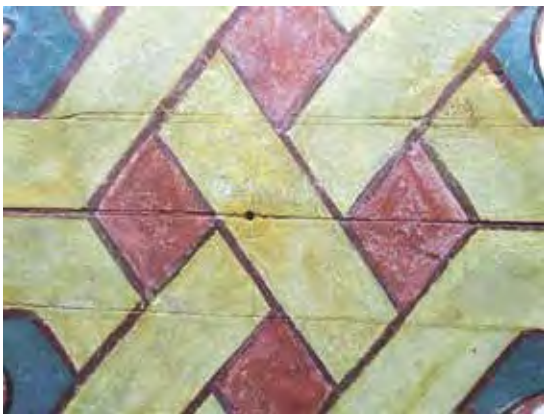
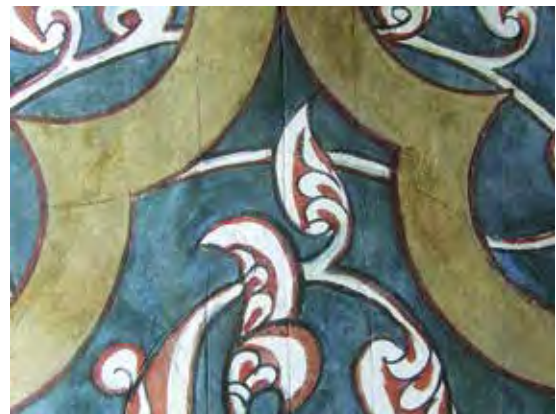
Figs. 39 and 40. Main dome: interior, close-ups highlighting the etched lines.

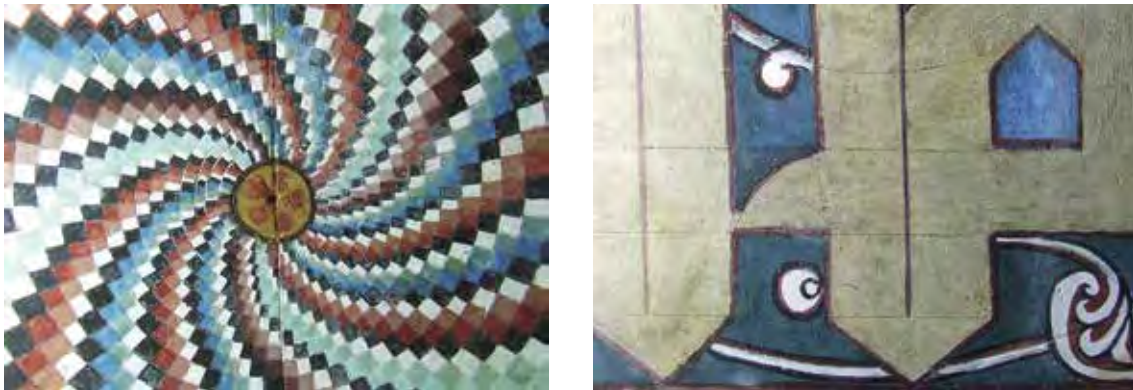
Figs. 41 and 42. Main dome: interior, close-ups highlighting the etched lines.

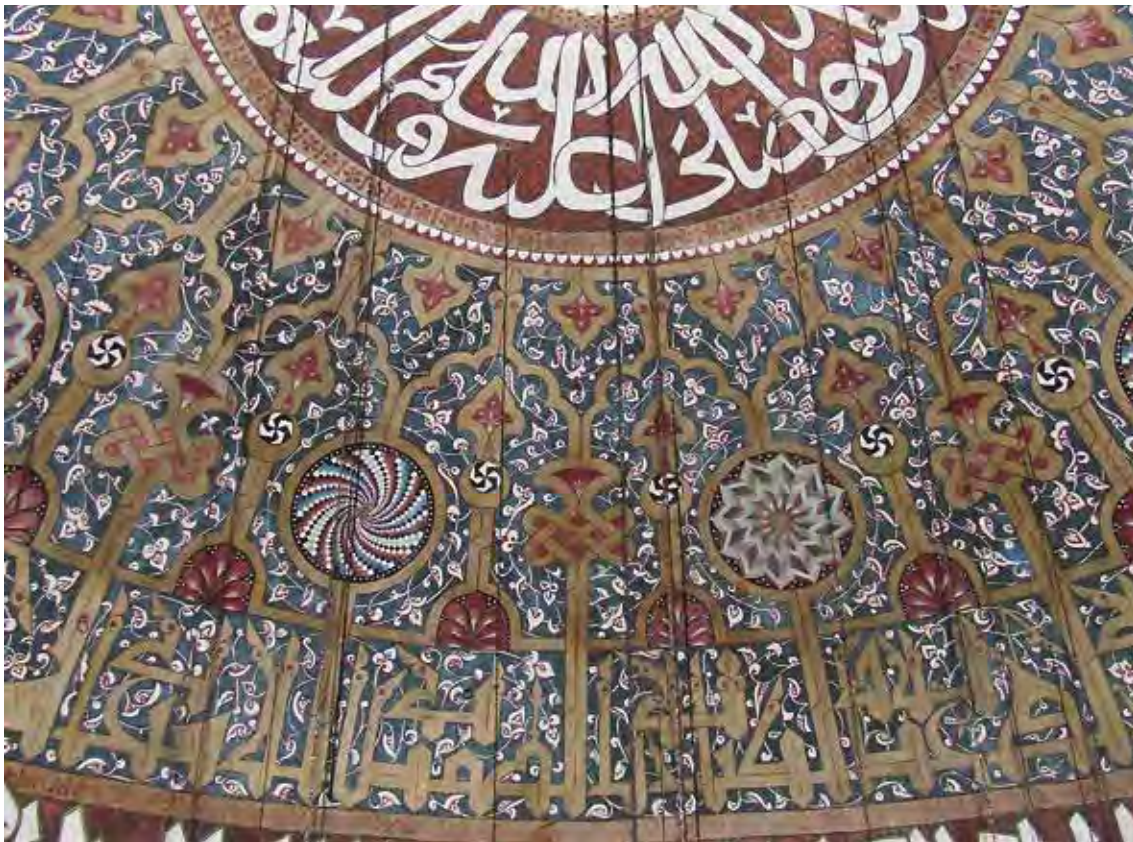
Fig. 43. Main dome: interior. The photo exemplifies the precise symmetry of the decorative project.

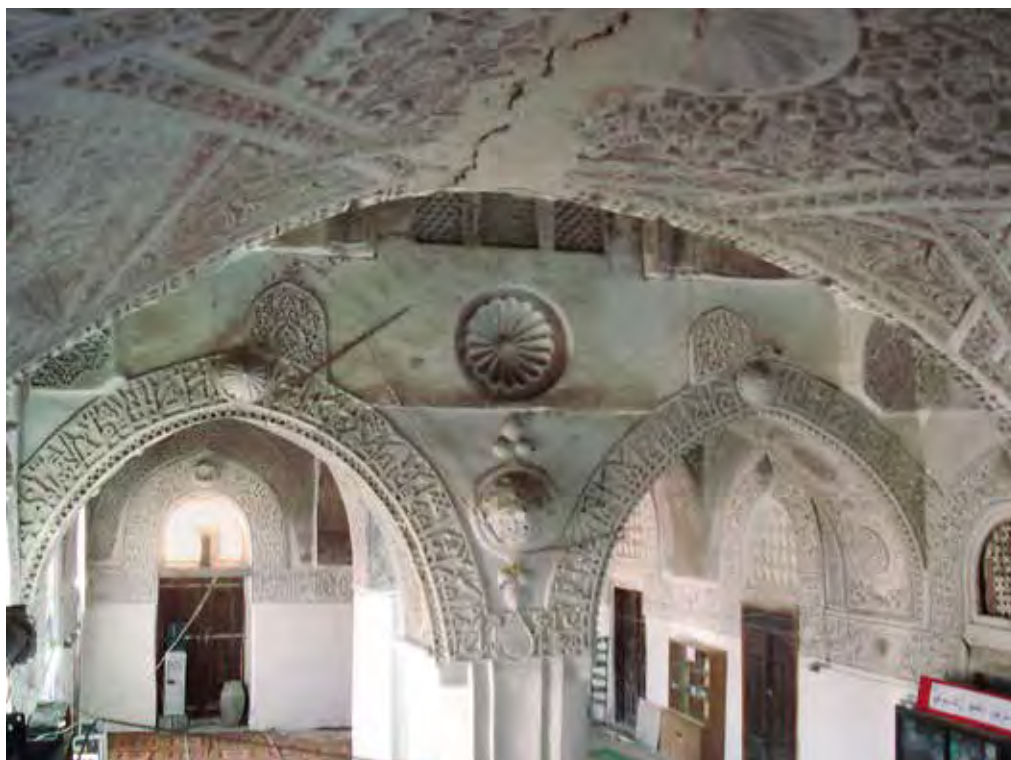
Fig. 1. Small domes. Fracture across the apex of the northwest archway.

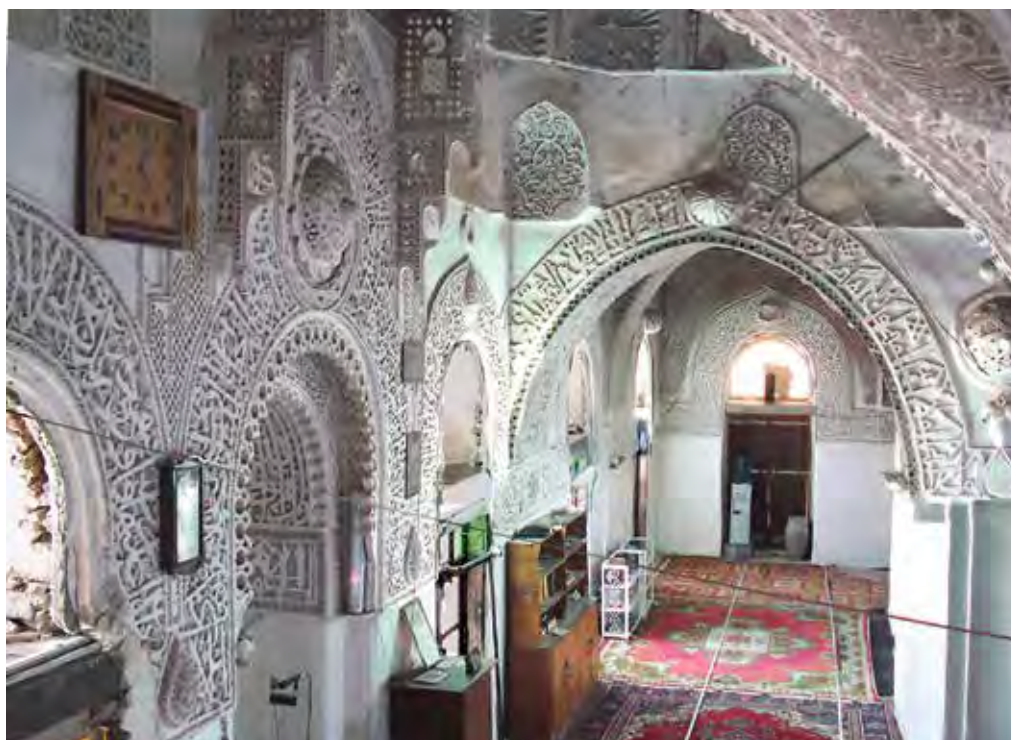
Fig. 2. Main dome, north wall with the *mihrāb* before restoration.

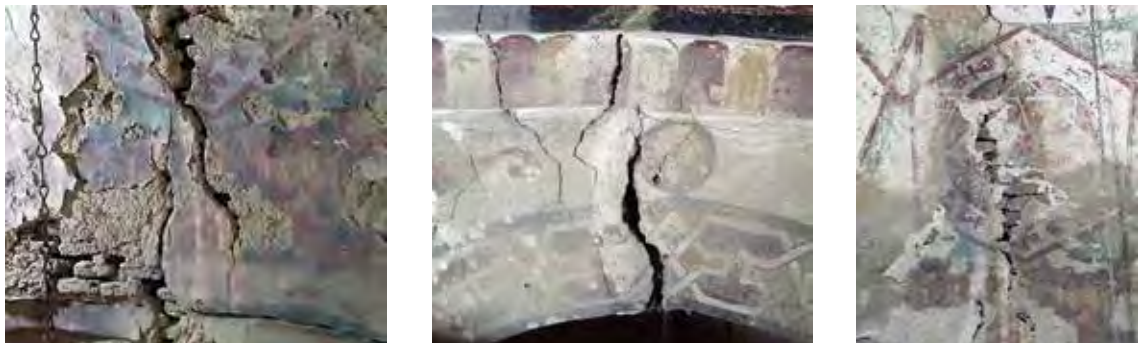
Figs. 3, 4 and 5. Small domes, fissures caused by structural sagging and detachment of the decorated plaster due to seepage.

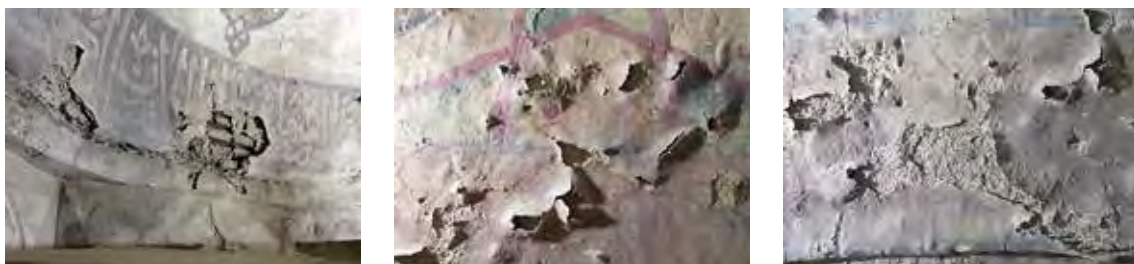
In some portions of the domes, bubble-like swellings had formed, significantly lifting the edges of the plaster, with exfoliation and pulverization of the pictorial film and surface erosion of the decorations.

Figs. 6, 7 and 8. Small domes: examples of gaps, swelling, lifting, bubbles and powdering. Details.

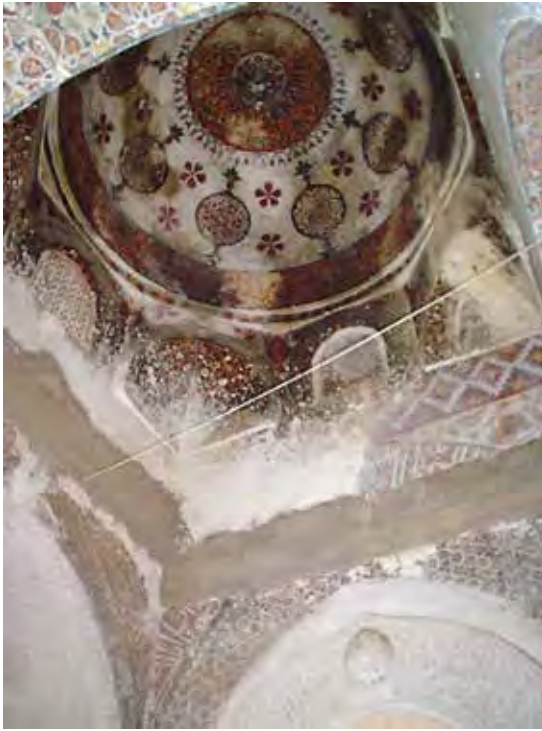
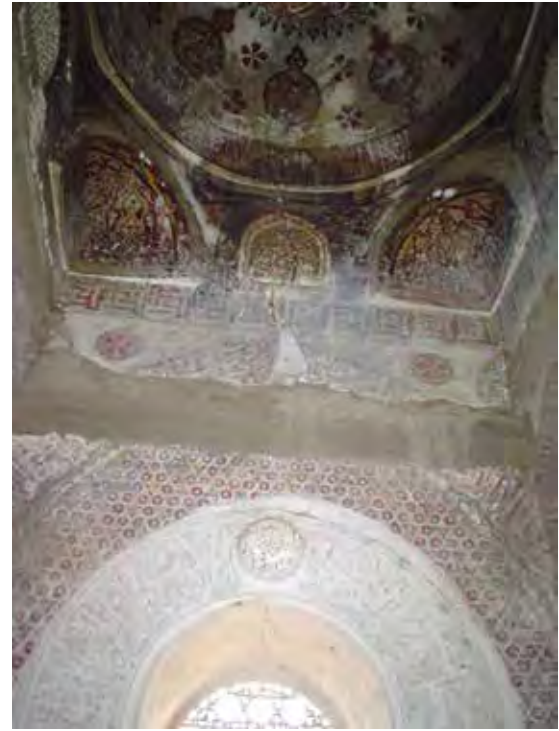
Figs. 9 and 10. Domes 1f and 1h, gray edging in reinforced concrete.

In the 1978-1980 period, just to remedy the static problems, fortunately excluding the main dome, it was found advisable to insert into the framework of the eight walls of the smaller domes, between the supporting arches and the tambour, reinforced concrete beams about 40 cm high, which formed a ring around all the sectors at the level of the intrados uprights supporting the hemisphere. It has been calculated that in the works for insertion of the concrete beams, about 40 square meters of painted decoration were lost.

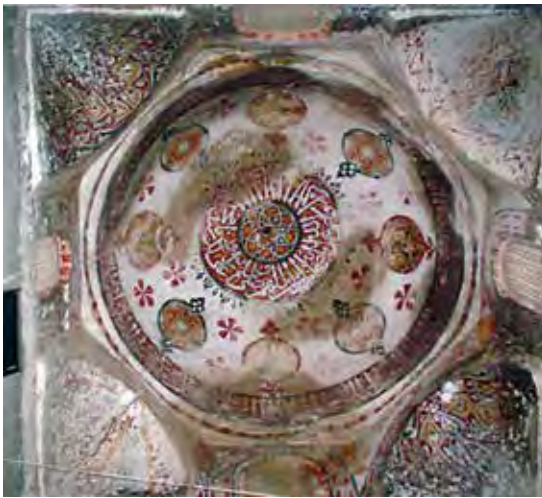
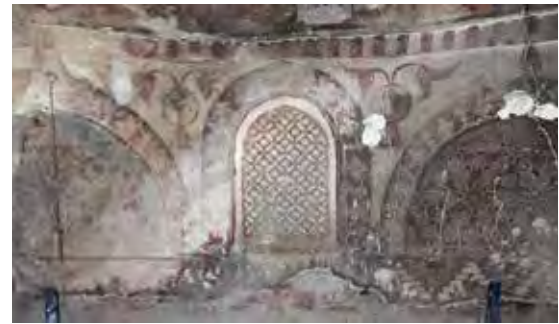
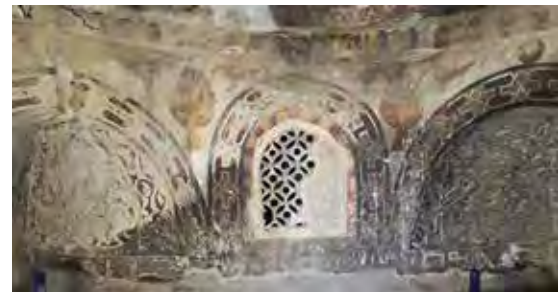
Figs. 11, 12 and 13. Dome 1a. Detail of intrados and tambour.

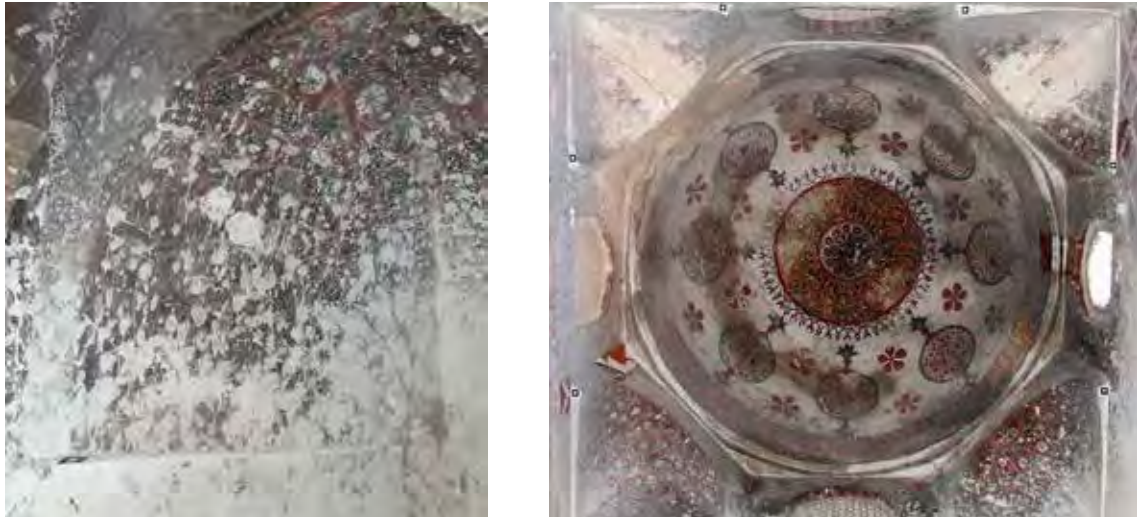
Figs. 14 and 15. Dome 1f. Detail of niche of tambour and intrados.

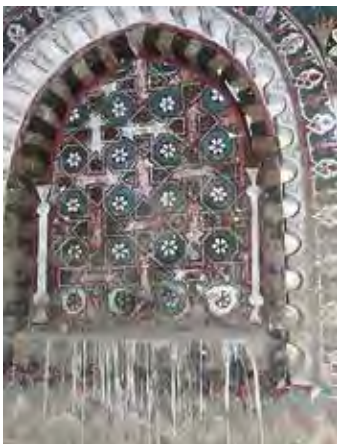
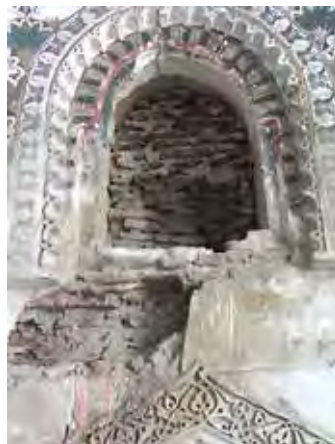
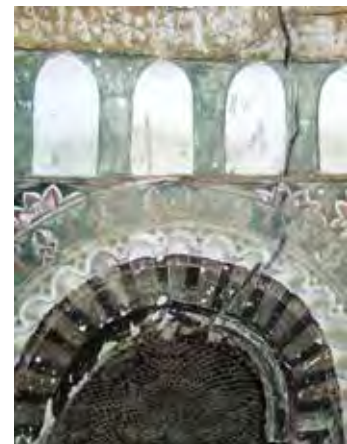
Figs. 20, 21 and 22. Tambours on west, south and east sides.

In the area of the tambour of the main dome, the apertures in the stuccowork, as they crumbled, created numerous openings toward the outside. In time, the dome had become the habitat of birds. The painted area, underneath the string course, showed clear streaks and stains due to the excretions of the birds, also absorbed on the inside of the porous plaster supporting structure. In addition, in order to cling to the string course where they built their nests, the birds had scratched the paint badly with their claws.

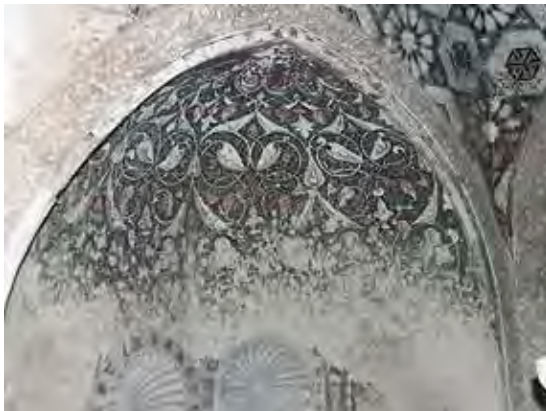
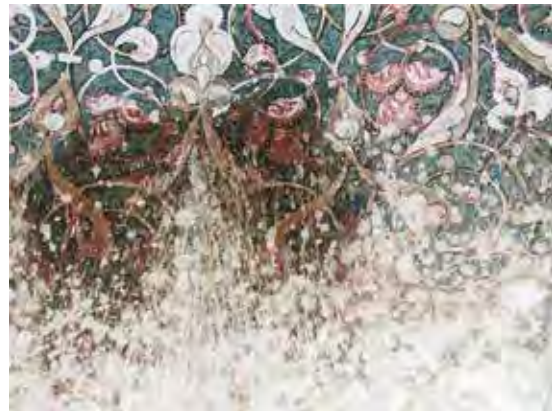
On the second register, two of the large niches with ogival arches in the four corners, richly decorated with stylized floral motifs, revealed a particular problem. Once, from the

top of the arches, chains were hung, connected to a bowl which held an oil lamp. The system for raising and lowering the bowl in order to light and extinguish the lamp, worked like a pulley. From time to time, in raising and lowering the chains, the bowl was overturned, spilling oil on the decorated walls and leaving obvious grease marks.

Figs. 23 and 24. Northwest niche of tambour, general view and detail of southwest niche.

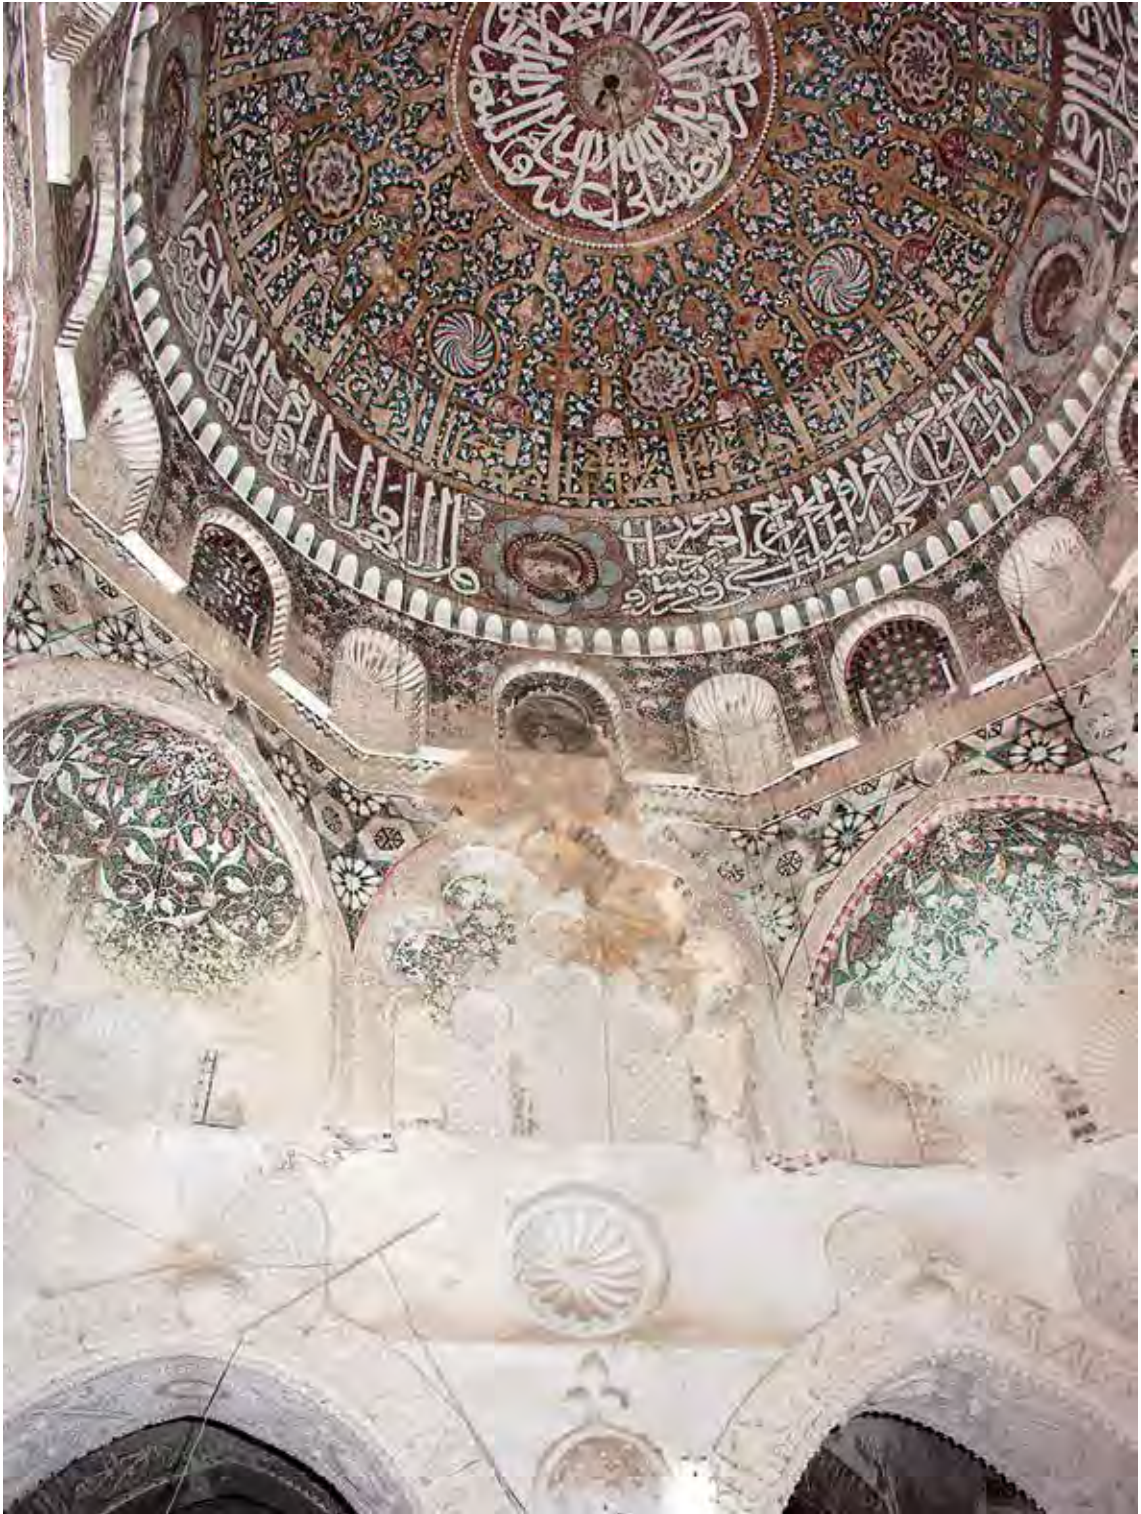
The plastering of the main dome, a treatment that is particularly sensitive to changes in moisture, had lost consistency in time, eventually flaking off entirely. The mechanical erosions were visible on the surface: patches that were detached from the masonry, plaster in a state of pulverization, paint film weakened on all the surfaces.

Fig. 25. Main dome, east side. General view.

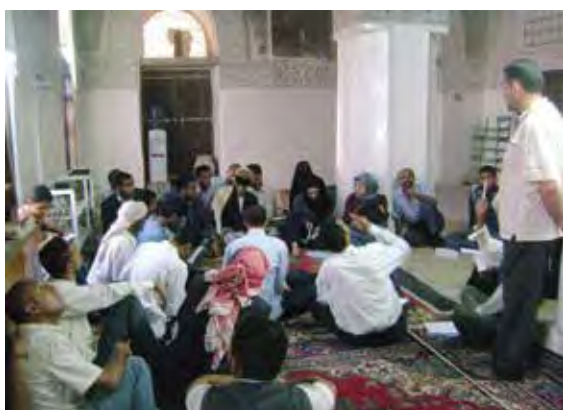
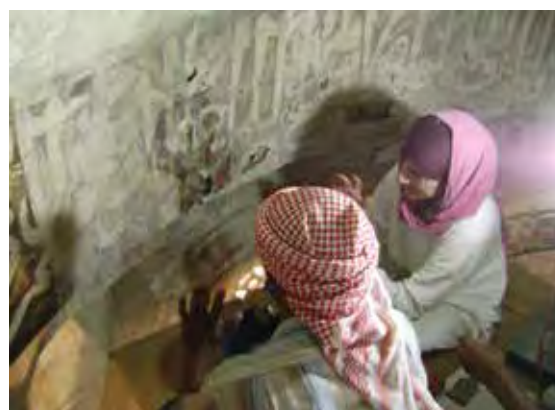
Figs. 3 and 4. Training course, appraisal of state of conservation and tests of surface adhesion.

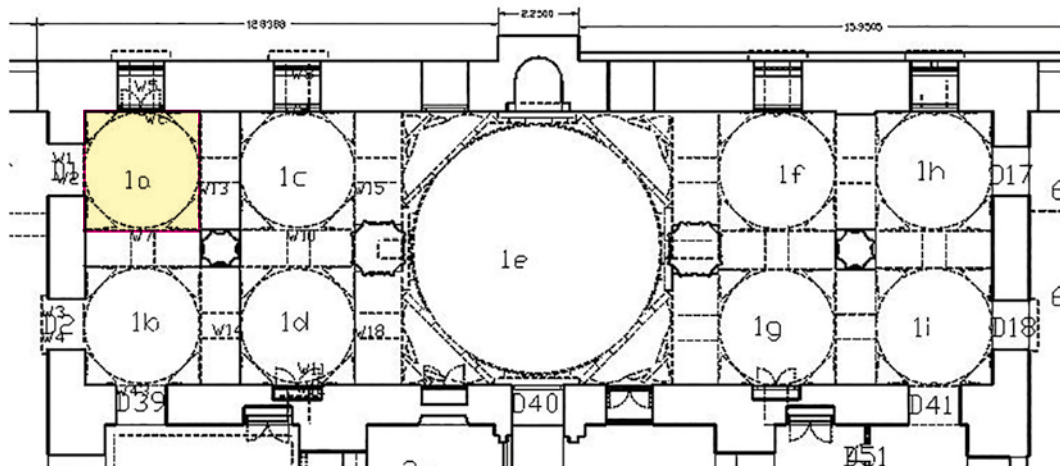
Fig. 5. Floorplan of the Prayer Hall. In yellow, the west wing, small dome 1a, pilot-worksite.

At the same time, the pilot worksite, having completed all the sample operating stages, focused on dome 1a, with a program that included: stabilizing the plasterworks, fixing the paint film, removal of the whitewash and previous patching with stucco, cleaning, repairing fissures and gaps, retouching of the painted decoration for a unified and balanced esthetic presentation.

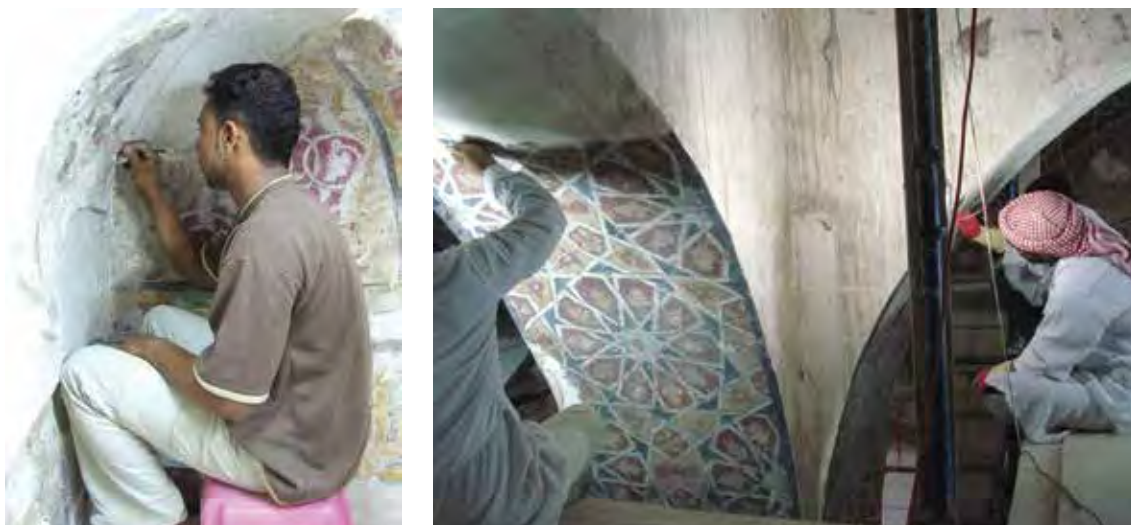
Figs. 6 and 7. Removal of lime whitewash and surface concretions using scalpels.

The first operations carried out in the four west sectors were the facing of the loose, endangered decorated plaster and the removal of the thick coating of whitewash that covered most of the surface of the mural paintings and stuccoworks, up to the tambour.

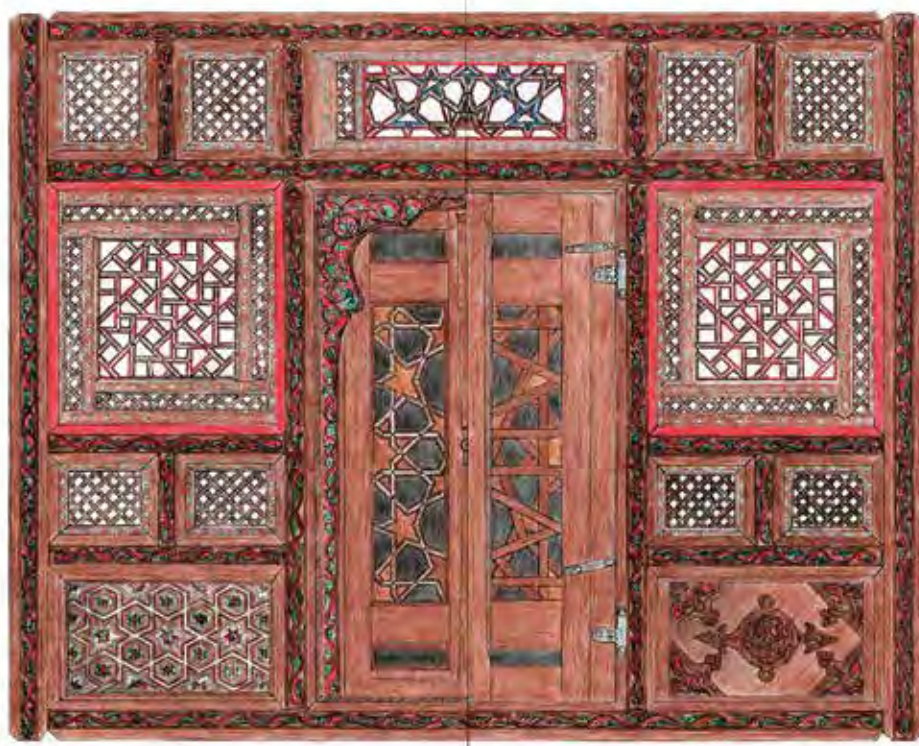
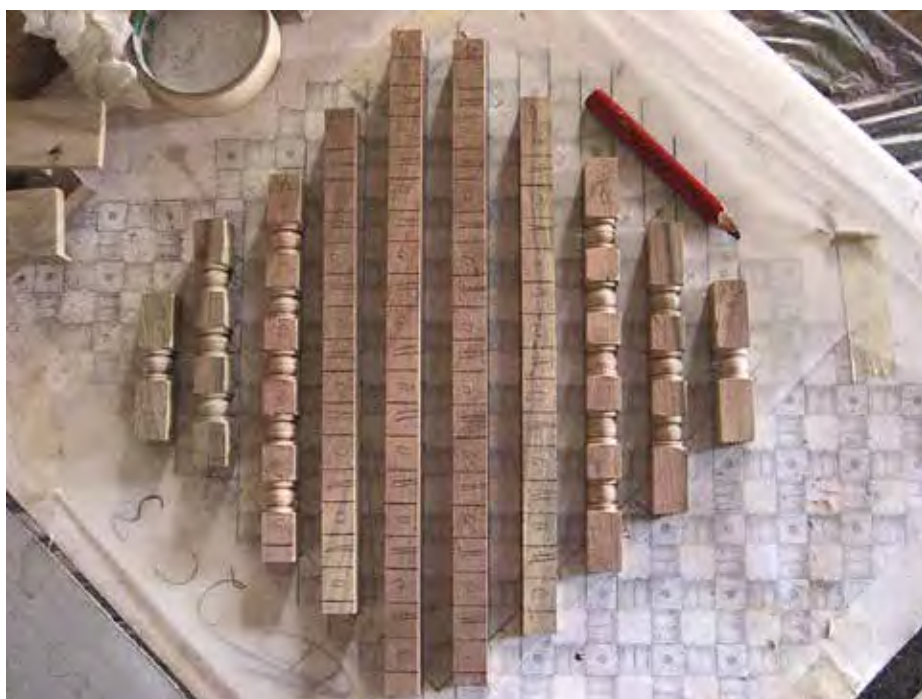
Figs. 10 and 11. Graphic reconstruction of a *mashrabiyyah*.

The students also had the opportunity to learn how to prepare and apply the consolidating agent Paraloid B72 to strengthen the wood, where that might be necessary. Hours were dedicated to drawing, in particular to the relief of the *mashrabiyyahs* found in the school of al-Ashrafiyyah.

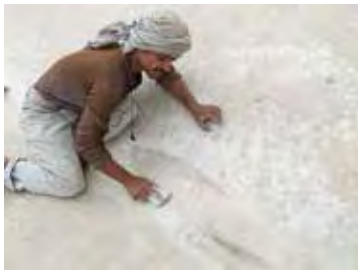
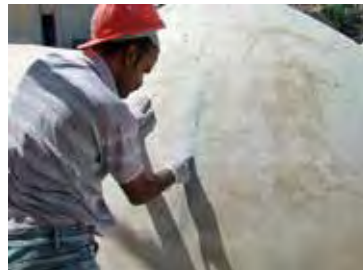
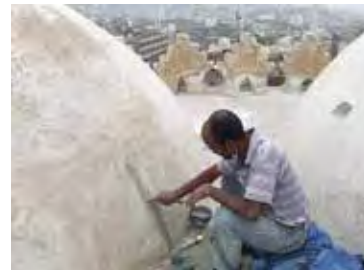
Figs. 3, 4 and 5. Workers from the building restoration company repairing cracks in the extradoses of the small domes.

roofing and on the extradoses of some the domes and the wall finish of the two minarets. With these interventions, the company was resolving one of the main factors of deterioration of the mural paintings and stuccoworks in the prayer hall, by preventing the continued seepage of rainwater from the roof and walls.³

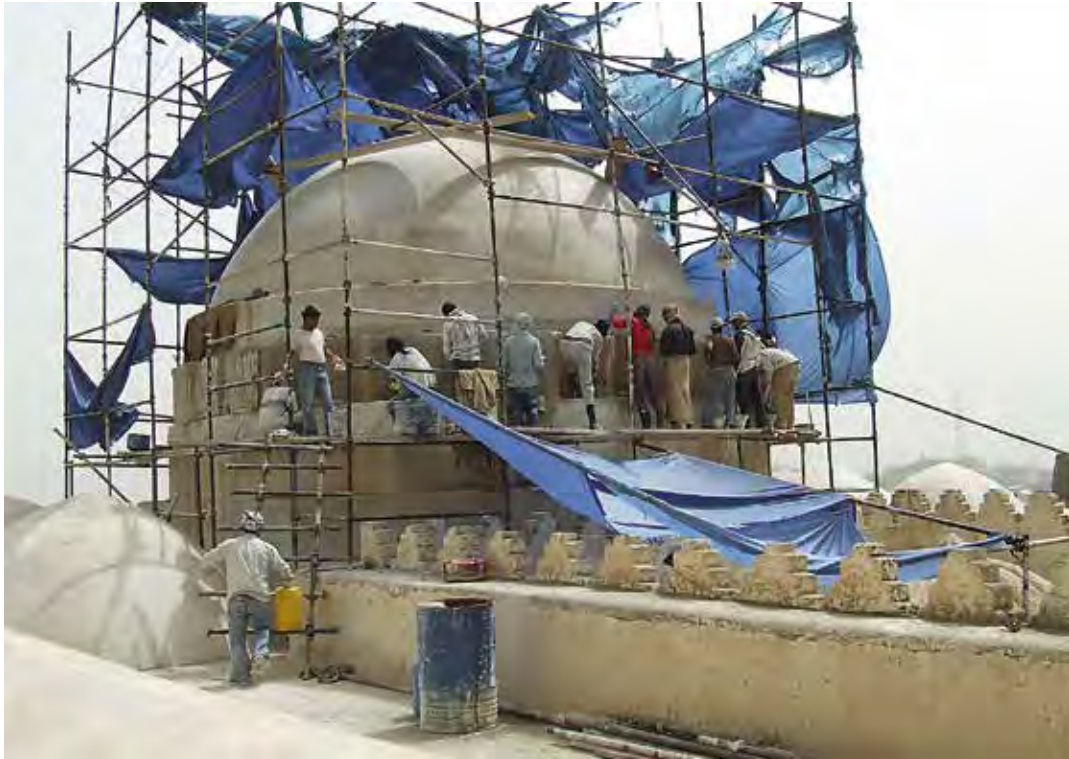
Fig. 6. The building restoration company resurfacing the *qadād* on the extrados of the main dome.

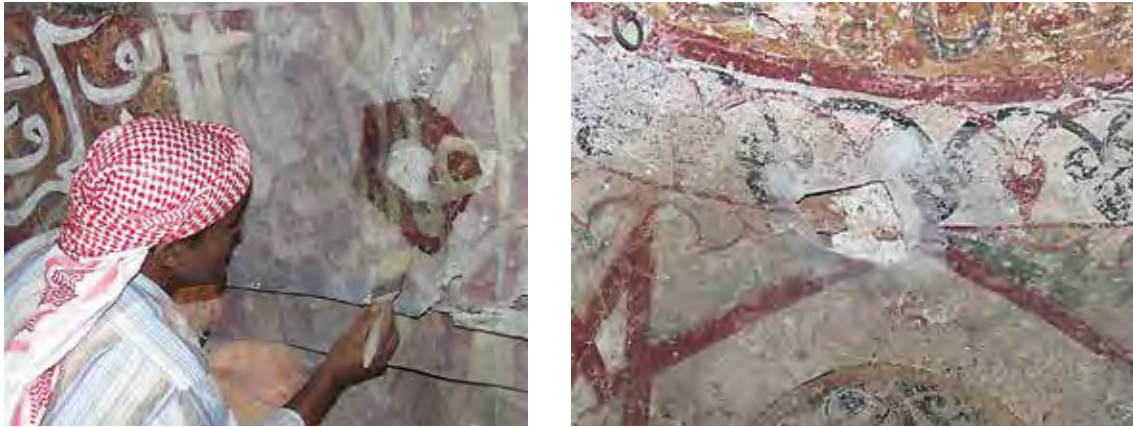
Figs. 7 and 8. Preliminary stages for the safety of the detached plaster with cotton gauze and acrylic resin.

Zones of detachment with flake-like thickness were first repaired with Paraloid B72 at 5% in acetone and Japanese paper. Later, starting from the edges of the flaking, localized injections of Primal AC33 in variable concentrations, not over 10%, were applied to the substrate with gentle pressure using a steel putty knife.

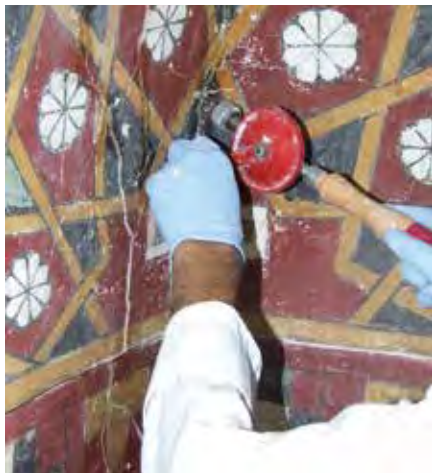
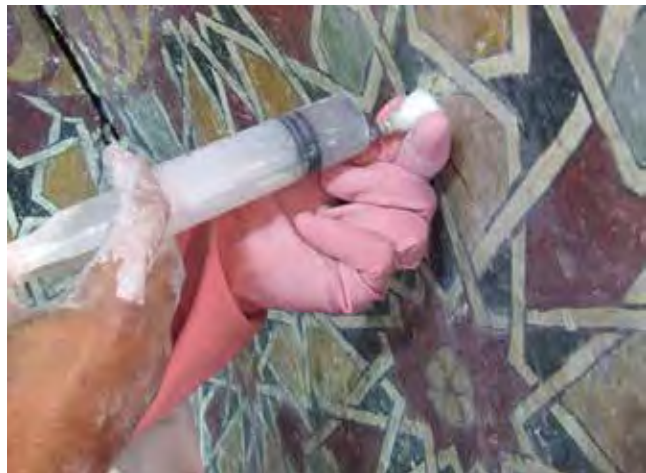
Figs. 12 and 13. Consolidation of plaster detached from a portion of the masonry.

Proceeding from the lower part of the walls upward toward the dome, in vertical sections, the re-adhesion and consolidation of detached portions of plaster from the wall sections was achieved using salt-free pozzolanic lime-based binders (Albaria, Basf), mixed in demineralized water. The method used ensured that, along the fissures in the plaster and the abrasions of the paint film, small holes were bored with a hand drill into which adhesives with different degrees of fluidity could be injected using a needle and syringe, after moistening with water and ethanol (1:1) to facilitate the passage of the material through the hole.

In areas with accentuated and complex situations of detachment of the painted plaster from the masonry structure below, after applying tissue paper, the sections were repositioned on the original site using props to hold them in place. The props were designed to apply gradually increasing pressure so as to make the plaster adhere slowly in the imprint of the original base. Later, the borders and raised edges of the gaps were fixed using a light mortar of putty and fine sand (ratio of binder to inert material 1:2).

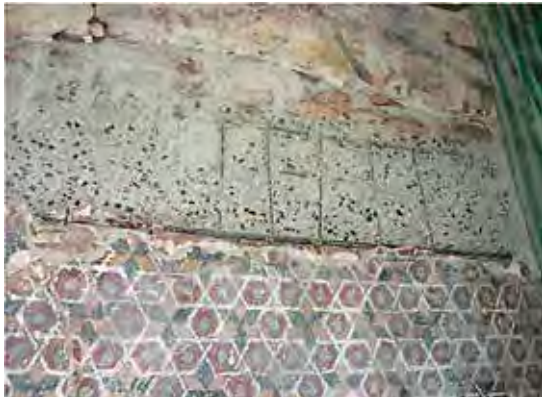
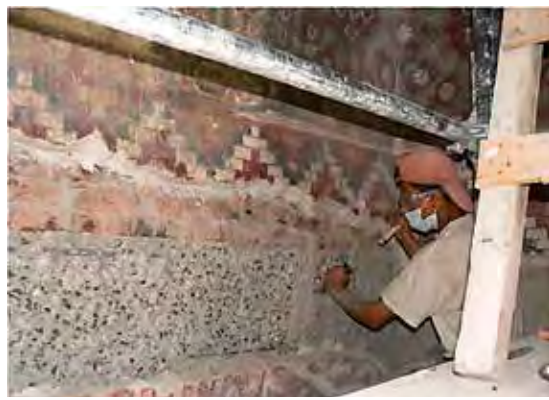
Figs. 14 and 15. Reducing the surface of the reinforced concrete beams using hammer and chisel.

The beams in reinforced concrete inserted between 1978-80 in the walls of the small domes were, at the same level as the mural decorations, if not higher. Regardless of the choice that would be approved later to restore the final esthetics, it was necessary to move the concrete structure to below the level of the paintings. Therefore, after consolidating

the decorated enclosing walls and welding the relative perimetral borders, a thickness of about 3 cm was removed, using hammer and chisel, so that the entire surface would be uniform and would facilitate the subsequent processes of applying the plaster finish.

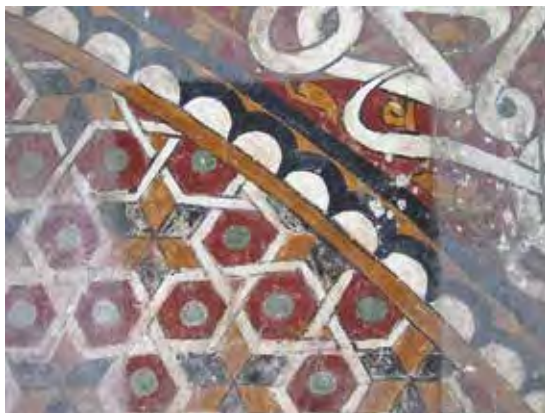
Fig. 16. West dome 1a. Cleaning test.

The paint film of the fresco on plaster showed a good resistance to the watery environment, so cleaning was done by applying a layer of Japanese paper and brushing it with a solution of inorganic salts at 50% in demineralized water (100 gr of ammonium carbonate per liter).

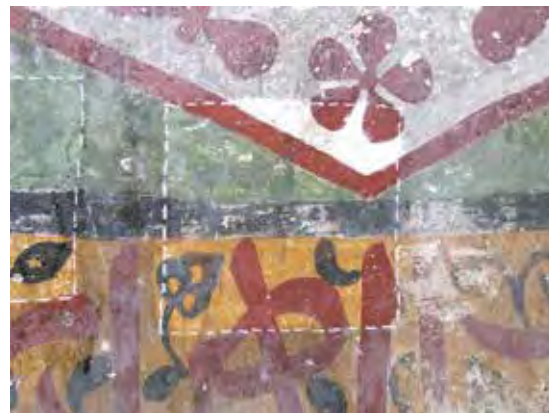
Fig. 17. Dome 1c. Cleaning test.

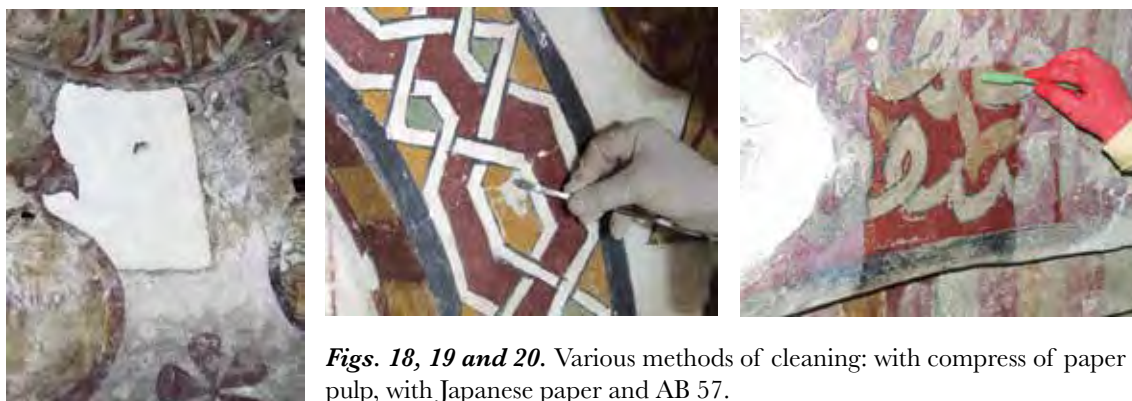
Figs. 18, 19 and 20. Various methods of cleaning: with compress of paper pulp, with Japanese paper and AB 57.

Later, on the dry surface, the residues of incrustations and saline efflorescence were removed dry with scalpels, pens with fiberglass and Wishab sponges⁴.
