AL-ASHRAFIYYAH MOSQUE AND MADRASAH IN TA'IZZ

Conservation intervention (2008-2015)

The subject of this volume is the work of restoration of the paintings, stuccoworks and woodwork, and the structural consolidation of the al-Ashrafiyyah Mosque and Madrasah in Ta'izz (Yemen, 13th-14th century), carried out by the Istituto Veneto per i Beni Culturali (IVBC, 2008–2015) thanks to the support of the Social Fund for Development (SFD – Culture Heritage Unit). It follows the previous volume *The Great Mosque of Ṣan'ā'. Conservation intervention (2005–2015)*, published in June 2022.

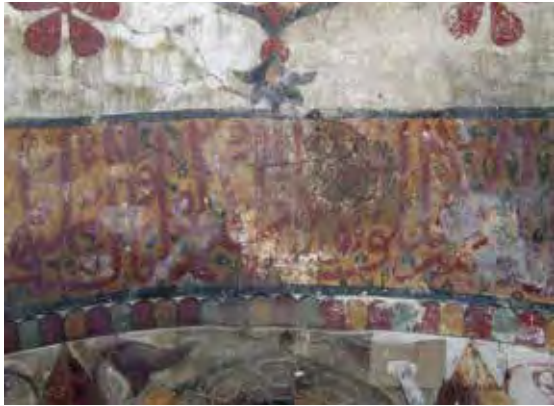
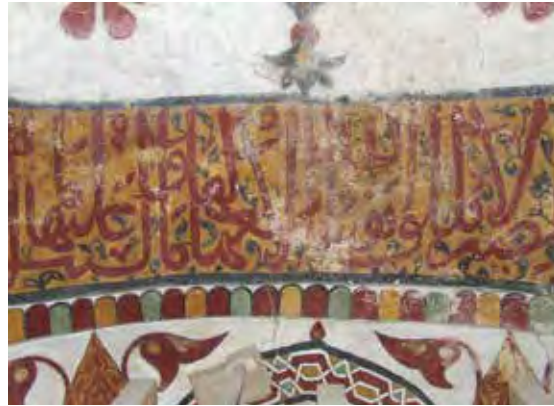
Figs. 21 and 21a. Dome 1f. Qur'anic inscription in the first ring of the dome, before and after cleaning.

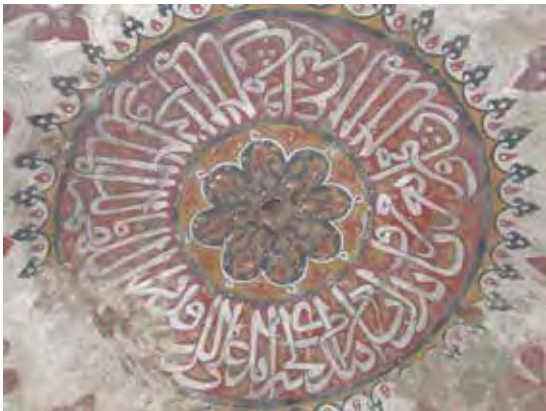
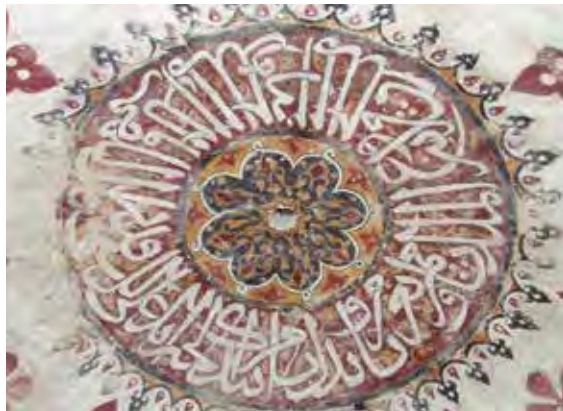
Figs. 22 and 22a. Dome 1g. Qur'anic inscription in the apex before and after cleaning.

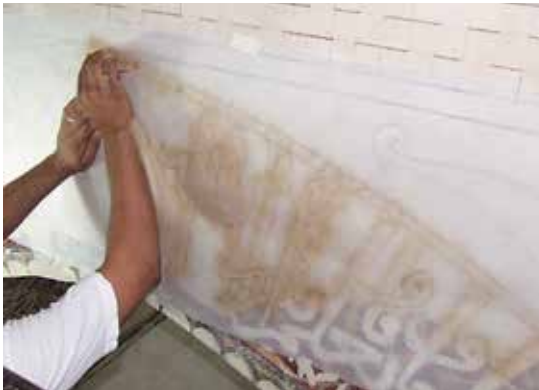
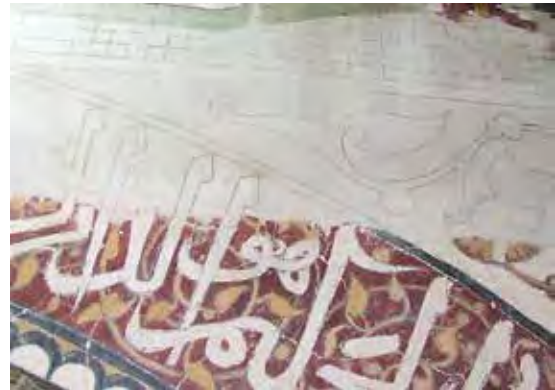
Figs. 23 and 24. Dome 1f. Retracing of preparatory design using powdered chalk.

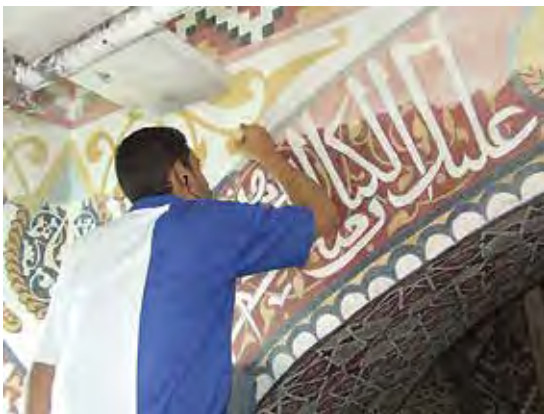
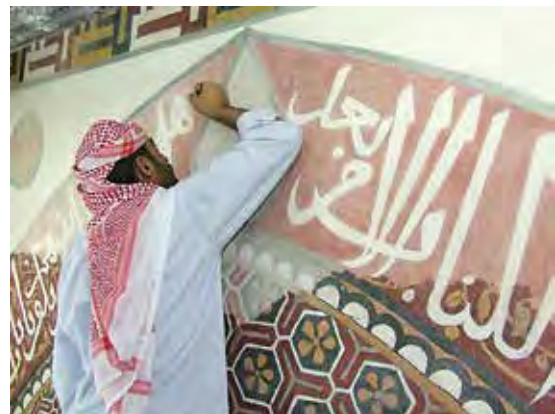
Figs. 25 and 26. Stages of restoration of painting by retouching.

In short, hatch retouching techniques is based on a system of different colored lines, clearly added, according to the principle of the division of shades. The vibrant and contrasting alignment of tonalities creates the perception of the shading of a single color. The method consists of filling in the light background of the plaster with vertical lines matching the original colors in order to achieve the maximum unity and continuity with the surrounding decoration.

To distinguish the reconstruction further, the details have been simplified and, in some parts, left unfinished. The red or yellow floral designs on the white background of the vaults, like other similar elements, were also resolved through retouching, however not in the vertical direction, but following the direction of the painting, i.e. arranging the colored lines in concentric expansion according to the graphic outline of the shapes.

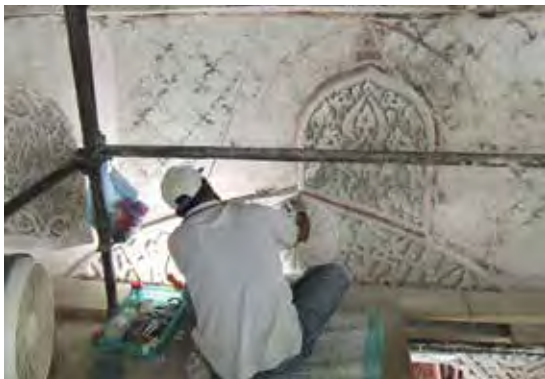
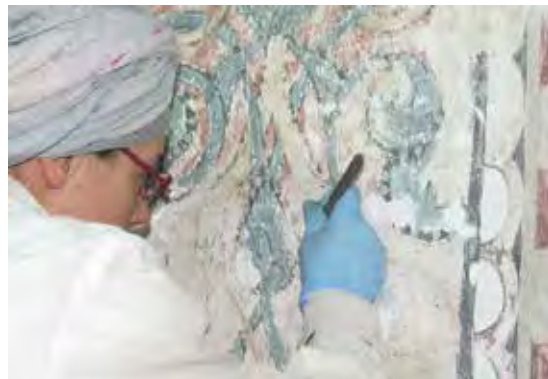
Figs. 40 and 41. Decorative band in the second register, at the height of the *mihrāb*. Removal of whitewash using a scalpel.

During the worksite-training course, in the early stages of the operation, the whitewash was removed from the lower walls by mechanical means, using scalpels or pens with fiber-glass refills. Fortunately, as regards the main central dome, the coating of whitewash only involved the lower portions of the zone of the walls involved and only limited portions of the decorated section.

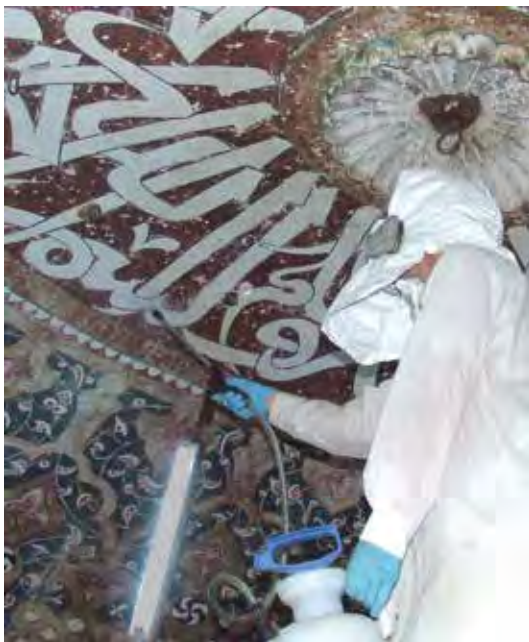
Figs. 42 and 43. Interior of dome. Stages in fixing the paint film.

Starting from the design in the apex of the dome, and proceeding downward to the string-course of the tambour, the decorated area was carefully studied up close in circumscribed sections, one square meter at a time, to check the adhesion of the paint film and identify any zones of precarious adhesion. Having ascertained widespread instability, with powdering of the paint film in several spots, tests were carried out to determine the best way to consolidate it. As a precaution, an overall pre-consolidation was applied by spraying an acrylic resin in a low concentration (Paraloid B 72 at 5% in acetone) on the entire inner surface of the dome up to the height of the canopy stringcourse of the tambour. The spray, absorbed in the substrate without altering the tonal gradation of the paint film, determined a first stage of blocking and stabilization of the color. Later, in the canopy as well as on the other decorated surfaces of the main dome, we operated where necessary to fix the paint film locally in the weaker zones, first applying Japanese paper and then applying the fixative by brush.

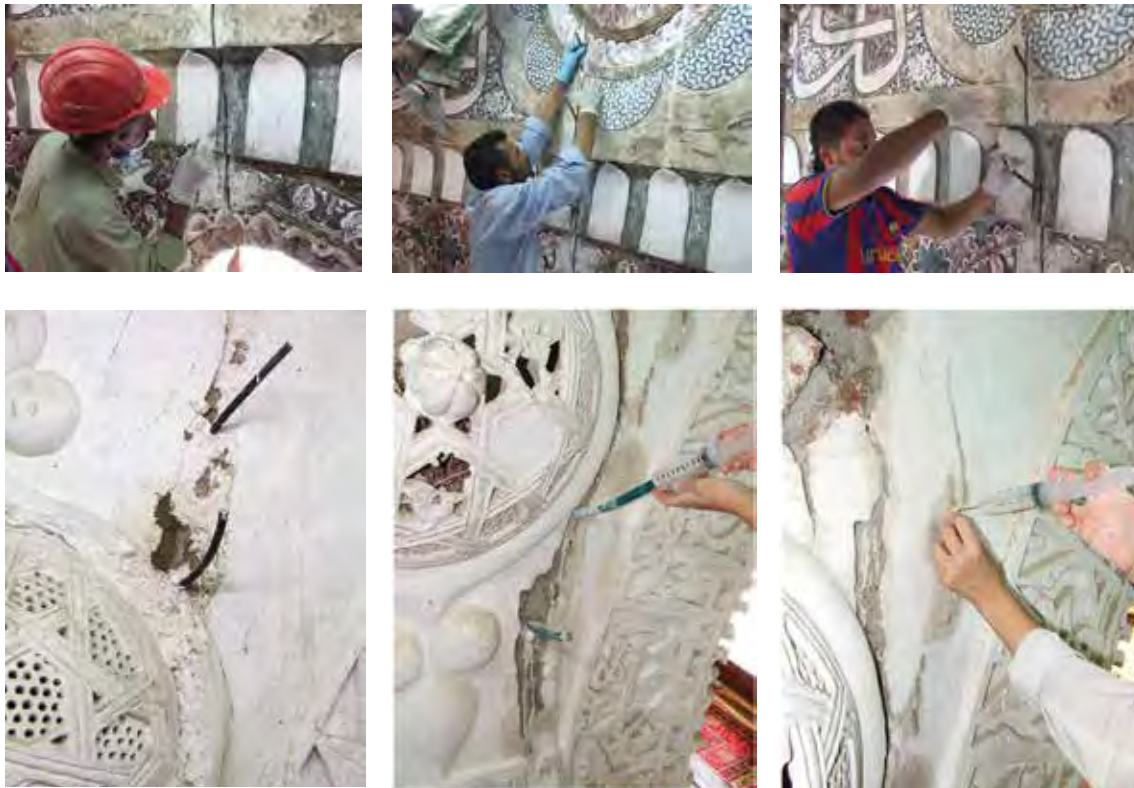
Figs. 44, 45, 46, 47, 48 and 49. Profound vertical fractures in the east and west walls. Stages in consolidation.

As a precaution, along the borders of the plaster that had lifted off the wall structure, material similar to the plaster used as preparation for the decorations was applied as a cementing sealant.

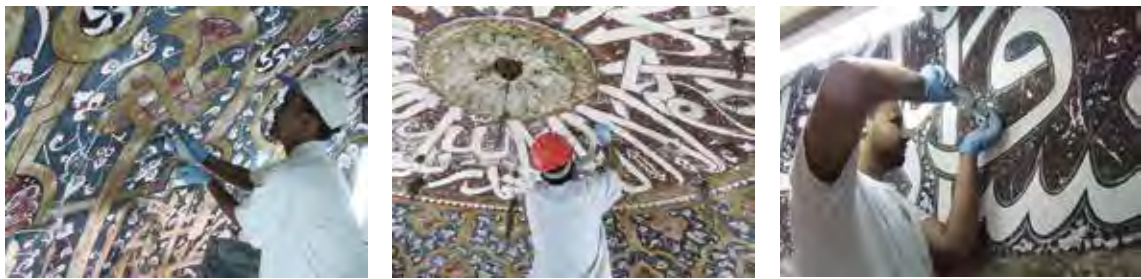
Figs. 50, 51 and 52. Interior of dome. Consolidation of detached plaster.

To repair the edges of the gaps and more in general on the detached plaster zones, operating from the ground and proceeding upward by circumscribed vertical areas to the inside of the hemisphere, holes were drilled with a manual drill between the substratum of preparation of plaster, the bedding for the *qadāḍ* and the masonry bedding. Using needles and syringes, a natural lime-based mortar was injected (PLM-A, C.T.S. S.r.l.) giving new characteristics of adhesion between the detached parts. This work proceeded, spacing work on the same area, where necessary, to every other day.

In the areas characterized by only slight detachment, consolidation could be achieved between the lifted portions of the plaster using small, targeted microinjections of acrylic resin (Prima AC 33 at 10% in water). In this second stage, the operating criterion was preceded by small injections of water and ethanol (ratio 1:1) to improve penetration of the product internally, operating on the walls from the bottom up in circumscribed vertical sections.

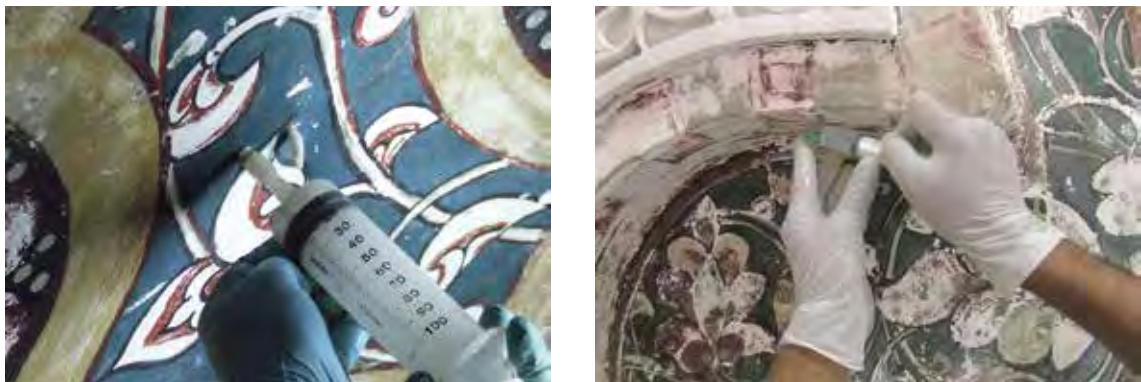
Figs. 53 and 54. Interior of dome, consolidation of plaster and polylobate arch, fixing of paint film.

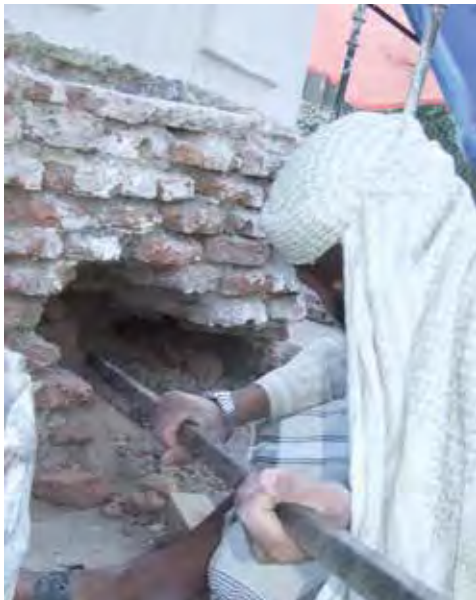
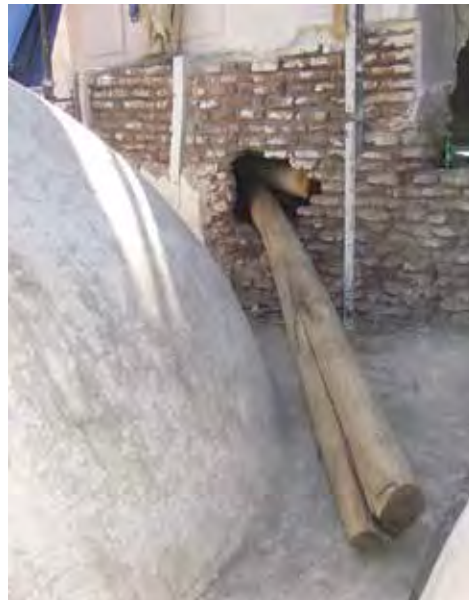
Figs. 55 and 56. Steps in replacement of beams from outside the tambour.

At the height of the tambour circumference, through the gaps under the windows and also after removing some old patches in the mortar, it was possible to ascertain the state of conservation of the large wooden beams that had been inserted in the masonry structure with a function of structural connection and as seismic shock absorbers. The beams were in a state of severe deterioration caused by the attacks of termites and fungi, to the point that they had completely lost their mechanical function of support and connection. To guarantee the static stability of the mosque, the Works Directorate decided to remove and replace the wood beams, operating from the outside of the tambour, that is at the roof level, at the base of the dome extrados, an extremely delicate operation. To prevent accidental damage to the decorations, in the perimeter at the corresponding height on the inside, a temporary protection was built. The operation consisted of covering the decorated surfaces for a height of about 50 cm all around the perimeter, with Japanese paper and cotton gauze, using a solution of acrylic resin (Paraloid B72, at 10 % in acetone).

The new wooden beams, before being installed in the masonry, were treated by brush with a solution of boric salts in a saturated concentration, dissolved in demineralized water. The impregnation served as a protective action and to prevent future damage.

After repositioning the beams from the outside, the empty cavities between the wood and the masonry were filled with a mortar of lime and plaster, maintained in a fluid state and made to penetrate by gravity, with the aid of special tilted tubing. After completing the complex operation of beam replacement, the protective tissues were removed from the decorated perimeter of the tambour on the inside, using a solutions of solvents (acetone and ethanol 1:1).

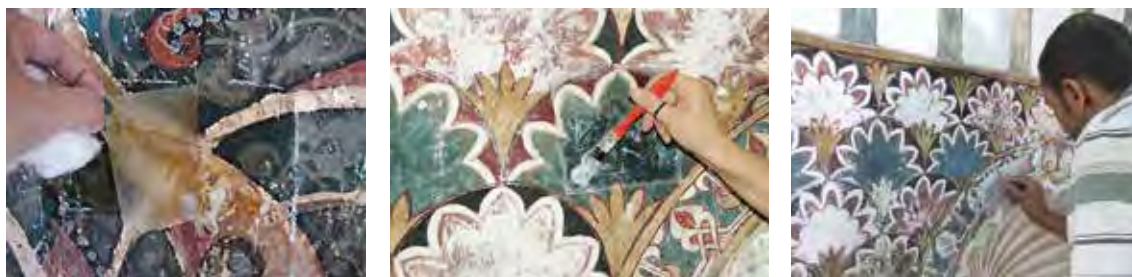
Figs. 57, 58 and 59. Decoration of the tambour, stages of cleaning with fatty emulsion.

The tambour, including the small decorated niches and windows in carved stuccowork, also showed a general darkening due to the stratification of smoke from the oil lamps and the alteration of a past conservative treatment. Moreover, scattered deposits caused by bird excrement contributed to the chromatic alteration. In consideration of the sensitive characteristics of the plaster, we developed a cleaning method that would exclude the use of water.

After a series of preliminary tests, a fat emulsion⁸ was found to be the safest and most effective solution. The operation called for the interposition of Japanese paper in small squares on which the emulsion was applied by brush. After a few minutes, the thin paper was removed and the area was gone over with a light mechanical action using a cotton pad on wooden pick.

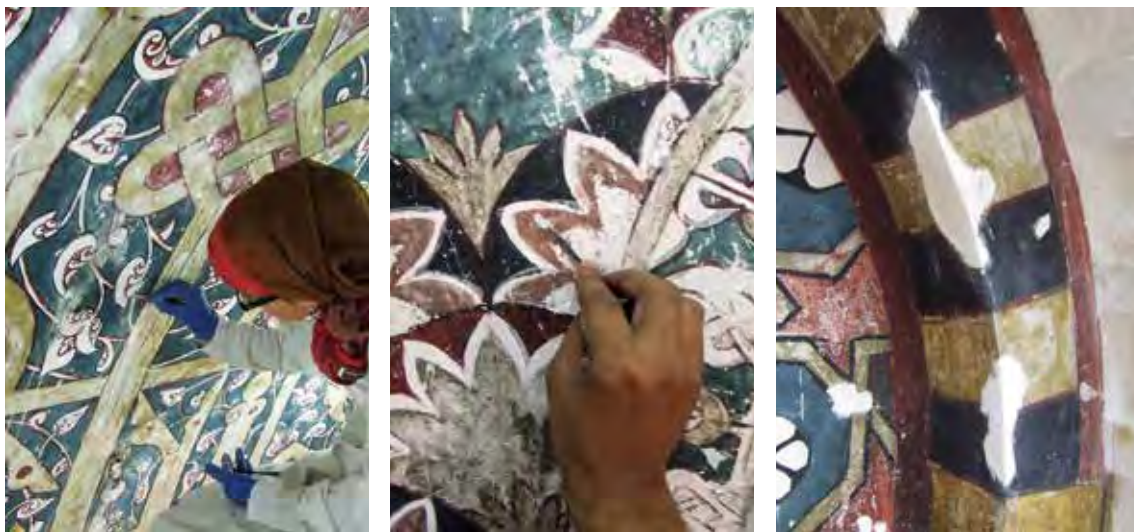
Figs. 60, 61 and 62. Stages of stuccoing the fissures and small gaps.

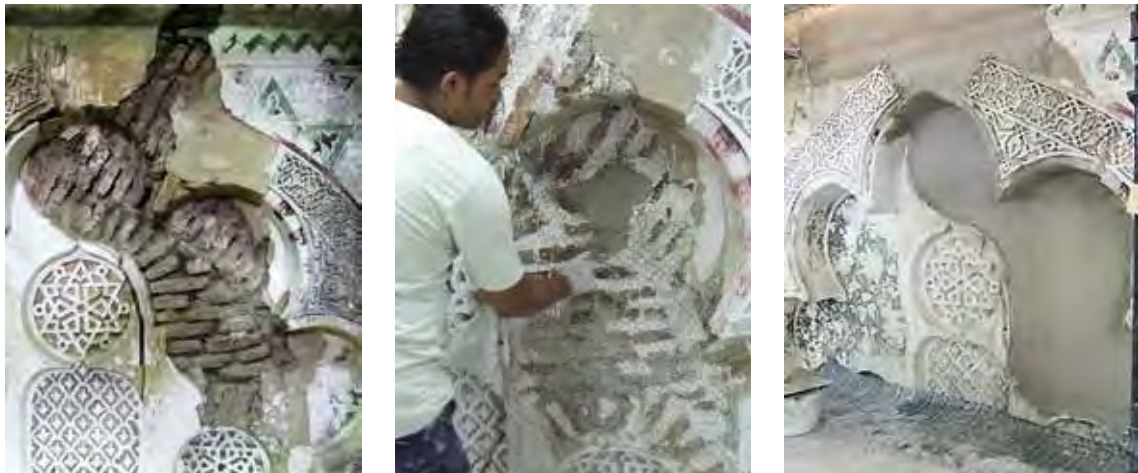
Figs. 63, 64 and 65. East wall. Polylobate arch, removal of stuccoing and stages of applying the first layer of *qadāḍ* plaster.

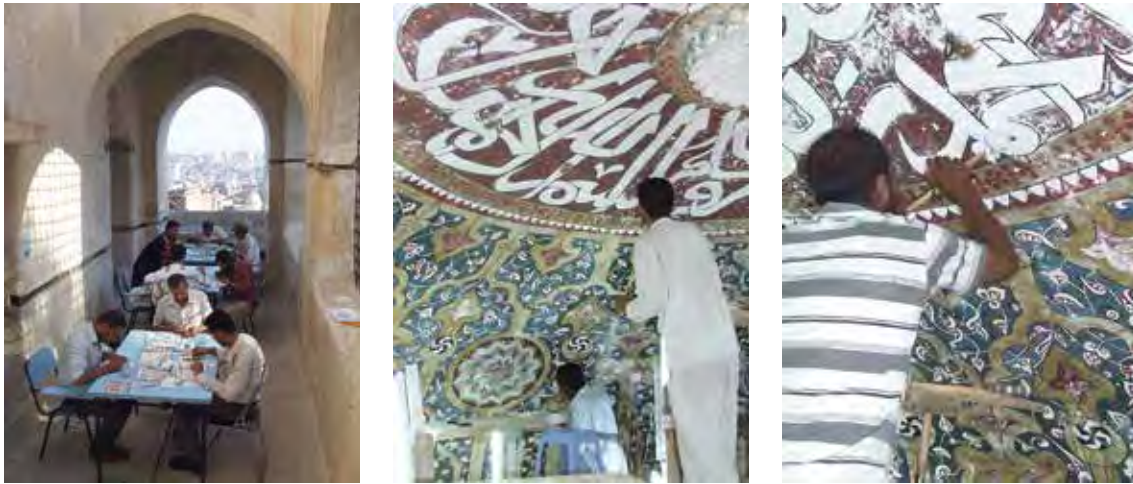
Figs. 66, 67 and 68. Workshop seminar for integration of painted decorations and initial stages of retouching in the apex of the dome.

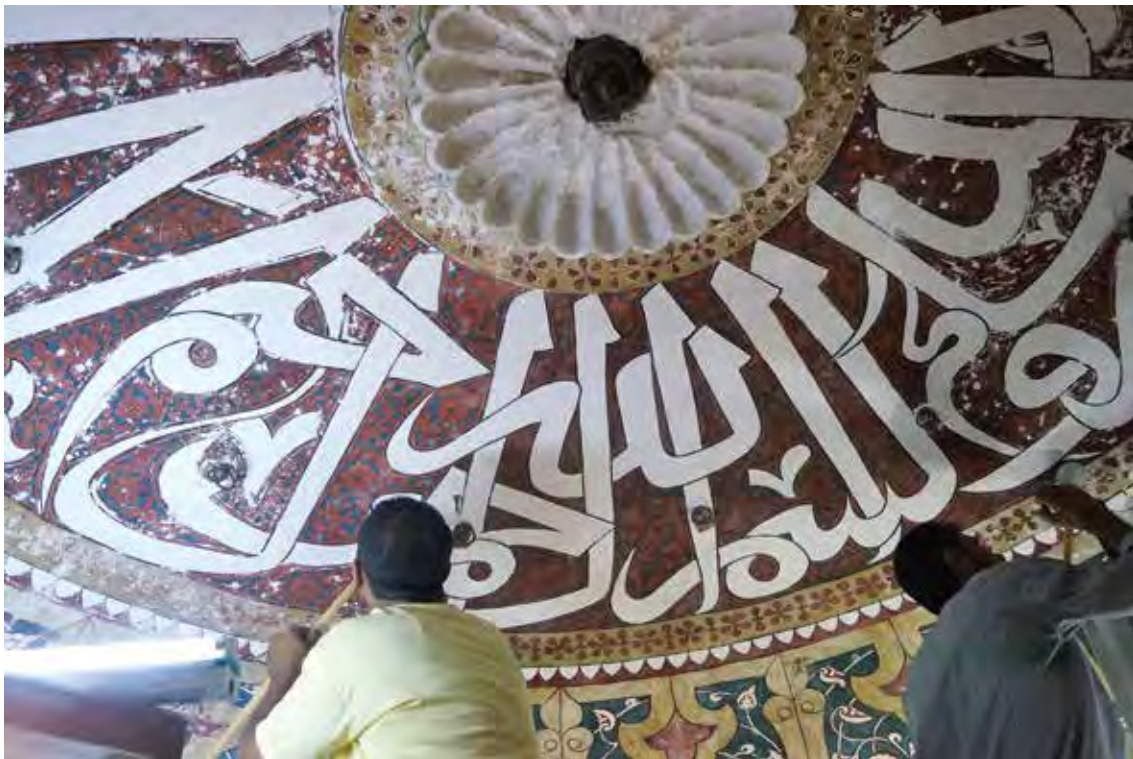
Fig. 69. Apex of the dome, the team engaged in the initial stages of retouching the *basmalah* in *thuluth* calligraphy.

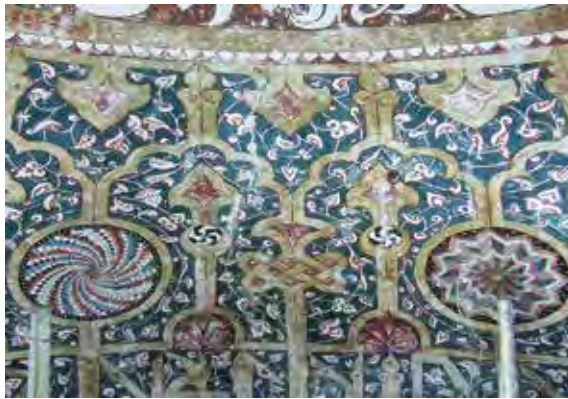
Fig. 70. Dome, west side. After cleaning.

The hemisphere and vaults of the tambour show local abrasions and fading of color all over the surface but in relatively circumscribed zones. Thus, using undertone veiling in an adequately balanced manner it was possible to restore a unified impression without too much difficulty.

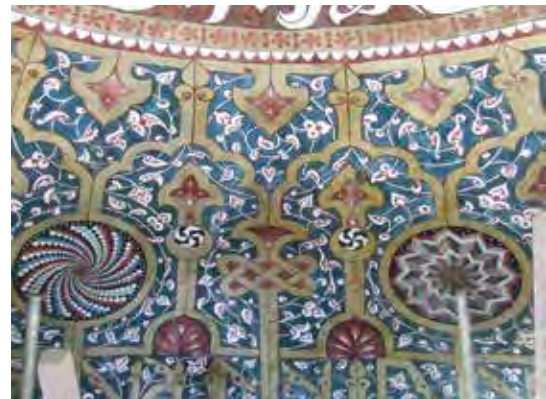
Fig. 71. Dome, west side. After retouching.

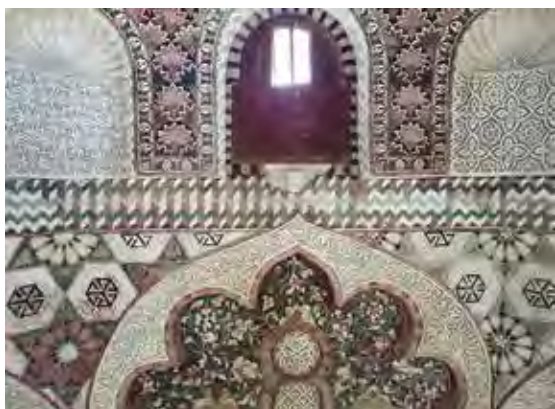
Fig. 72. Tambour, north wall, after retouching.

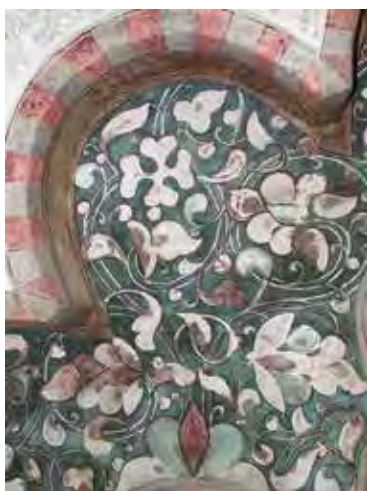
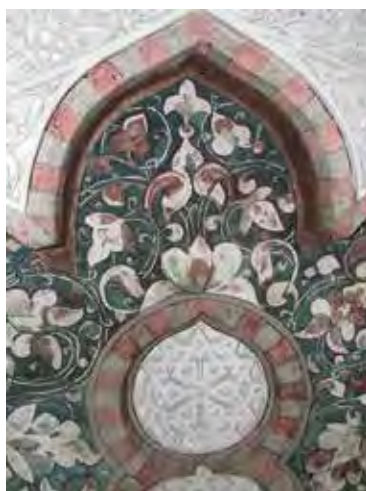
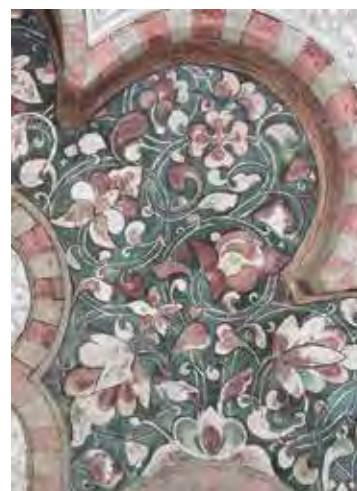
Figs. 74, 75 and 76. Tambour, north polylobate arch, detail after retouching.

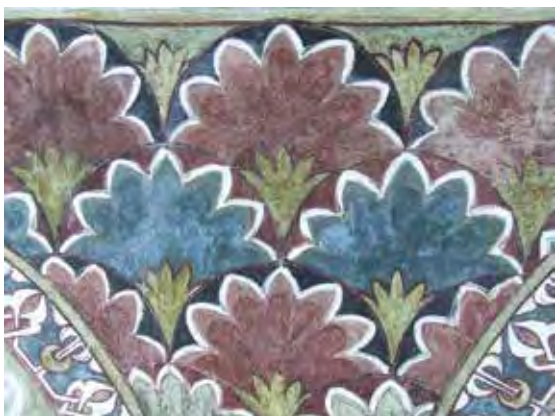
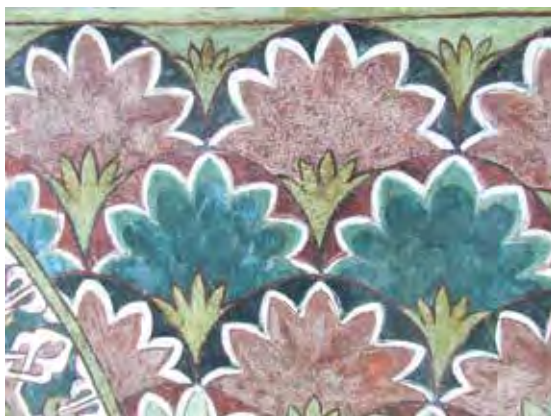
Figs. 77 and 78. Tambour, west vaults, with palmette motif, detail after retouching.

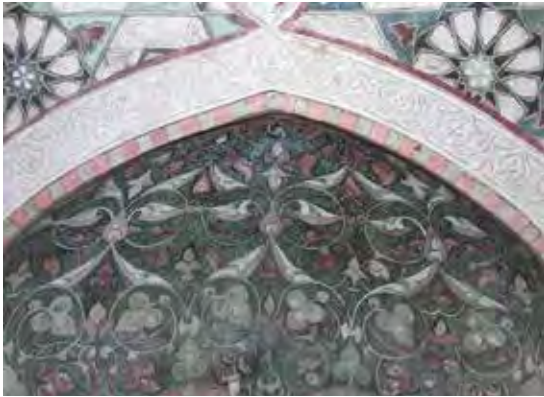
Fig. 79. Northeast niche after retouching.

The four large niches in the corners, decorated with refined symmetrical stylized floral decorations presented a general disunity, due to the type of flaking of the paint film and extensive abrasions. By applying undertone integration, without representing the formal design, we were able to restore it in an adequate and balanced manner.

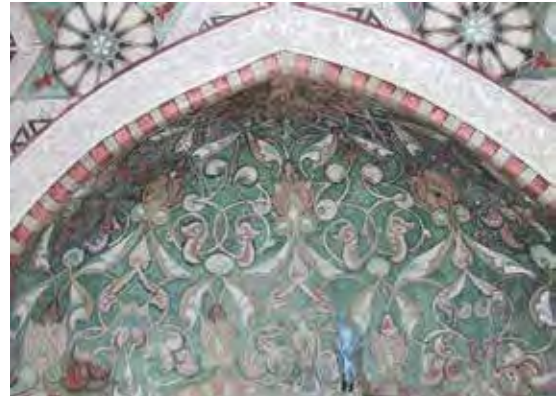
Fig. 80. Southeast niche after retouching.

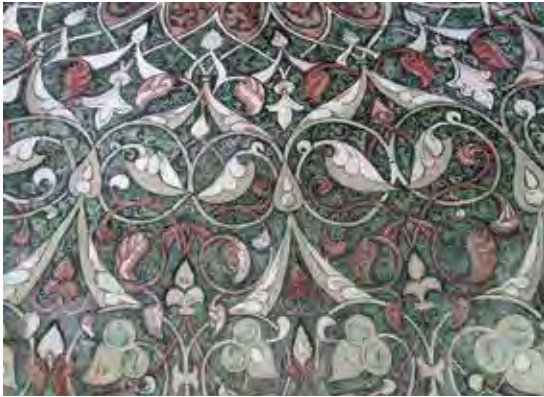
Fig. 81. Northwest niche. Detail after retouching.

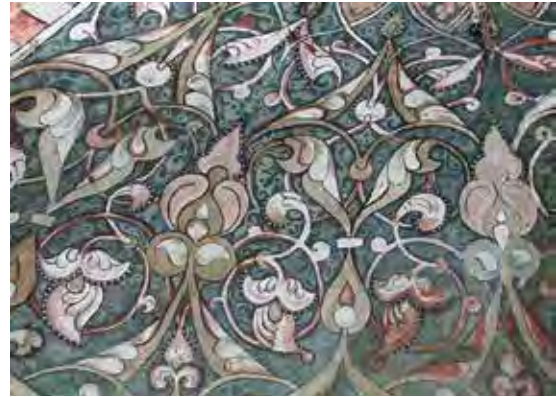
Fig. 82. Southwest niche. Detail after retouching.

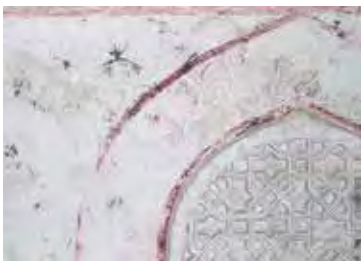
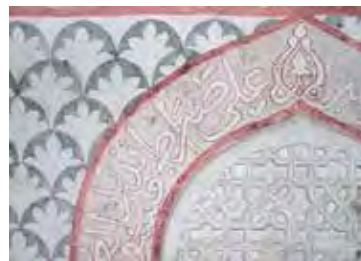
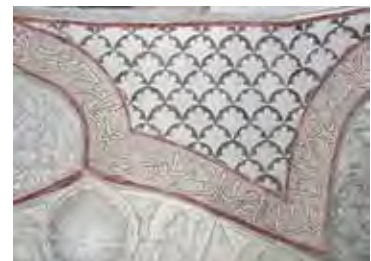
original decoration, on the fine plaster, still almost completely intact. The barely legible traces indicated a long Qur'anic inscription in *thuluth* calligraphy which, with red-violet borders, crept onto the bottom profile and followed the line of the windows in carved stucco. The remaining surfaces of the base were resolved with a dense covering of pentalobate palmettes, inserted diagonally in a semicircle on the gray-black background.

Figs. 83, 84 and 85. Decorative perimetral band over the *mihrāb*. Detail before and after retouching.

Consequently, with a view to restoring a harmonious balance between the two registers, and a comprehensible reading of the Qur'anic inscription, a restoration functional to the comprehension and unity of the architectural space was carried out. After adequate study, the outlines of the Qur'anic inscriptions were traced, the rows of pentalobate palmettes redrawn and veiled in watercolor, maintaining a transparent undertone.

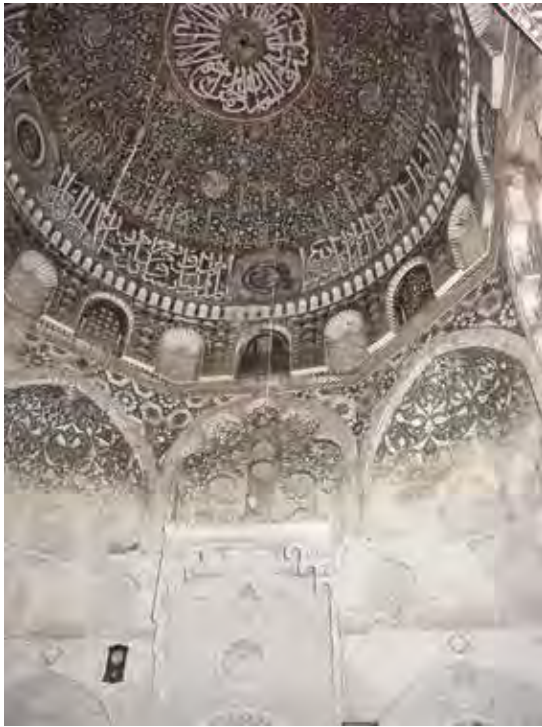
Fig. 86. Main dome, north side, prior to restoration.

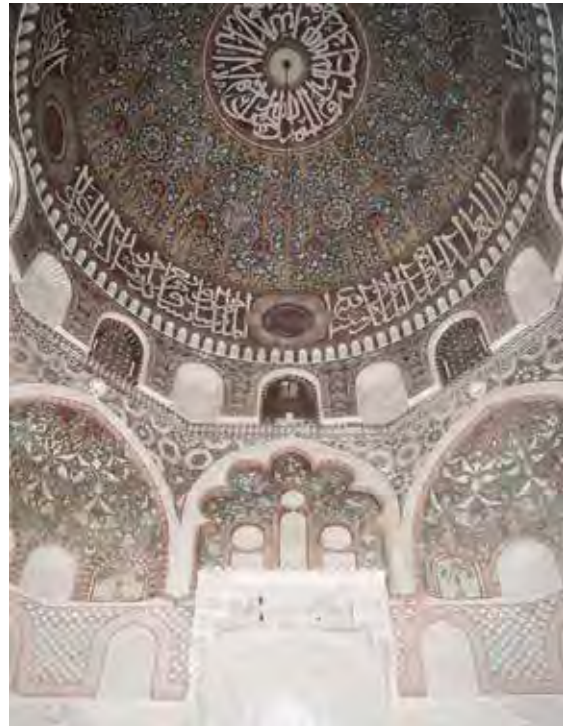
Fig. 87. Main dome, north side, after restoration.

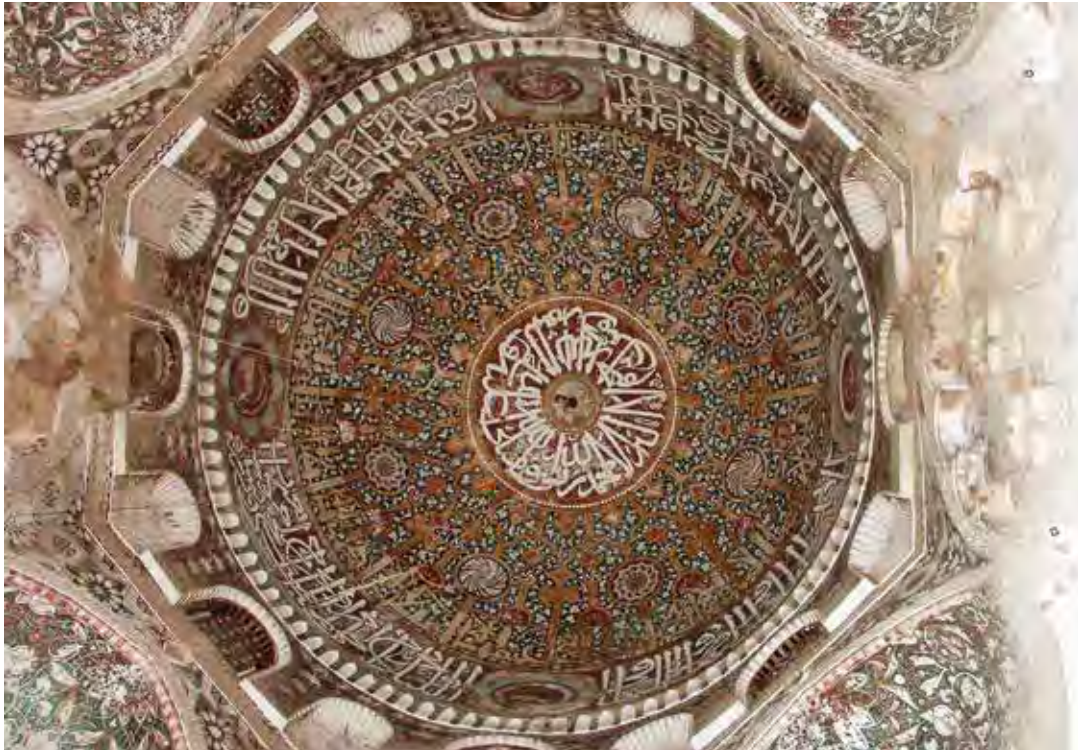
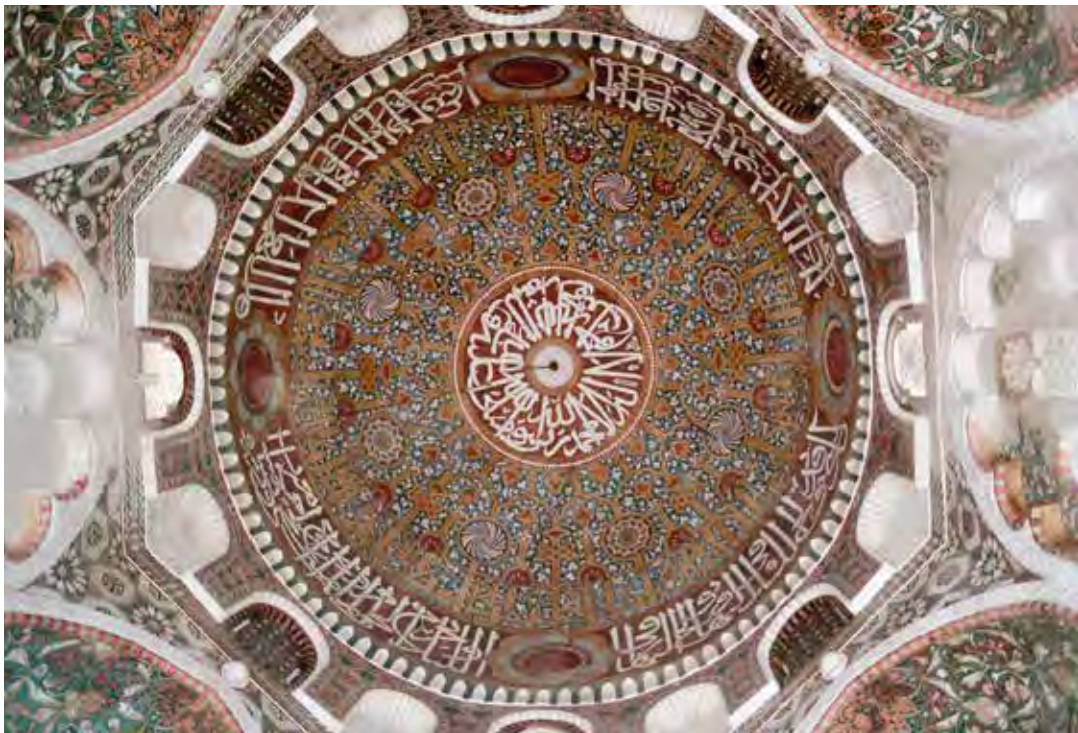
Figs. 88 and 89. Overview of tambour and dome before and after restoration.

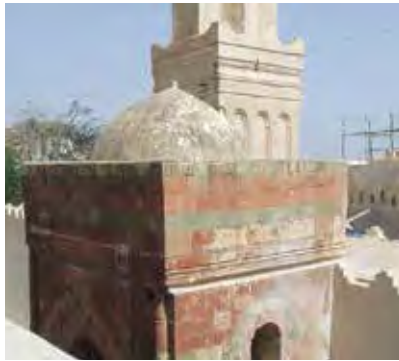
Figs. 1 and 2. View of the portal prior to the restoration works.

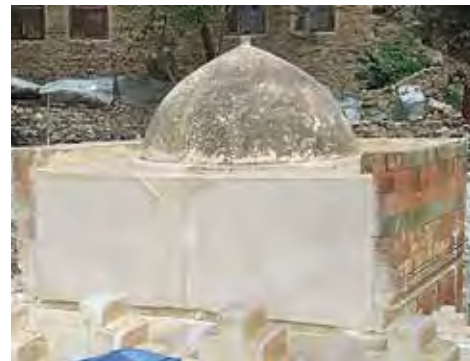
Fig. 3. External view of the dome of the north portal prior to the restoration works.

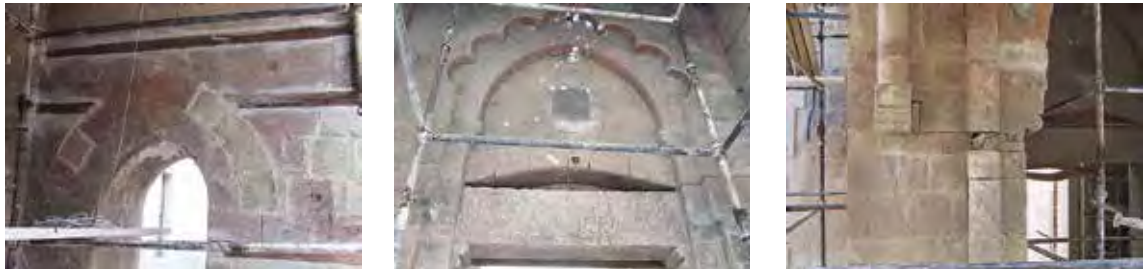
Figs. 4, 5 and 6. Some architectural details of the portal prior to the restoration works.

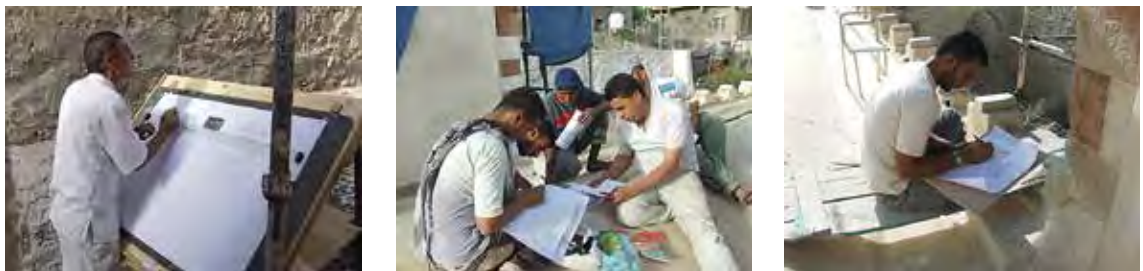
Thanks to the presence of the scaffolding, it was possible to examine all the internal and external risers that were used to map the state of conservation of the structure, make a macroscopic identification of the different types of stone used in the three façades and plan the works. We were also able to distinguish the original stones from those replaced in other maintenance works. This became even easier after cleaning.

Figs. 7, 8 and 9. The pictures show the group of restoration students intent on taking measurements and appraising the relative state of conservation.

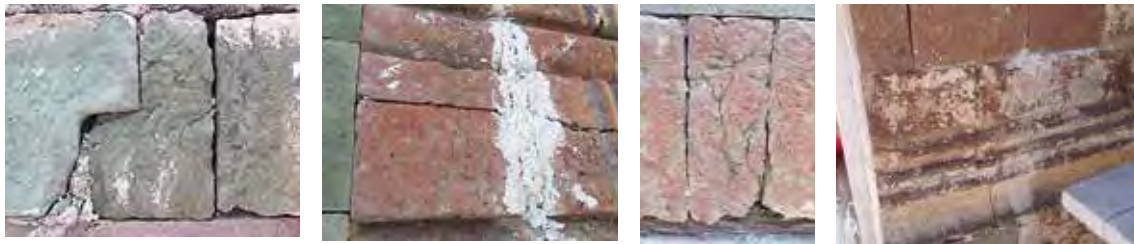
Another factor of deterioration is linked to a poor choice of materials, also during past maintenance works. We found patching done with plaster and cement, which was also used to anchor precarious stones.

Figs. 10, 11, 12 and 13. These photos show some examples of badly done past repairs, where inappropriate techniques and unsuitable materials were used.

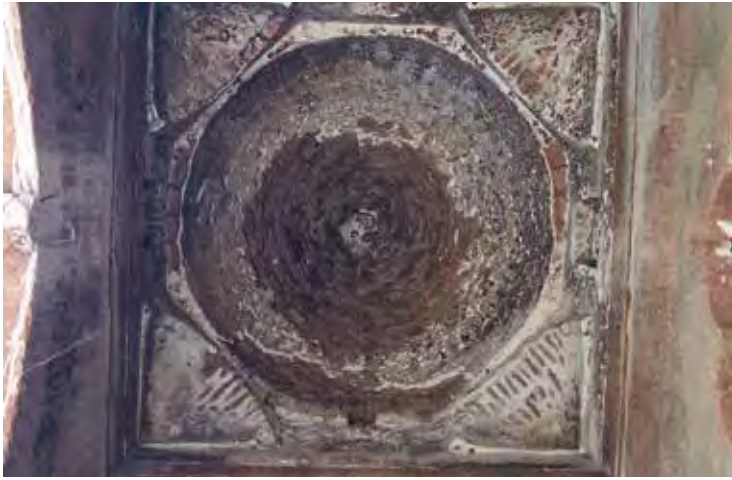
The stone walls in the interior were somewhat better preserved aside from the presence of thin coatings of black crust found mainly in the undercut, and a layer of dust that altered the general enjoyment of the different shadings of stone. The dome, however, was in a state of severe deterioration on the inside. The seepage of water had caused most of the plaster to fall and the masonry itself, also damaged, was almost completely bare due to the large gaps in the plaster. Fortunately, in previous years, works of restoration of the external *qadāḍ* had been done on the dome, as well as some structural consolidation, which had slowed the progress of the deterioration.

Fig. 14. The inside of the dome prior to restoration.

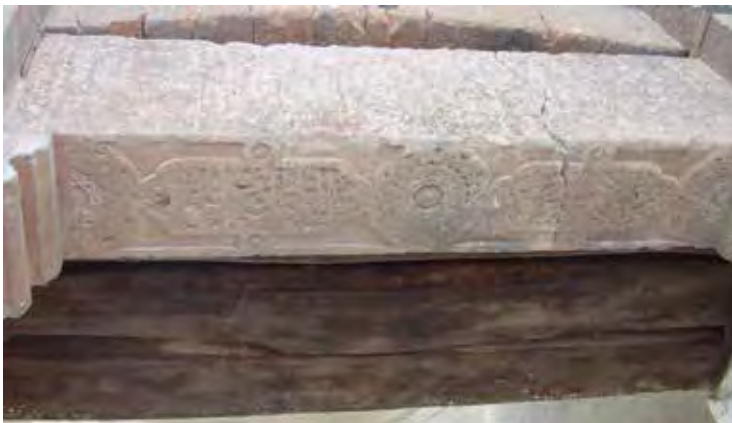
A deep fracture was visible on the right-hand side of the sculptured lintel over the inside door. This problem was evidence of structural movement, probably caused by an earthquake. The stone lintel, being less elastic than the rest of the building, was unable to amortize the movements of the masonry fabric and reacted to the stress by breaking.

Fig. 15. Detail of the lintel with its deep fracture on the right.

Particular attention was given to structural consolidation of the interior lintel, inserting an 8 mm fiberglass bar and injecting fluid bicomponent epoxy resin so that it penetrated not only the pin hole but also all along the fractures, solidifying the two parts.

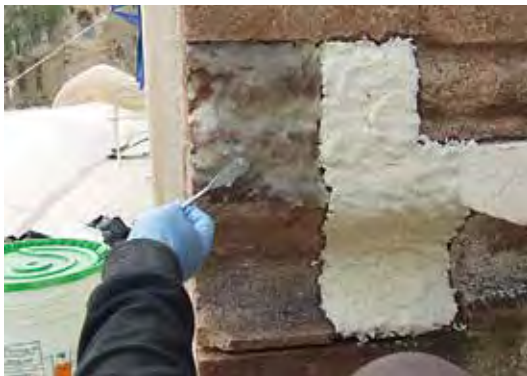
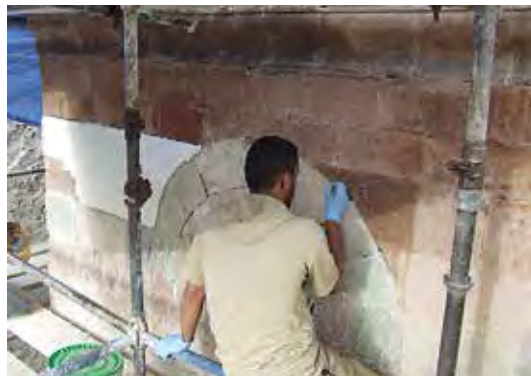
Fig. 16 and 17. Cleaning with compress of paper pulp soaked with ammonium carbonate.

To remove dry deposits, we applied compress of paper pulp soaked in a saturated solution of ammonium carbonate in demineralized water. In general, this method was used on all the stone surfaces with different variants depending on the problem to be dealt with, as we went on with the work. In some cases it was necessary to add EDTA in low concentration, in other cases we had to prolong the time of contact with the pad. In the presence of very hard incrustations, we used ion exchange resins, which gave good results.

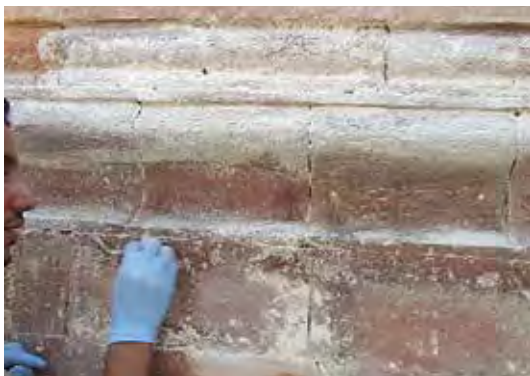
Fig. 18. Cleaning step using ion exchange resins.

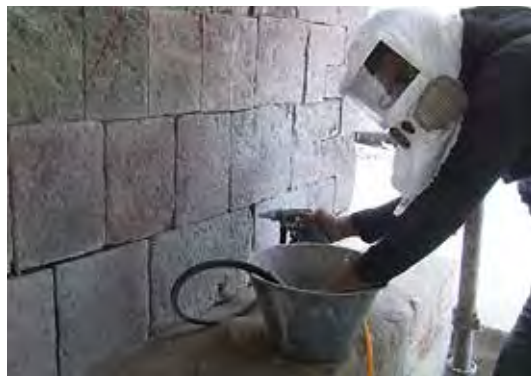
Fig. 19. Cleaning step using micro-sandblasting.

Almost always, after cleaning with chemical means, it was necessary to go over the area mechanically using scalpels and micro-chisels. Where the presence of coats of whitewash was particularly hard to remove, we developed a system of localized micro-sandblasting to reduce the thicknesses covering the baseboard zone of the interior walls and the last three rows of stone blocks in the exterior walls.

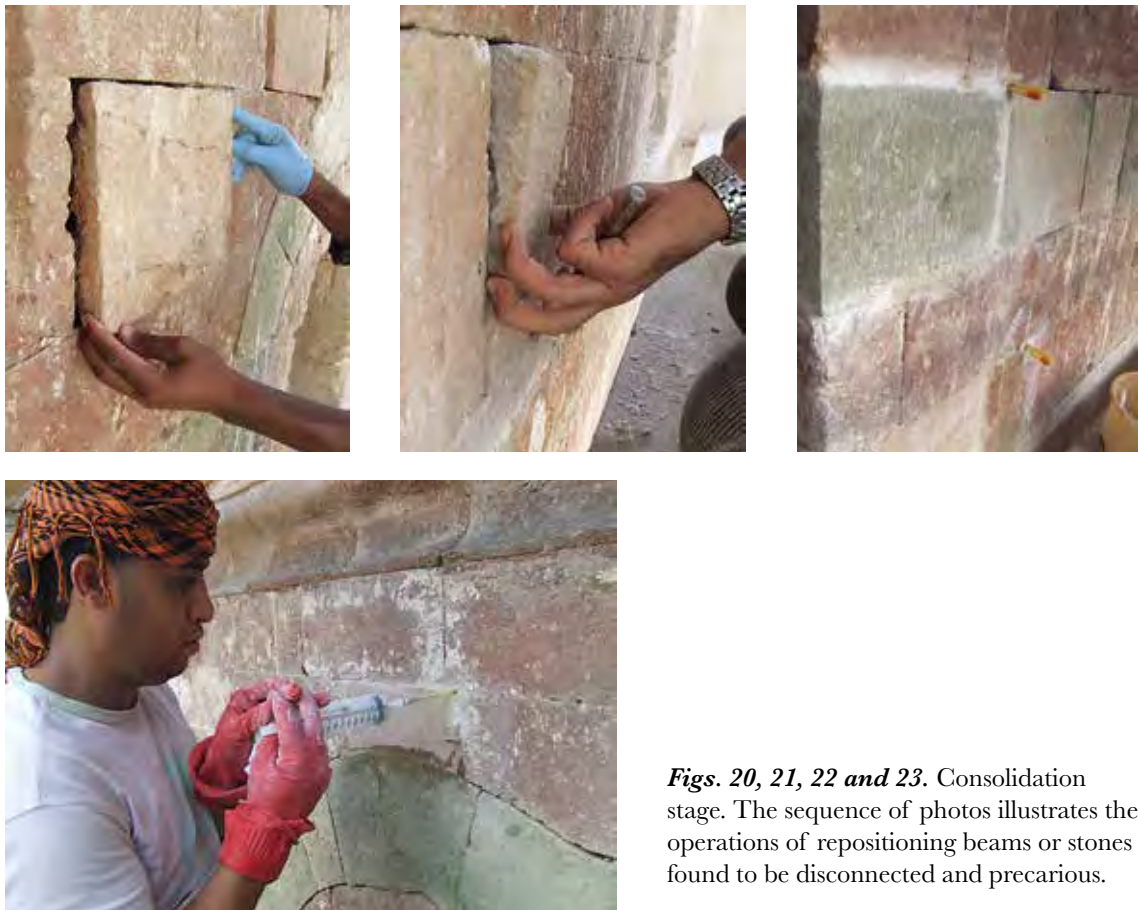
Figs. 20, 21, 22 and 23. Consolidation stage. The sequence of photos illustrates the operations of repositioning beams or stones found to be disconnected and precarious.

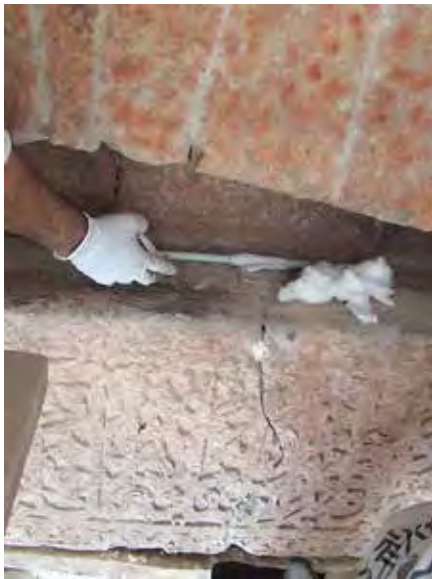
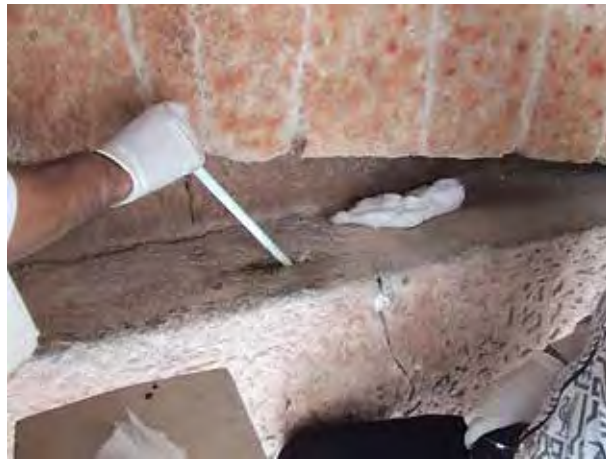
Figs. 24 and 25. Consolidation of the fractured lintel with insertion across it of bars in fiberglass.

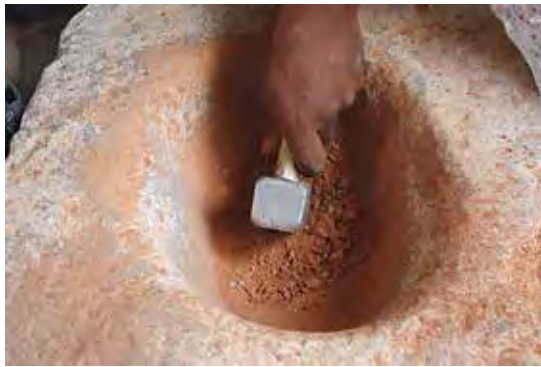
Fig. 26. Preparation of the stone powder and crushed brick that will be used to color the mortar used to grout between the stone blocks.

The mortars were obtained with a mixture of hydraulic lime and inert materials in a ratio of 1:3. Local hand-ground stone powder was used, so as to have different colors to mix with the sand, in particular red and green. We were not always able to arrive at the exact color, due to the variation of coloring among the stones. This forced the operators to make continuous changes in the initial blend.

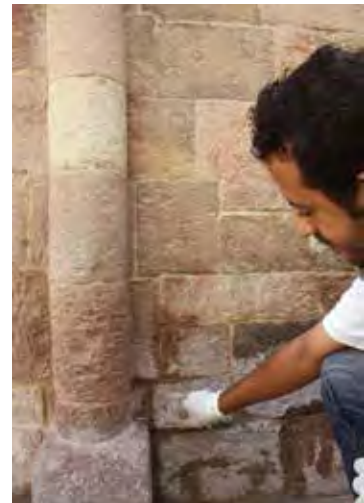
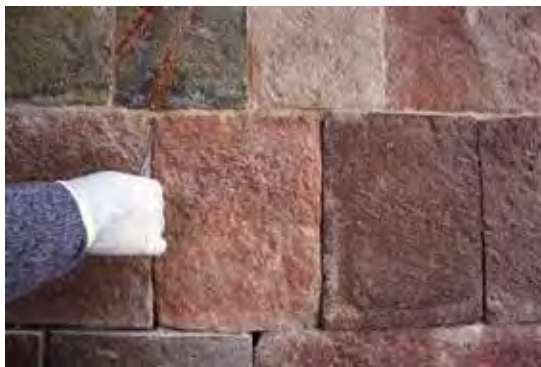
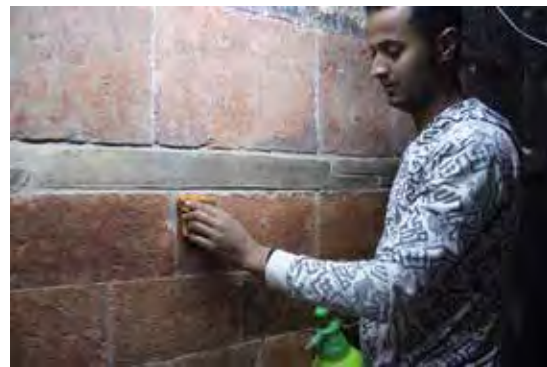
Figs. 27, 28 and 29. Stuccoing to finish the grouting between stones of the portal.

On the inside of the individual stones, we sealed any fractures and reconstructed gaps using a mortar that was chromatically as close as possible to the color of the stone, so as to prevent future stagnation of rainwater.

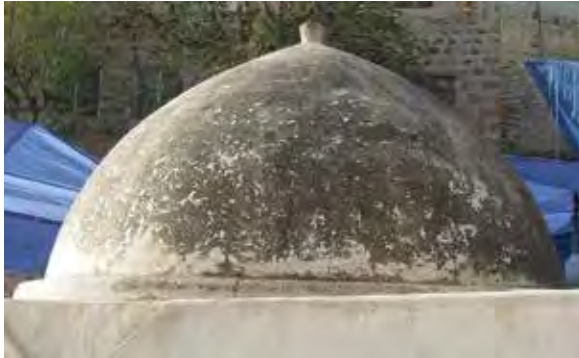
Fig. 30. Detail of the lichen covering the outside of the dome prior to starting the works.

The exterior of the dome was infested by a heavy accumulation of lichen on the recently restored *qaḍāḍ*. We initially opted to treat the surface with a biocide solution, rinsing it afterward with demineralized water. Later, it was necessary to repair the cracks uncovered with a thin fluid mortar and apply localized stuccoing with a mortar of lime, sand and marble powder.

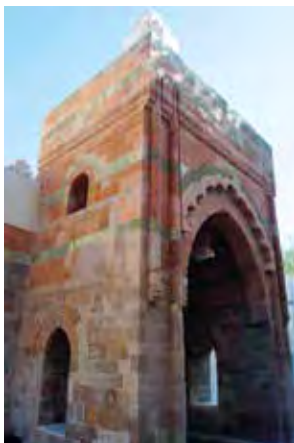
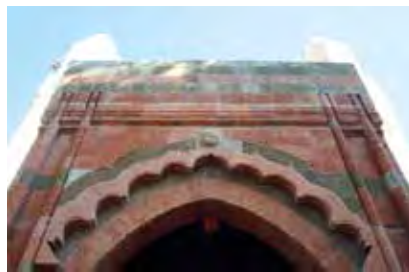
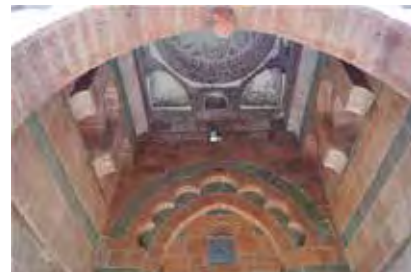
Figs. 31, 32 and 33. Overview of the south portal after completing the restoration.
