AL-ASHRAFIYYAH MOSQUE AND MADRASAH IN TA'IZZ

Conservation intervention (2008-2015)

The subject of this volume is the work of restoration of the paintings, stuccoworks and woodwork, and the structural consolidation of the al-Ashrafiyyah Mosque and Madrasah in Ta'izz (Yemen, 13th-14th century), carried out by the Istituto Veneto per i Beni Culturali (IVBC, 2008–2015) thanks to the support of the Social Fund for Development (SFD – Culture Heritage Unit). It follows the previous volume *The Great Mosque of Ṣan'ā'. Conservation intervention (2005–2015)*, published in June 2022.

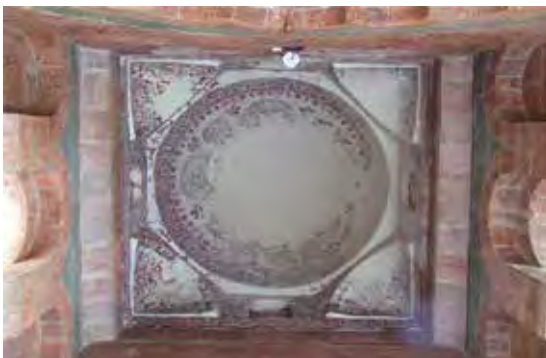
Figs. 34 and 35. Details of the south portal after completing the restoration.

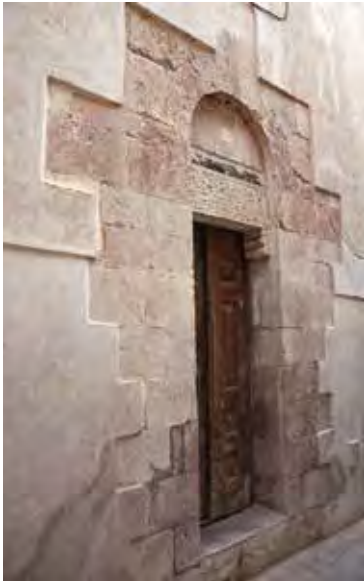
Fig. 36. West portal prior to starting works.

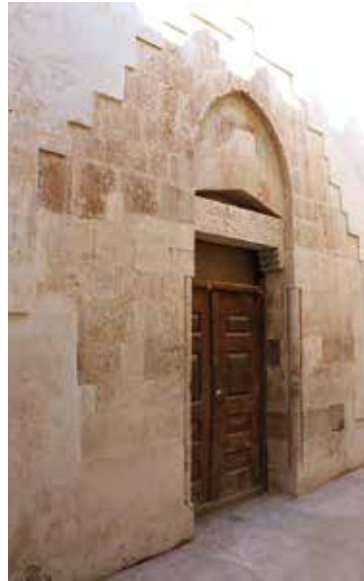
Fig. 37. Central portal prior to starting works.

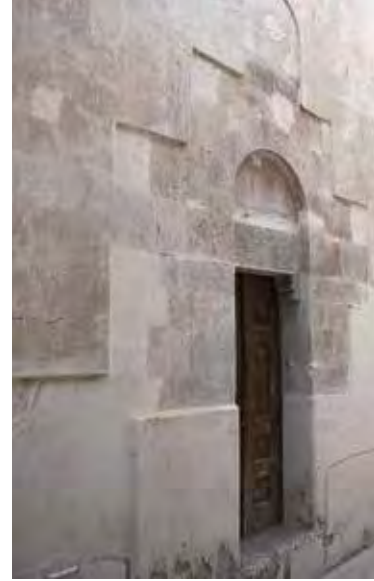
Fig. 38. East portal prior to starting works.

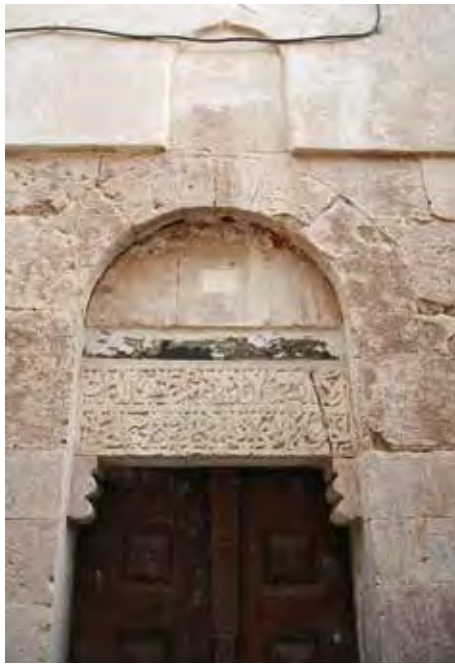
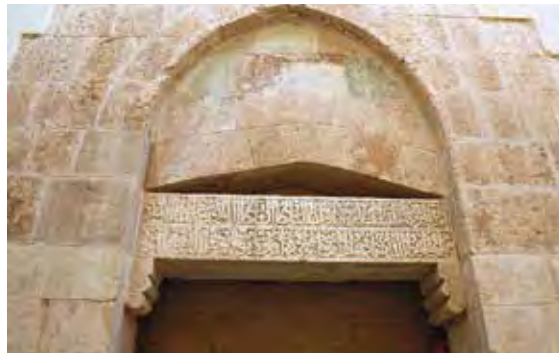
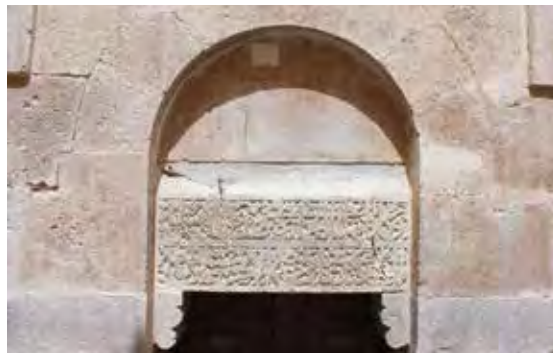
Erosion, breakage and small cracks were observed in many stones. Aside from the profound cracks along the entire thickness of the lintels on the east and west doorways, their general state of conservation was fair but the lack of uniformity of past maintenance works created a sort of esthetic disorder that disturbed the general visual unity, requiring a serious, carefully planned action of conservative restoration.

Figs. 39, 40 and 41. Details of the lintels prior to restoration.

After completing all the stages of cleaning, we concentrated on consolidating the eroded stones, fastening any broken parts and inserting pins to secure the fractures of the lintels. The largest missing parts were replaced with limestone blocks of similar tone and color to the originals.

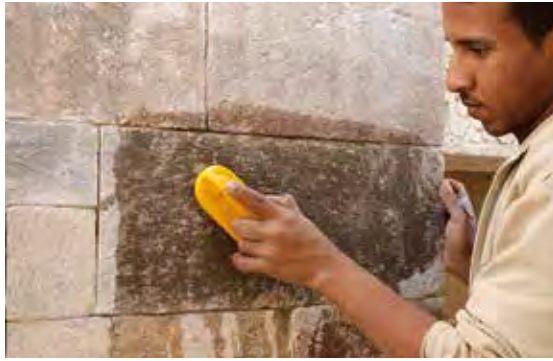
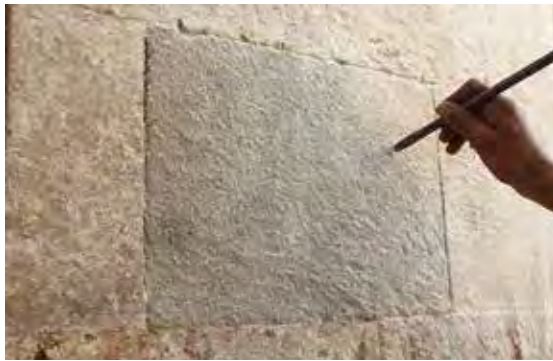
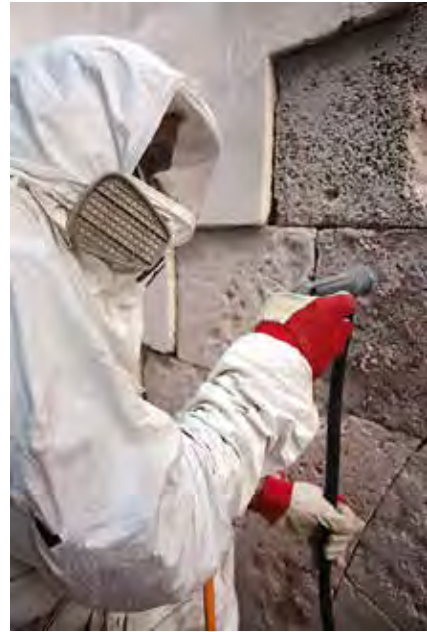
Figs. 42, 43 and 44. Cleaning the stonework portions of the portal.

At the same time, the residues of whitewash and old stucco were removed with scalpels and micro-chisels. To ensure a more uniform cleaning of the stone blocks, we opted for a light sandblasting process, calibrating the gauge of the inert material and using a gun with a medium-sized nozzle. In this way, it was possible to remove all the residues of lime, when tended to be very stubborn. In some cases, we also tested an anionic exchange resins, which gave good results.

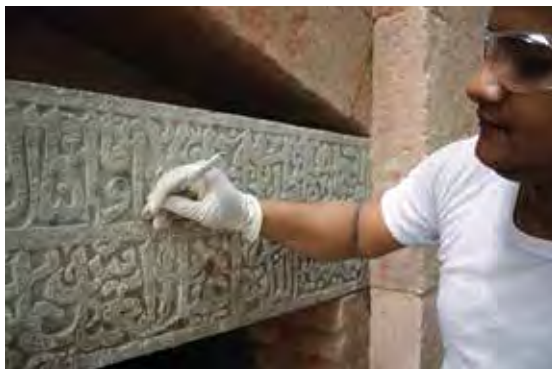
Fig. 45. Cleaning the lintel.

The lintels sculptured in gray marble were treated with a careful and meticulous mechanical cleaning with scalpels, to remove all the whitewash. Compress of paper pulp soaked in ammonium carbonate were applied in the corners and on the ledges supporting the lintels, to remove the stains and thin black crusts. We also treated the wooden beam positioned above the lintel. On the west doorway, the beam was cleaned using a pickling gel in a water suspension, which had the ability to swell the black substance that concealed it. On the west doorway, it was necessary to remove a thick layer of plaster and, with the collaboration of the carpentry team, insert two wooden beams to support the original beam, which had been partially damaged. The beams were then consolidated and protected with Paraloid B72 acrylic resin in a 5% solution.

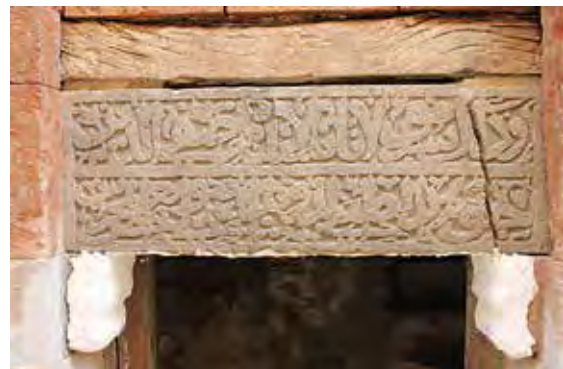
Fig. 46. The lintel after cleaning.

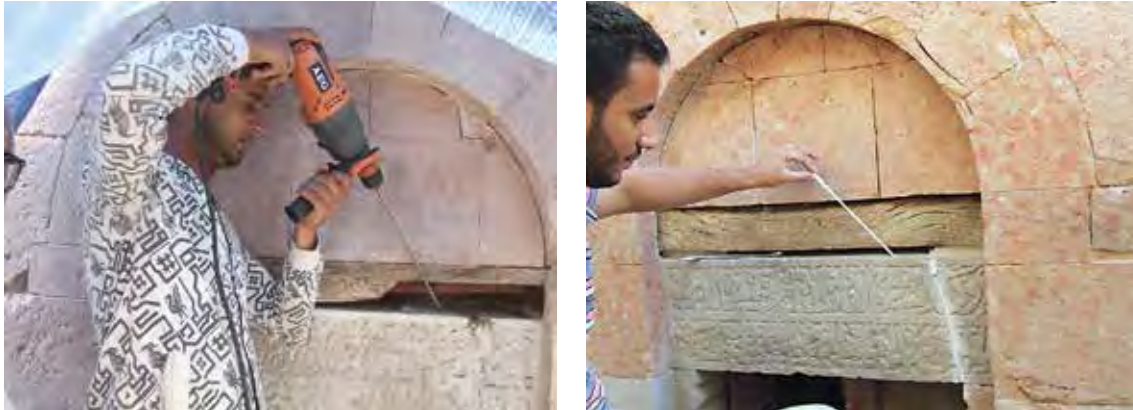
Figs. 47 and 48. Work of consolidation of the lintel, with insertion of fiberglass bars across it.

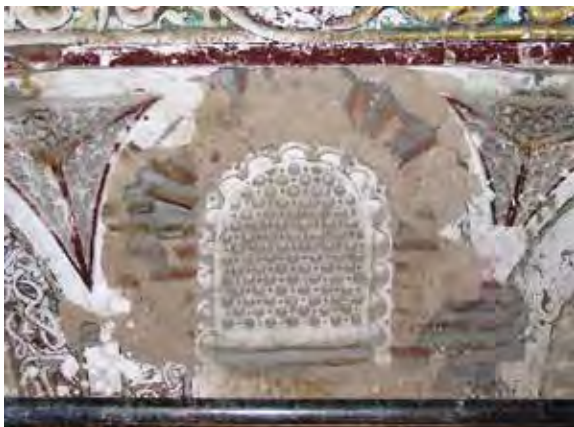
Fig. 2. Below the large gap around the window, it is possible to see the bedding mortar.

The masonry consists of solid bricks on a bedding mortar of clay, straw and lime, as well as parts of wooden structures. The same compound has also been used as a mortar undercoat on the outside of the masonry, on which to lay the final coat of plaster.

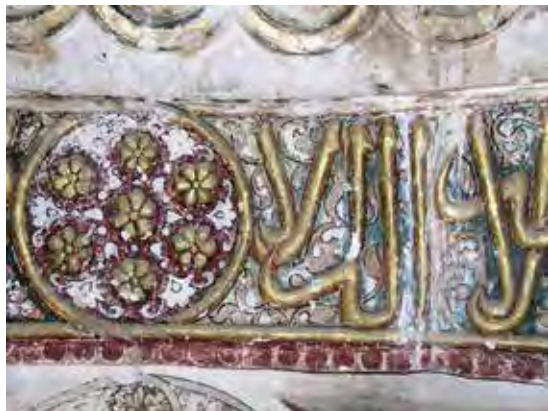
Fig. 3. Detail of gilded inscription in the lower band of the dome in sector 2a.

A new and difference element that is found among the decorations of the cenotaph is the gold leaf applied with mission gilding on plaster. Gilding is used here to define the lettering of the Qur'anic verses at the base of the dome, and some of the outlines of the large shell pattern that define the shape of the large decoration in the vault of the dome.

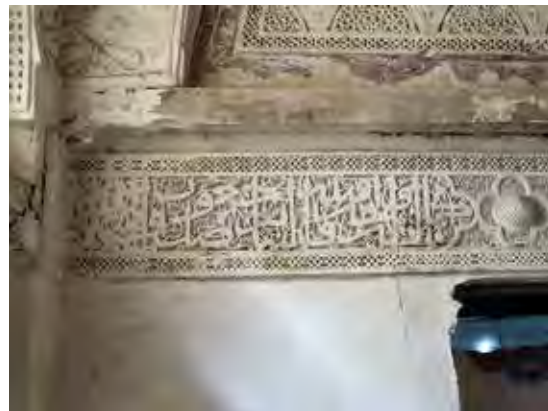
Fig. 4. Section of the qur'anic inscription in carved stucco found in sector 2a. The branches of the floral decoration form long coils filling every bit of space between the letters.

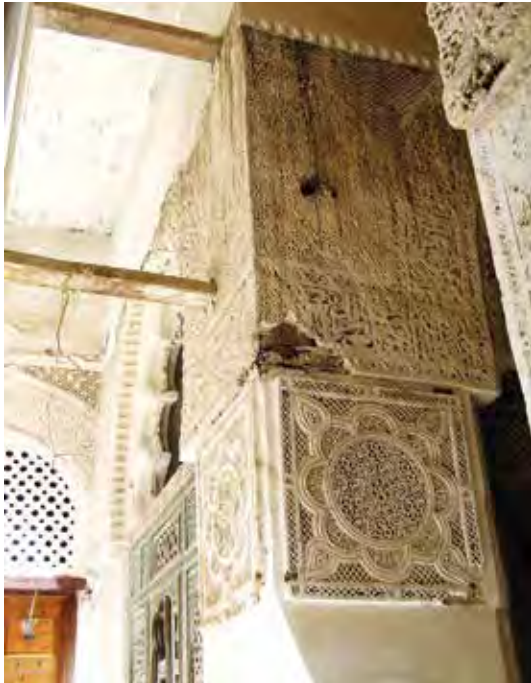
Fig. 5. Exterior stuccowork in sector 2 prior to restoration works. The geometrical design was disturbed by the thick layer of whitewash.

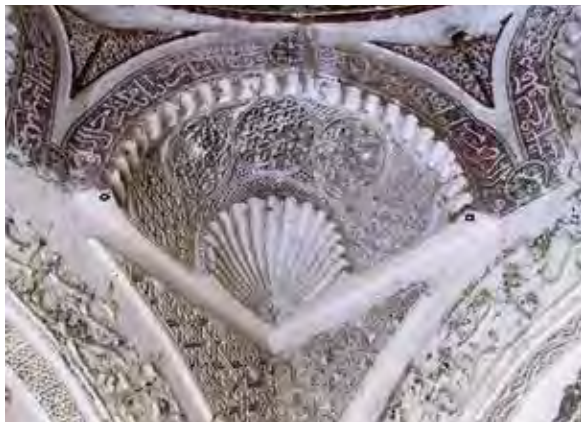
Fig. 6. Example of niche decorated with stuccowork in plaster found in sector 2a prior to restoration works.

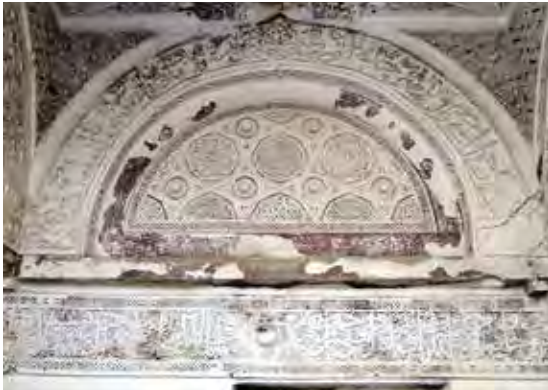
Fig. 7. Decorated lunette on the north wall of sector 2a, prior to restoration work. Also in this case the refined ornamentation was disturbed by the layers of whitewash painted over it.

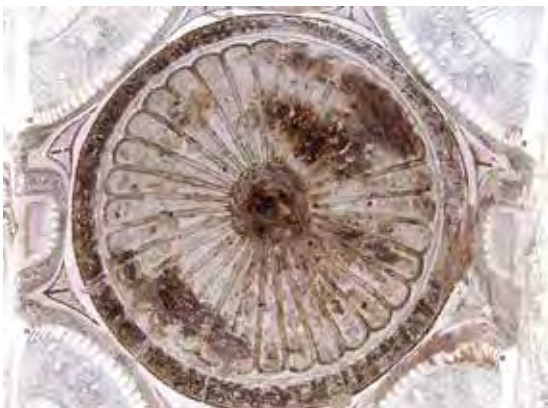
Fig. 8. View of the base of dome 2a with its characteristic modulation in a shell pattern.

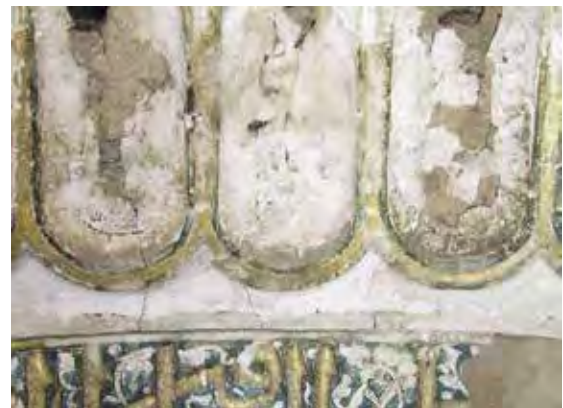
Fig. 9. Detail of the gilding of the internal decoration of dome 2a.

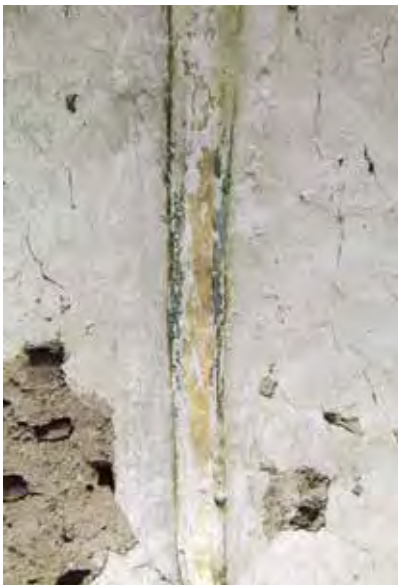
Fig. 10. Detail of the gilded pattern in dome 2a. Note how the gold leaf is set off by two colored lines, red on the inner edge and green on the outer edge.

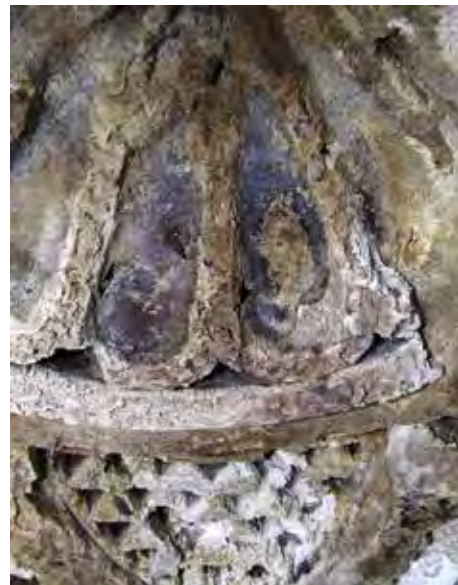
Fig. 11. Detail of the central shell of dome 2a. Traces of darkened red color can be seen on the inside of the shell.

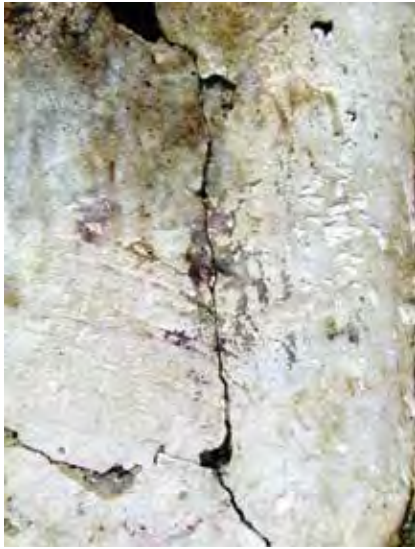
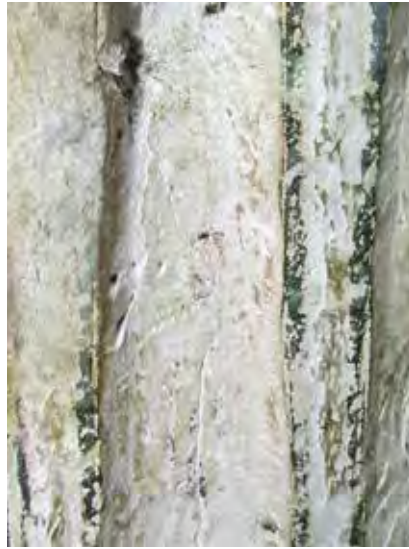
Figs. 12 and 13. Detail of one of the petals of dome 2a. Fragments of red color are visible, suggesting that they were entirely colored. This is also confirmed by comparison with the tomb in sector 2c.

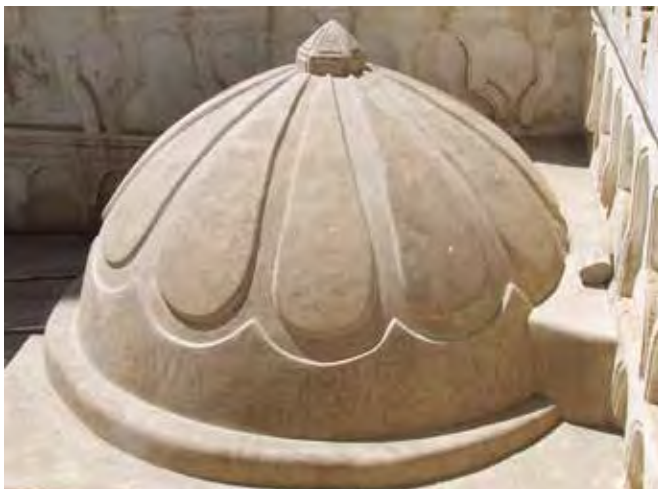
Fig. 14. Exterior view of the dome in sector 2a.

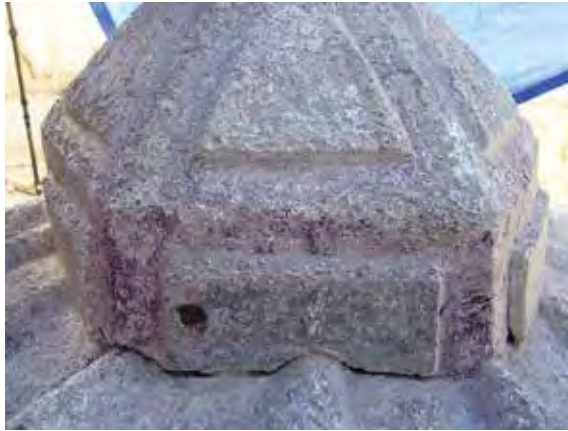
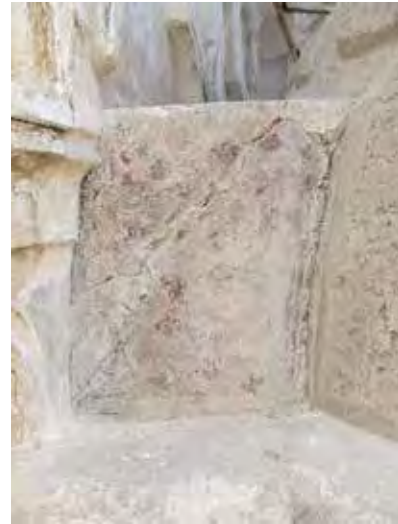
Figs. 15 and 16. Detail of a fragment of color of the exterior finish on the dome.

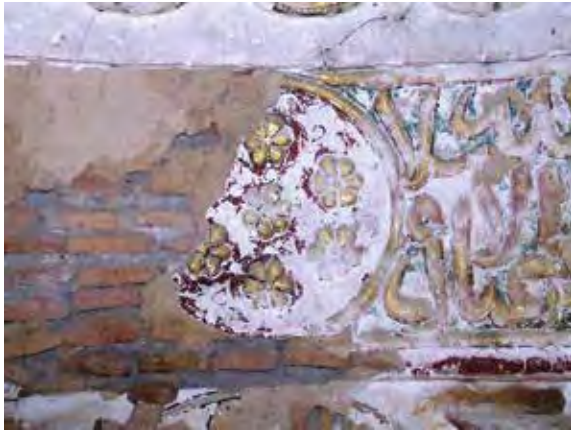
- *Infiltrations of rainwater* from outside, through the roof, had caused large brownish-yellow stains on the painted plaster as a consequence of soaking deeply into the masonry structure with its bedding mortars made of earth and clay. The water then causes soluble salt crystals to migrate to the surface where they form thick concretions. This unsightly problem damaged the decorated parts, particularly the domes, where the situation was often catastrophic, with the pulverization and complete destruction of the paint film, and

Fig. 17. Example of the effect of washout on the color of the Qur'anic inscription in dome 2a. There are also a number of white spots caused by saline incrustations scattered over the entire surface.

loss of adhesion of the supporting plaster, as well as swelling and loss of shape with fragmentation of the finish. On the walls, the decorations were better preserved thanks to the whitewash brushed on top, which acted as a protective coating.

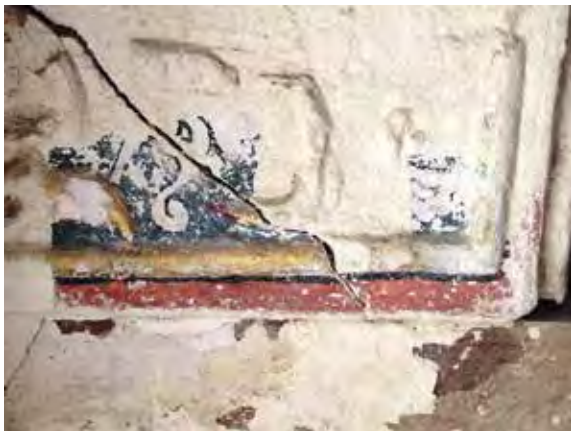
Fig. 18. Tests for removal of whitewash from the decorations of the arch in sector 2a.

However, the presence of this whitewash, which had to some extent protected the surface, did not completely prevent problems from developing. From the first assays of removal, it was possible to observe how the bottom layers of plaster had deteriorated, becoming incoherent and powdery, while the color was absent in places.

As first operation it was necessary to eliminate the whitewash, removing all those coats of lime and plaster that covered and rendered illegible the refined ornamentation of the decorations in painted stuccowork, and the elegant Qur'anic script with gilded lettering. Removal of the whitewash had the advantage of revealing the real state of the original surfaces, making visible all the gaps and cracks that had been sealed over. This operation proved to be quite difficult and delicate as the surface layer of whitewash was thicker than the base plaster, which in turn was highly porous and inconsistent, so that the paint film applied to a surface in those conditions was unable to bind itself effectively. To facilitate the operations, after several trials in which different acrylic and polyvinyl resins were tested, it was decided to resort to pre-consolidation with the acrylic resin "Paraloid B72" diluted in solvent at 5% and injected in depth.

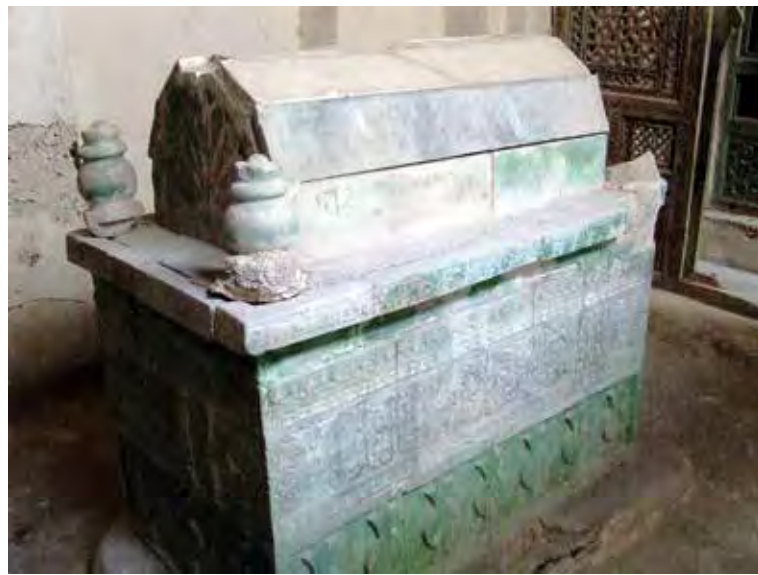
Fig. 19. Lateral view of the cenotaph in sector 2a.

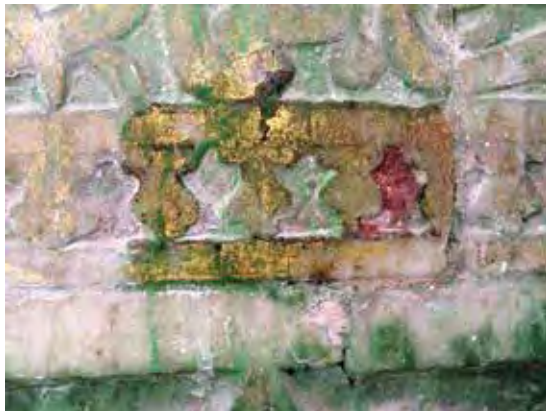
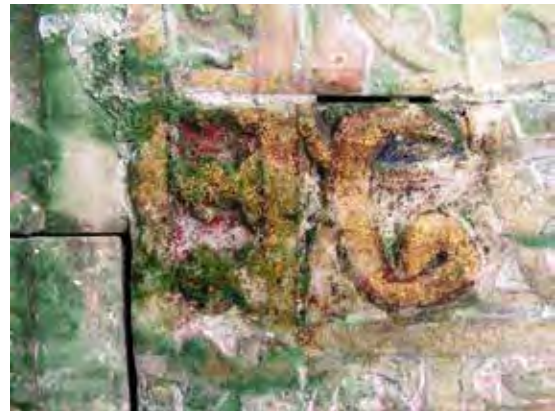
Figs. 20 and 21. Preliminary cleaning trials. Note how the gold leaf gilding of the letters is outlined by a brown edging and the spaces filled with bright red.

The particular executive technique used for the decorations, consisting of painting directly on plaster, made it impossible to use water-based products on a large scale. Even the use of gel was found to be harmful if excessively prolonged. Following mechanical cleaning with Wishab sponges or fiberglass pens, a fatty emulsion was used to remove any dark stains or saline efflorescence. The operation called for the interposition of small squares Japanese paper on which the emulsion had been applied by brush. After a few minutes, the thin paper was removed and the area was gone over with a light mechanical action using a cotton pad on a wooden stick.

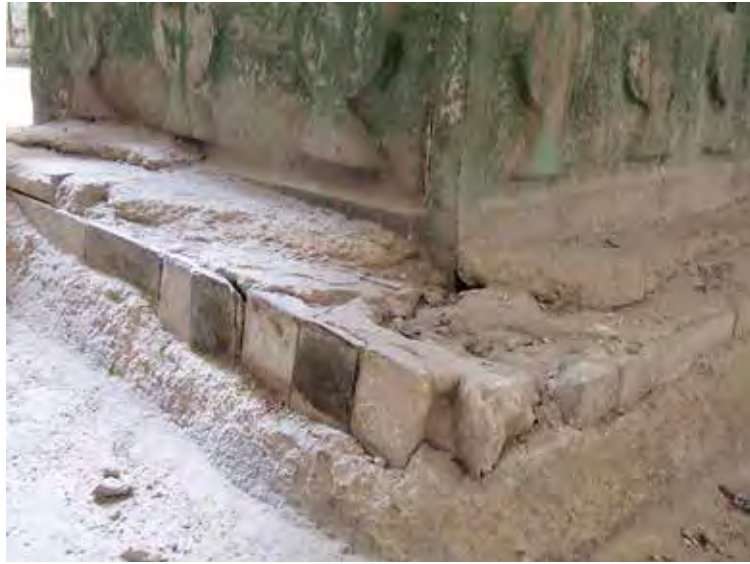
Fig. 22. Detail of the base of the cenotaph in sector 2a. A few stone tiles alternating black and white, emerge from the cement that covers the entire floor.

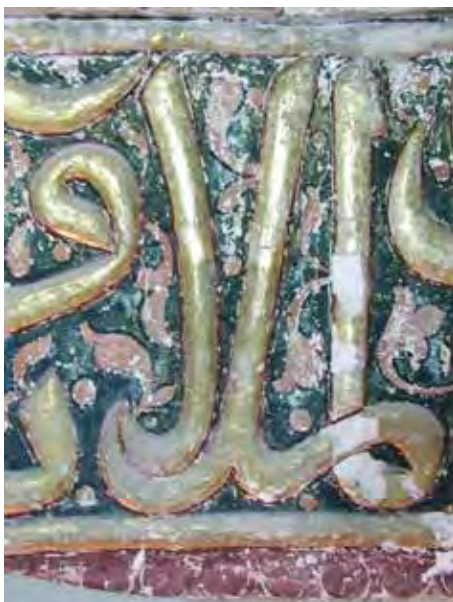
Fig. 23. Sample section of cleaning on gold Qur'anic inscription of the lower band of dome 2a.

On the gilded Qur'anic script, the gold appeared badly deteriorated due to the efflorescence of saline concretions, deposits of dust and organic substances of various kinds. There were also gaps in the lettering due to the constant seepage of water that had dissolved parts of the surface. The removal of the deposits was achieved, after some testing, with a solution of chelating gel pH8, in two or three separate passages. Given the particular fragility of the gold and underlying plaster to most liquids and solvents, every passage required complete drying of the surface from the previous passage, and turned out to be a very time-consuming and delicate process, but with highly satisfactory results.

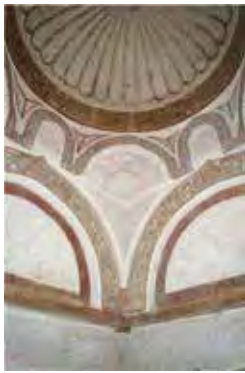
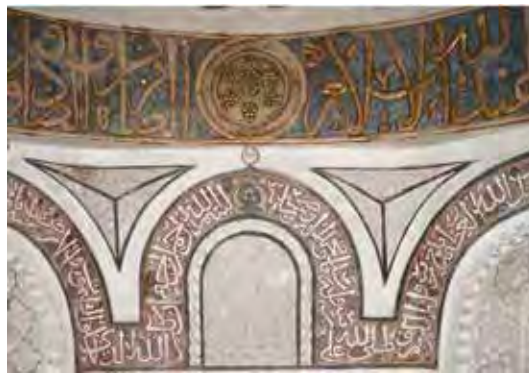
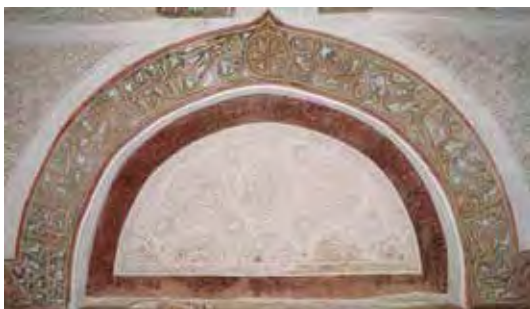
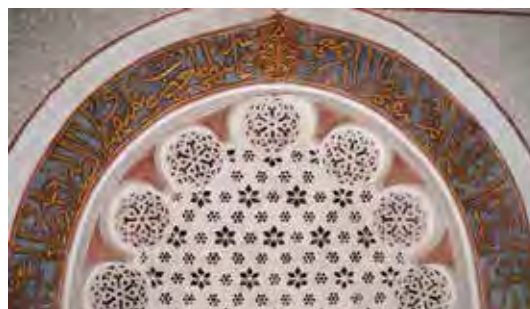
Figs. 24a - 24d.

Some details of the carved and painted stucco at the end of the restoration work.

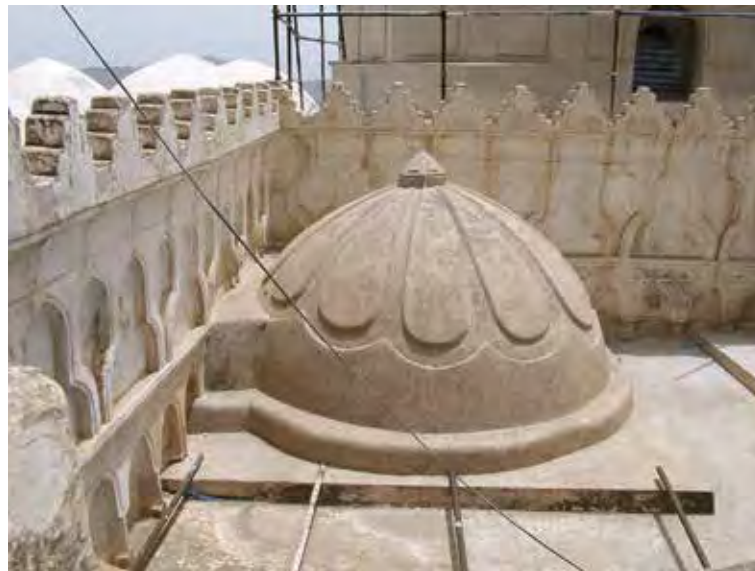
Fig. 25. Overview of the outside of the dome in sector 2a after restoration.

The next step was to repair the stuccoing of the external coating of the dome. A complete replacement and restoration of the external covering was not done, as in the case of the dome on the Prayer Hall. In this case it was decided to repair the gaps one by one so as to preserve the fragments of color restored and reconstruct the original smooth aspect.

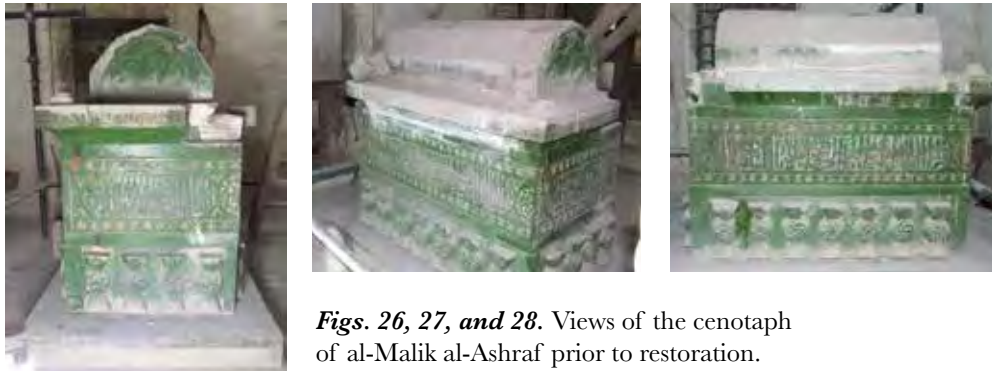
Figs. 26, 27, and 28. Views of the cenotaph of al-Malik al-Ashraf prior to restoration.

Both cenotaphs were covered with a thick coat of green paint applied in relatively recent times. Underneath the paint we found another layer consisting of a black, tarry substance that in some points allowed glimpses of the original multicolored decoration and traces of gold leaf. From the structural standpoint, the monument appeared to be in fairly good condition in the lower portion. The most significant problems were found in the projecting cornice and on the cover, which had probably been tampered with to examine the inside. The slabs bore traces of adhesive cement-based mortar, carelessly applied. Some of the stones had also been repositioned incorrectly. A block of the cornice positioned on the south side was overturned and actually belonged on the west side, and another missing block was attached to the monument of the nearby al-Malik al-Nāṣir Aḥmad cenotaph. The four corners of the cornice were precarious because of the movements caused by rusting of the iron framework which, by increasing its volume, had caused detachment of the bedding mortars. The corner decorations, probably representing lanterns, had been lost.

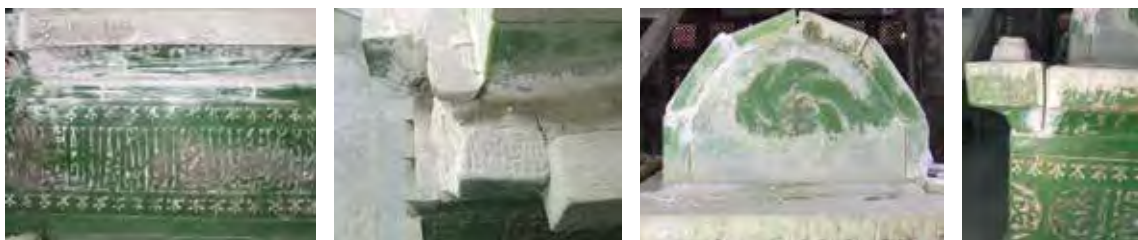
Figs. 29, 30, 31 and 32. Details views of the cenotaph of al-Malik al-Ashraf prior to restoration.

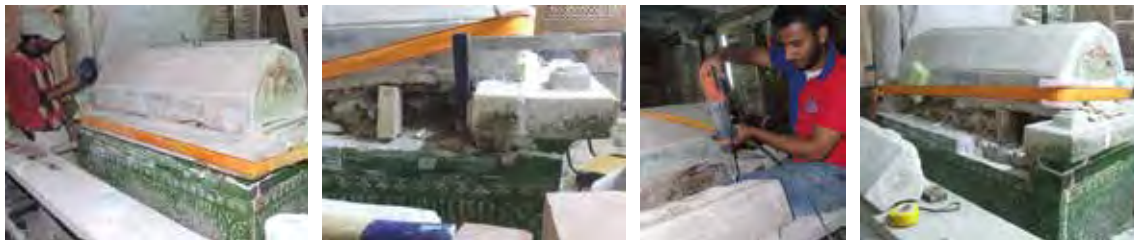
Figs. 33, 34, 35 and 36. Details views of the cenotaph of al-Malik al-Ashraf prior to restoration.

The first stage was the work of structural consolidation, made necessary by the presence of endangered elements. All the stones that were not in the proper place or had been positioned improperly were removed. This work involved the cover and the overhanging cornice. Before repositioning each element, particular care was taken to clean the internal structure, removing any deteriorated mortar and all the incoherent material deemed inadequate at this point in time. Where possible, the original internal iron frameworks were preserved, cleaned, treated with a rust converter and protected with Paraloid B72 to delay the formation of future rust. At this point it was suggested to use a system of bricks bonded with hydraulic Lafarge lime to rebuild the missing portions of the internal structure. For the adhesive operation, a slow-drying bi-component epoxy resin was used, with the addition of micronized silica. Where necessary, fiberglass pens were inserted to add stability and security of anchorage. The operation was laborious and time-consuming; the aid of tensioning straps contributed to its effectiveness. After completing the adhesion process, injections of fluid hydraulic mortar were made to fill any possible remaining gaps, so as to give complete stability to the restored structural system.

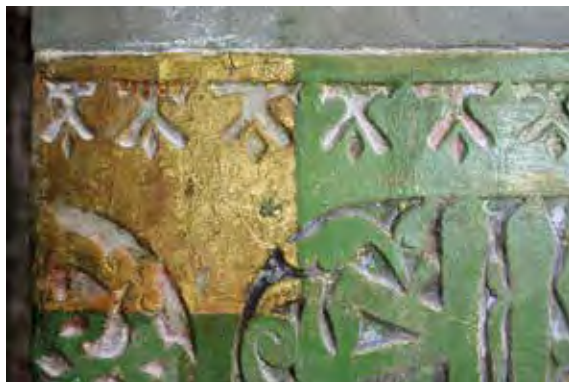
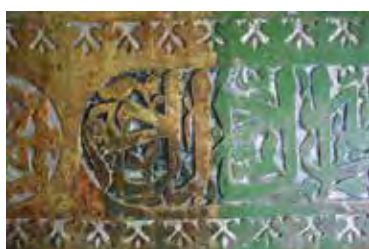
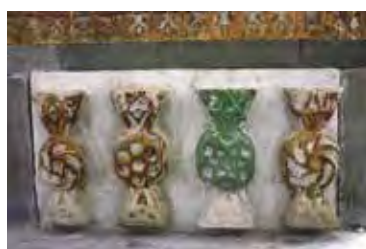
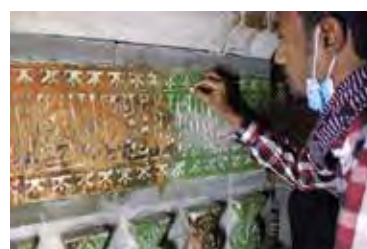
Figs. 37, 38, 39 and 40. Views of the early stages of cleaning of the gold leaf decorations on the cenotaph. The first step was solely concerned with removal of the green paint.

First a mixture of Tween20 and ethanol was applied. Working with a cotton swab it was possible to remove the coat of green paint, paying particular attention to the indentations of the gilded bas reliefs, for the presence of the red color and intense blue, extremely

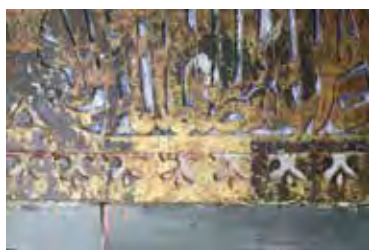
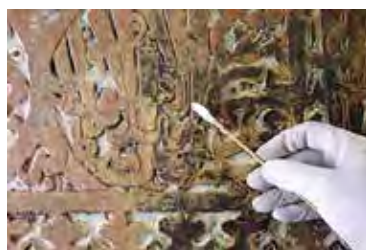
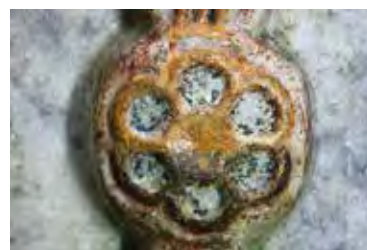
Figs. 41, 42 and 43. Views of the later stages of cleaning of the gold leaf. The second step involved removal of the brown deposits and oxidation of the gold leaf.

After that, the next stage of cleaning consisted of using a chelating solution with pH 7.5 in a base solution of demineralized water, citric acid and triethanolamine which was able to remove the black substance. In general, the operation was very lengthy and complex. Cleaning was done with a compress and swab of cotton, through a slow but constant action. The workers had to proceed with great care and sensitivity.

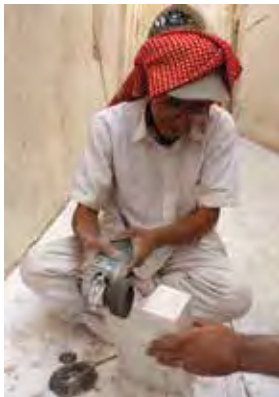
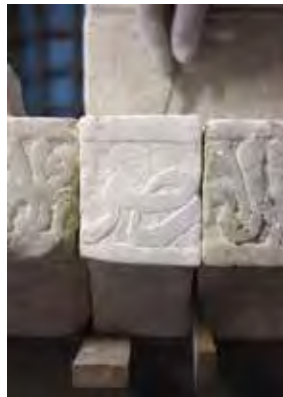
Figs. 44 and 45. Views of insertion of a reconstructed portion of the Qur'anic inscription.

After completing the conservative works, it was necessary to undertake the works of integration. Part of the overhanging cornice had to be integrated, sculpting the missing letters in the same style and choosing a stone similar to the original. The top was hammered like the original stones and a patina was then applied to harmonize with the rest.

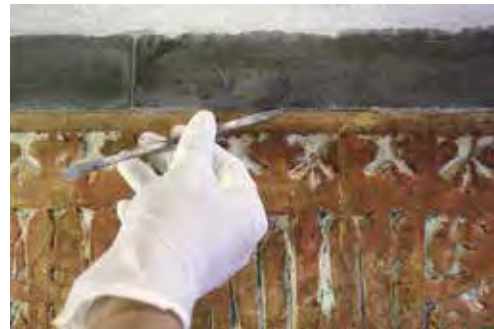
Fig. 46. Detail of the process of stuccoing the joints between the stones of the cenotaph.

The joints between the different marbles were then plastered with a mixture of lime, fine sand and marble dust, in an attempt to achieve a neutral tint that would match with the general shading of the lighter stones. Around the gray stones and the gilded decorative parts, it was decided to opt for a lightening of the shade through the application of a veil of color.

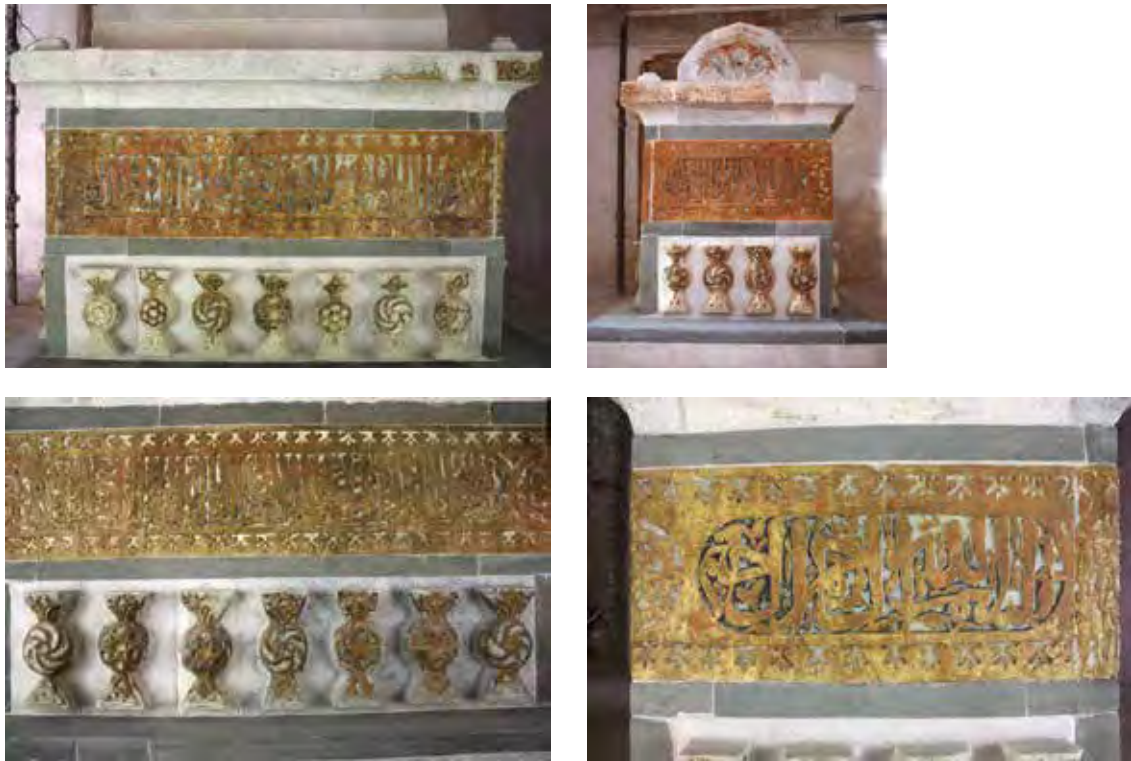
Figs. 47, 48, 49 and 50. The cenotaph of al-Malik al-Ashraf after restoration.

All the gilded and painted decorative parts were protected with a coat of Paraloid B72 at 5% in acetone. Any retouching of the painting was only done on the gilded decorations of the central slabs. In the abraded zones and where material was missing, a subtle veiling with paint was applied to rebalance the level of the orange tint of the bole used in the preparation for the gold leaf, harmonizing it with all the surrounding decoration.

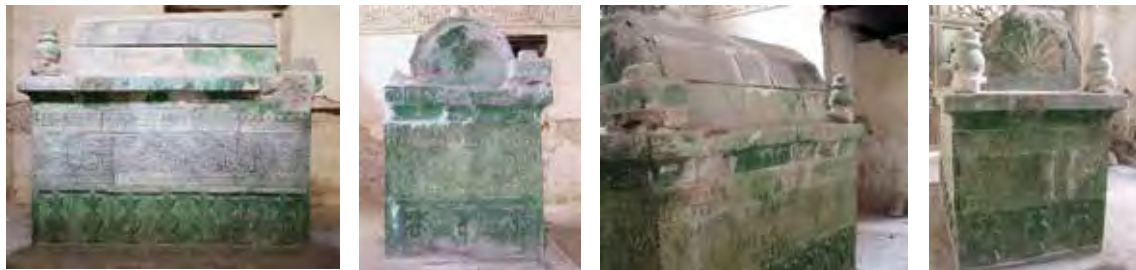
Figs. 51, 52, 53 and 54. Views of the cenotaph of al-Nāṣir Aḥmad prior to restoration.

The sculptured parts revealed traces of color hidden by the green paint. The cover consisted of stones, alternating white and gray, and traces of decorations could be observed on the east and west faces.

The cenotaph had been tampered with in the past and had been subject to some cursory works of maintenance. On careful study, it was possible to see that the slabs had been removed and replaced rather clumsily, leaving wide spaces between the stones, which had not been repositioned in their proper place. At that time, the gray stones of the cover may

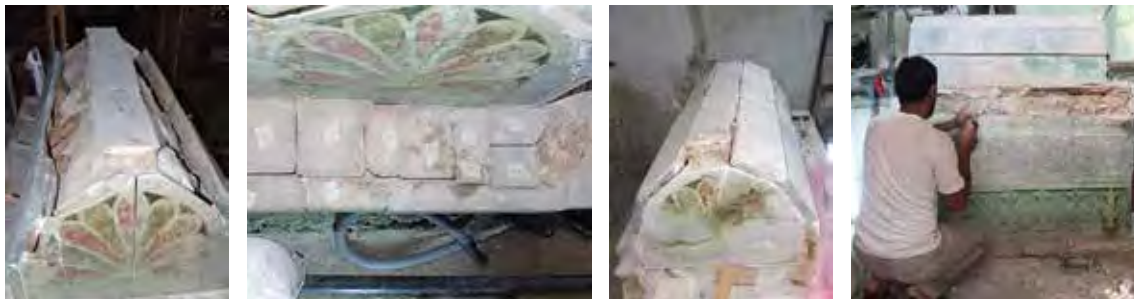
Figs. 55, 56, 57 and 58. Views of different stages of the process of structural consolidation of the cenotaph, which involved disassembly followed by complete documentation of part of its elements.

The works were concentrated initially on structural consolidation. All the stones at risk of detachment or positioned erroneously in previous maintenance operations were removed and carefully catalogued. Before removing the stones, the internal structure of the monument was cleaned and all the crumbling and broken material was removed. In a later stage the load-bearing structure was reinforced with lime and sand. Where necessary, portions of bricks and new bedding were inserted to reposition the original stones correctly.

In the same way, the cornice was removed, as well as several precarious slabs. Where necessary, in case of broken pieces or on the cornice, at risk of collapsing due to rusty iron hooks, bi-component epoxy resin reinforced with micronized silica was used. Later, fluid hydraulic mortar was injected to fill any remaining gaps.

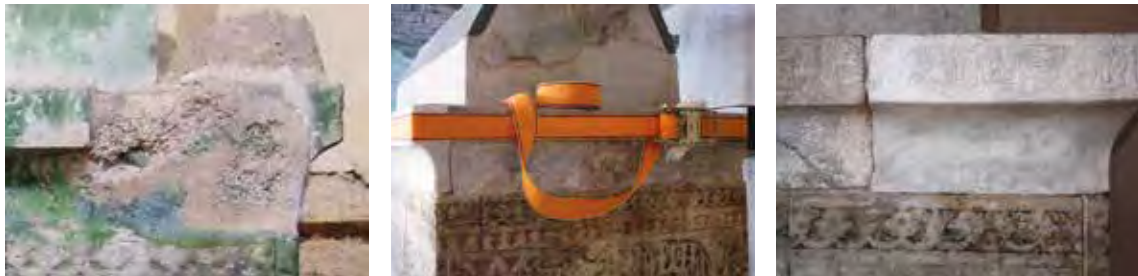
Figs. 59, 60 and 61. Views of different stages of the process of structural consolidation and insertion of a reconstructed element for completion of the Qur'anic inscription.

The missing stone from the southeast corner was added, sculpting the missing Qur'anic verse, and it was lightly hammered to resemble the original stone. A light patina was applied to antique the new stones and harmonize the shading with that of the original structure.

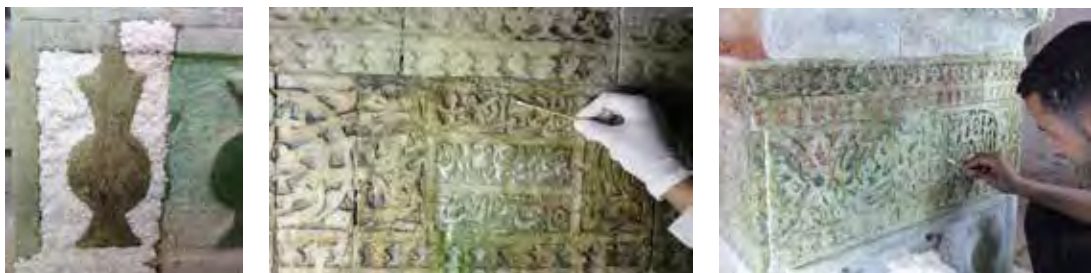
Figs. 62, 63 and 64. Views of various stages of the cleaning process.

Also in this case, the cleaning turned out to be a very painstaking operation. The tenacity of the green paint with respect to the delicacy of the original underlying colors limited the use of solvents. Due to this difficulty, it was decided to work step by step on different fronts: to start cleaning with compresses of ammonium carbonate on the stones where there was no painting; in the gilded sections and wherever we encountered colors, an acetone-based solvent gel was used to remove the green paint. It was necessary to go over the areas several times to eliminate all traces completely. Where possible, the gilded zones were treated with Paraloid 5% in acetone to pre-consolidate and allow the solvent solutions to act on the paint that had to be removed. The operation was very time-consuming in general, requiring extreme attention by the workers.

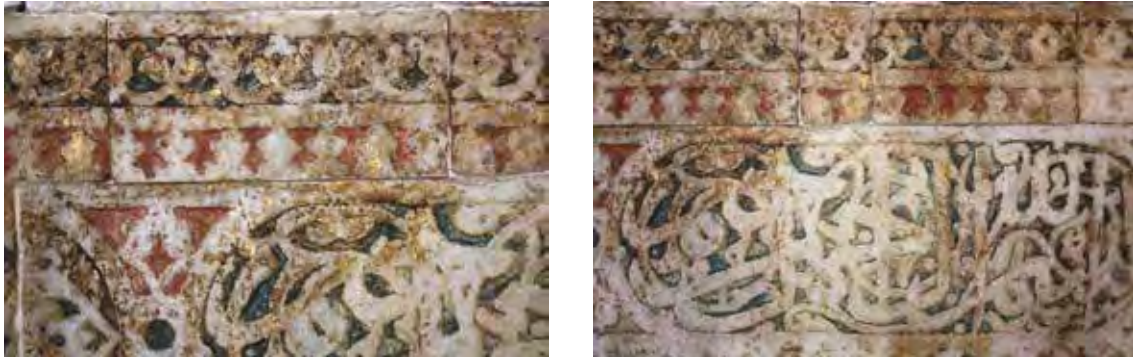
The final result brought to light an elegant play of colors alternating with the use of gold leaf in the inscriptions and floral decorations on blue and red backgrounds. The conclusion of the entire cleaning process also revealed the many different types of marble used, with veining and tints that restore much of the monument's original splendor.

Figs. 65 and 66. Details of the decoration and inscription at the center of one side of the cenotaph after cleaning.

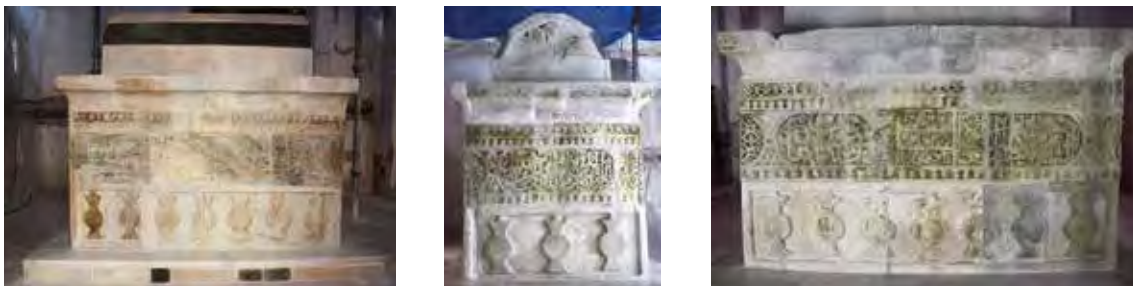
Figs. 67, 68 and 69. The cenotaph of al- Malik al-Nāṣir Aḥmad after restoration.

The final repairs with stucco were made below the surface with a mixture of lime and marble powder in a neutral tint with respect to the different shades of the marble and polychrome parts. Where necessary, the tint was corrected with a veil of watercolor.

On completion of all the stages of the work, a finish was applied using a base of microcrystalline wax diluted to 4% in white spirit, applied with a brush.

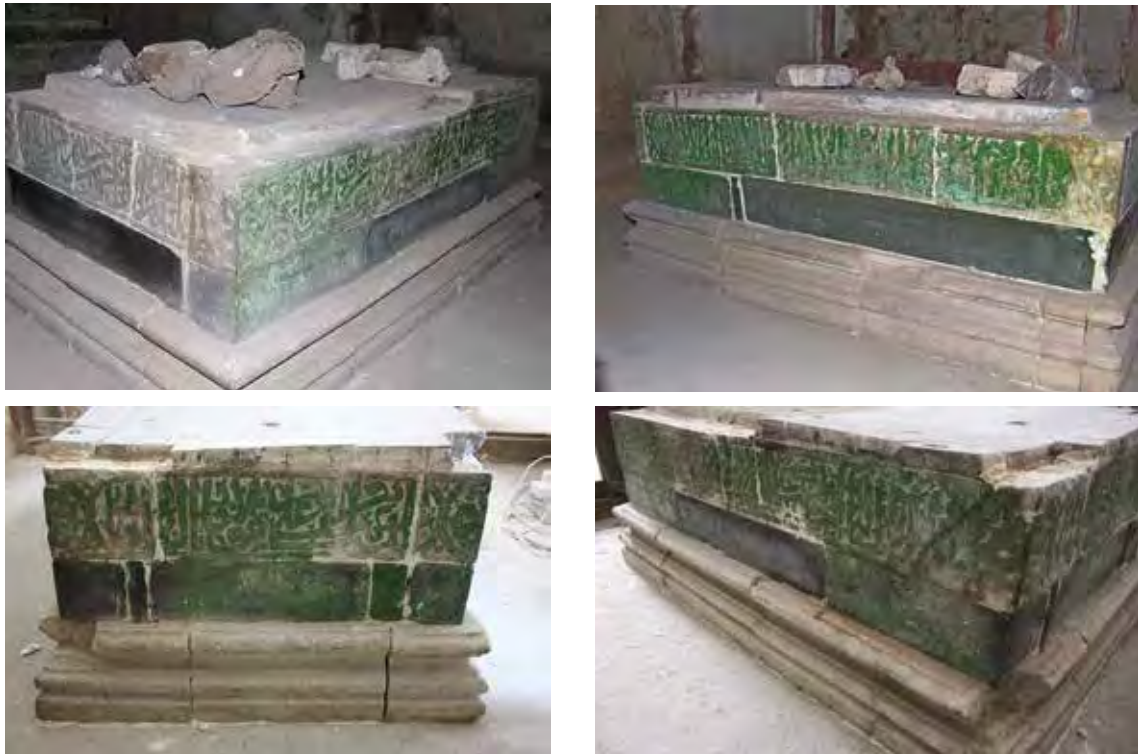
Atop a lovely white marble molding base runs a strip of black stones, the same stone used in the cenotaphs of the sultans. Above it is a band containing an inscription in bas relief. A row of light-colored slabs placed horizontally, but fragmentary, creates a border for the inscription and in the upper part, closing the cenotaph, there is a large slab of the same dark stone seen below.

Figs. 70, 71, 72 and 73. Different views of the cenotaph of al-Mujāhid prior to restoration.

The odd shape of this cenotaph with respect to the others gave rise to the idea that the cover might be missing. The misalignment of the stone slabs suggested possible tampering and dismantling in the past, as did the irregular and clumsy applications of stucco between the joints. Like the other cenotaphs, a synthetic green paint had been applied to much of the stone surface, under which it was possible to see a black color and a few traces of gilding. A black border outlined the edges of the gilded letters.

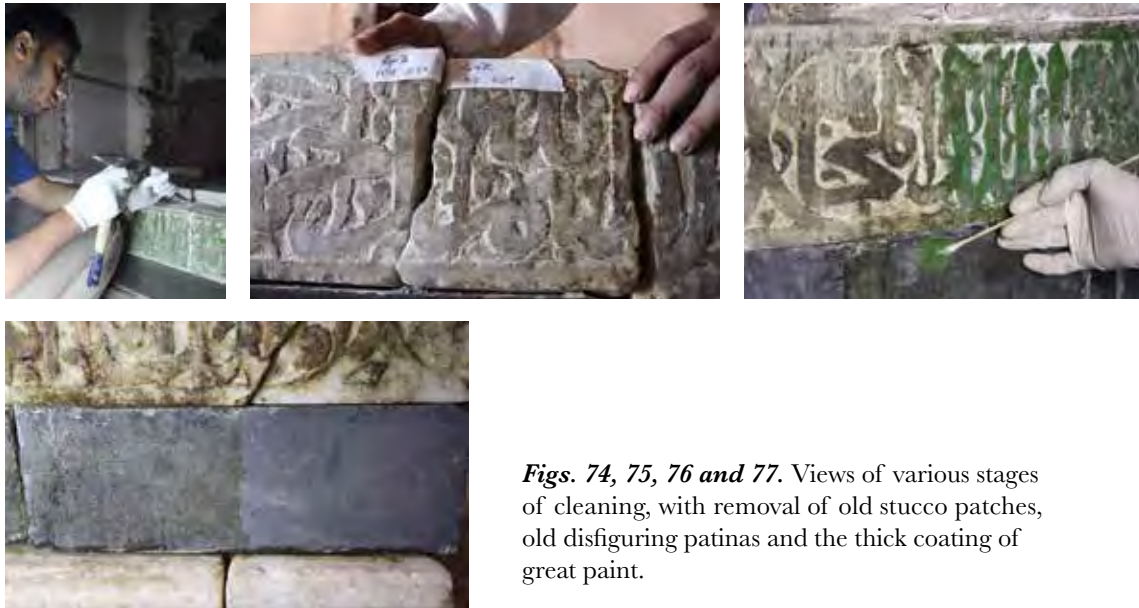
Figs. 74, 75, 76 and 77. Views of various stages of cleaning, with removal of old stucco patches, old disfiguring patinas and the thick coating of great paint.

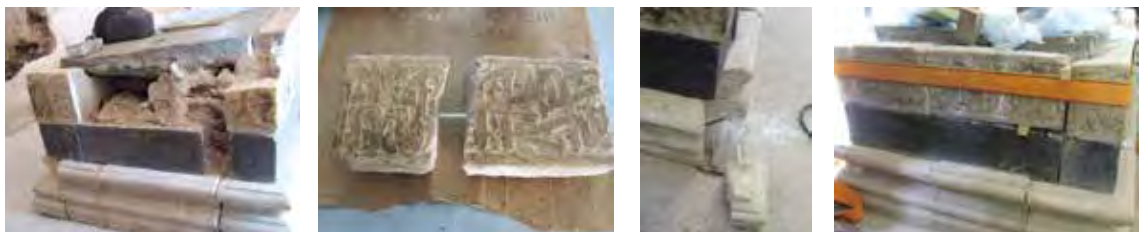
Figs. 78, 79, 80 and 81. View of different stages of the process of structural consolidation which required, among the various works, insertion of fiberglass bars.

All the marble blocks found to be in precarious conditions were detached and catalogued. Following the removal of the inner parts of crumbled mortar and residues of plaster, and after restoring the internal load-bearing structure, we proceeded to the adhesive stages. Where necessary, a first bedding mortar was applied, mixing lime and sand, after which the broken marble blocks were reattached using bi-component epoxy resin. In some cases, fiberglass bars were inserted as well.
