AL-ASHRAFIYYAH MOSQUE AND MADRASAH IN TA'IZZ

Conservation intervention (2008-2015)

The subject of this volume is the work of restoration of the paintings, stuccoworks and woodwork, and the structural consolidation of the al-Ashrafiyyah Mosque and Madrasah in Ta'izz (Yemen, 13th-14th century), carried out by the Istituto Veneto per i Beni Culturali (IVBC, 2008–2015) thanks to the support of the Social Fund for Development (SFD – Culture Heritage Unit). It follows the previous volume *The Great Mosque of Ṣan'ā'. Conservation intervention (2005–2015)*, published in June 2022.

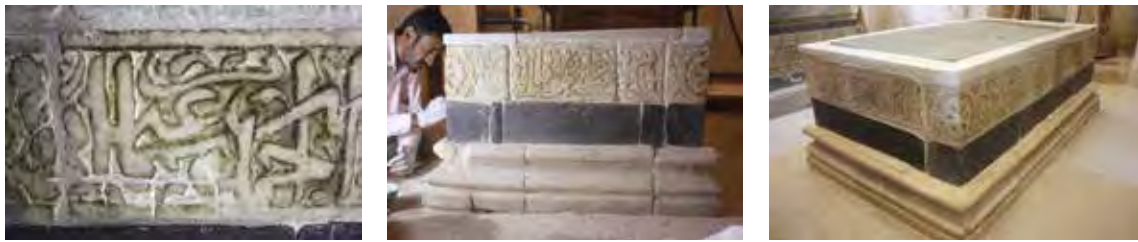
Figs. 82, 83 and 84. The cenotaph of al-Mujāhid after restoration.

Following the same operating line of restoration used for the other cenotaphs, we decided to reintegrate the missing parts that in this case consisted of the cornice above the inscription. We were able to procure a local marble with coloring similar to the original, then attempted to adapt the new portion with the existing part by applying an antiquing patina that harmonized while at the same time leaving the addition legible.

On completion of the works on the cenotaph, we performed the final stucco repairs with a mixture of lime, sand and marble dust, slightly below the surface level.

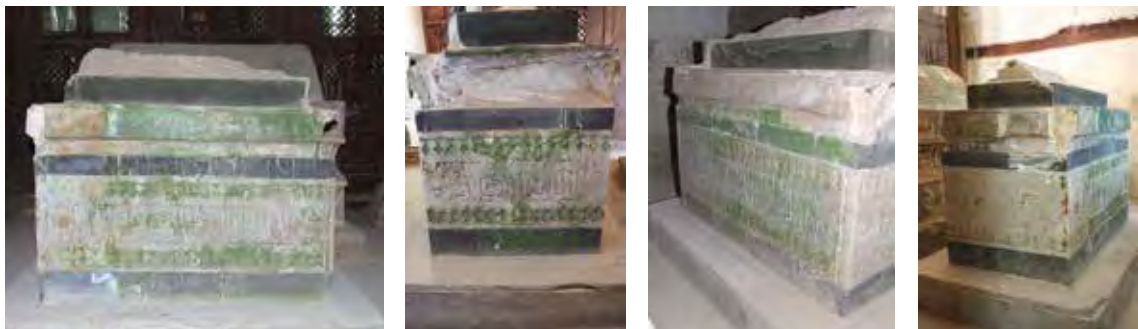
Constructed in a highly precious marble, its base is in white marble. On this base stand two strips of black stone with white veining that frame marble slabs bearing inscriptions sculptured and painted in many colors, but badly damaged. An overhanging cornice tops the structure, on which there must have been a canopy with a kiosk-type cover. Only a few fragments of this cover remained, scattered around other areas of the hall.

The usual coat of green paint covered part of the stone surfaces of the cenotaph. The stones at the four corners of the cornice had been lost, as had the entire west side of the cornice. Numerous clumsy adhesions due to cursory maintenance works remained.

Figs. 85, 86, 87 and 88. Different views of the cenotaph of al-Zāfir prior to restoration.

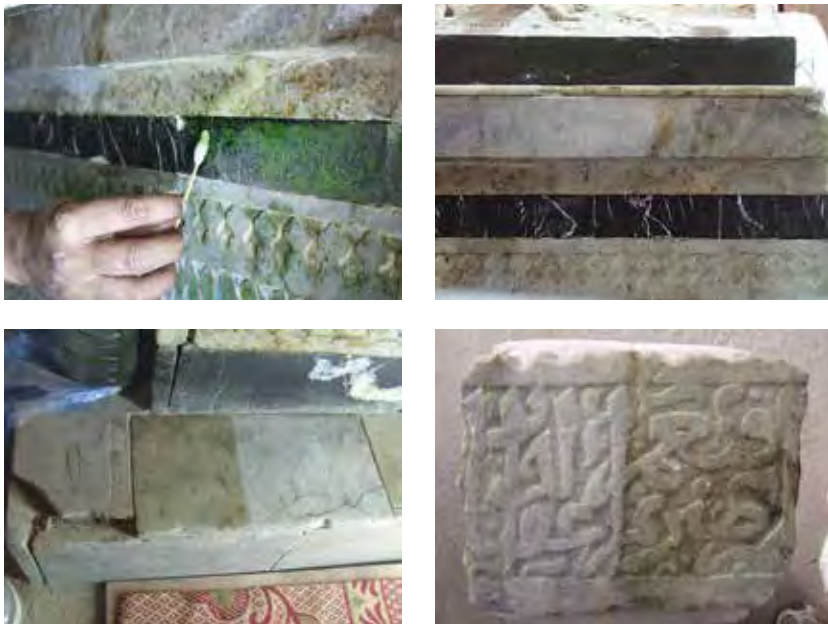
Figs. 89, 90, 91, and 92. Views of various stages of the cleaning process, including removal of old stucco patches, old disfiguring patina and the thick coating of green paint.

As was done for the other cenotaphs, we first put the general structure in order, removing all the clumsy stuccoing done to reassemble the marble slabs during previous maintenance works. After that, we carried out a delicate operation of surface cleaning using the solvents, materials and methods tested previously. The overhanging cornice on the top and the base were both covered with a waxy substance that, in time, had been darkened by the dust trapped in it. An additional cleaning step brought the marble back to its original luminous sheen. Using the same method, we cleaned the fragments of the cover. Sadly, only traces remained of the gilt preparation and black borders around the carved letters.

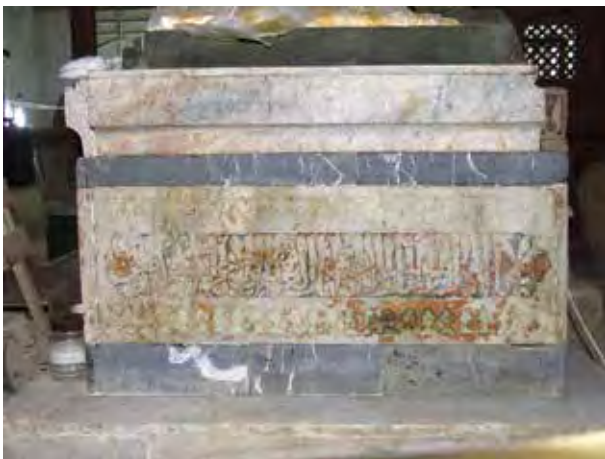
Fig. 93. The cenotaph after cleaning.

After cleaning, despite the traces of gilt preparation and of the blue background of the letters that remained, the polychrome decoration was largely lost.

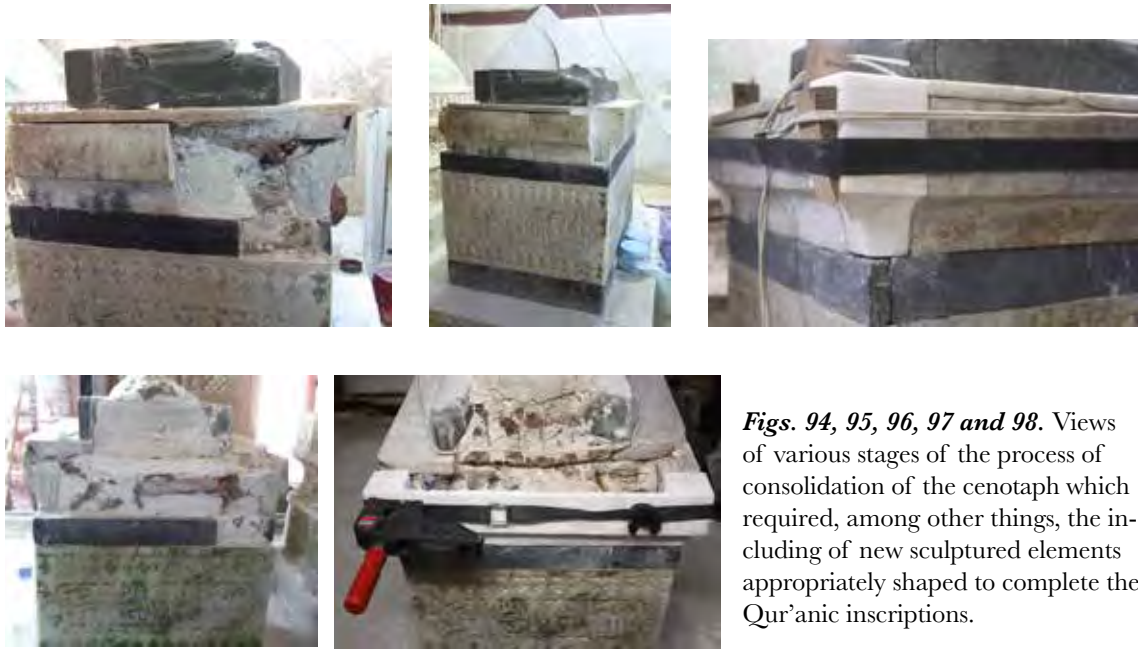
Figs. 94, 95, 96, 97 and 98. Views of various stages of the process of consolidation of the cenotaph which required, among other things, the including of new sculptured elements appropriately shaped to complete the Qur'anic inscriptions.

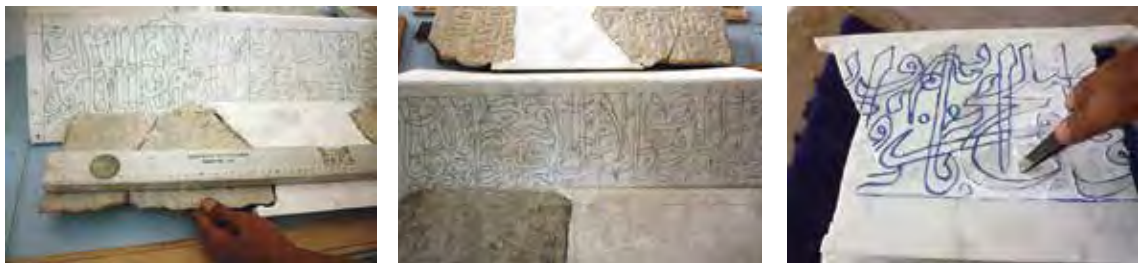
Figs. from 99 to 106. The sequence of pictures briefly describes the process of reconstruction of the upper section of the cenotaph, with the inclusion of the new elements sculptured to fill the large gaps in the Qur'anic inscription.

Reconstruction of the cover of the monument was a complex, painstaking job. A full-scale model in styrofoam was made by the master plasterer, 'Abd al-Rashīd, and was helpful in assembling the fragments recovered and for insertion of the new stones. After having perfectly drawn the missing parts, the stones were cut. Later, using micro-scalpels, the Qur'anic inscriptions were etched onto them. In this way we reconstructed the north and south sides of the cover.

To do this, it was necessary to remove the plaster bedding structure that had been applied in previous maintenance operations. A new bed in lime and sand was prepared in which to lay the new stones. Replacement of the surviving stones in the upper part of the cover, harmonizing them with the new stones, was not a simple task: the edges were often chipped and the bedding was not all on the same level.

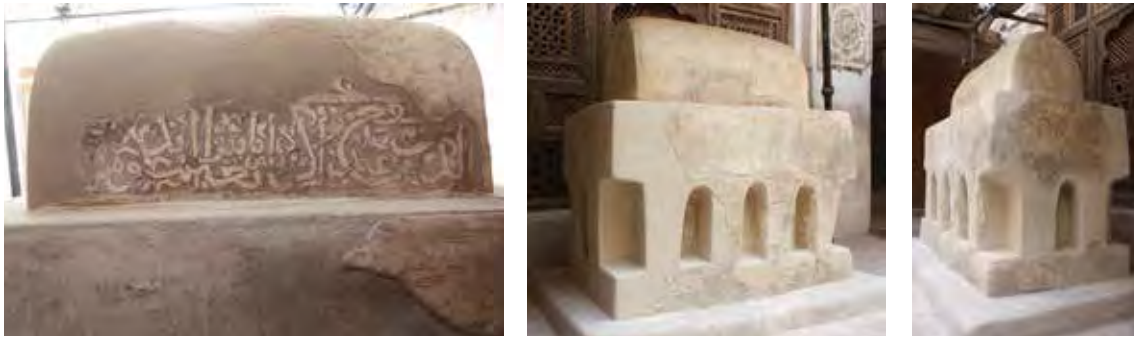
Figs. 112, 113 and 114. Views of the cenotaphs after restoration.

After removing the layer of surface dirt, several coats of whitewash had to be removed by mechanical action using a scalpel. This made it possible to uncover clear portions of the original *qadād*, with respect to that applied during subsequent maintenance works. The borders were carefully cleaned to facilitate reading, and guards were installed to protect the corners, using injections of fluid hydraulic mortar. Considering the historic character of the works undergone by the Mosque and Madrasah, it was decided to remove only those replacements that covered the original inscriptions, conserving those below which there was no original painted layer.

The cement-based mortars were entirely eliminated, however. With this operation we were able to recover small portions of the original decoration, with inscriptions in relief in white, bordered by a thin red painted outline. The inscriptions were cleaned

with a solution of ammonium carbonate and consolidated. The base was restored with a structure in bricks covered with the *qaḍāḍ* technique. The missing parts in brick were reconstructed and, where necessary, a load-bearing structure was created using a grid of fiberglass pins crossed and fastened together with steel wire. After completing this stage, a layer of lime and coarse sand was applied to prepare the rough plaster topped with the final fine plaster finish. After performing various tests, we developed a fine plaster type maintained slightly below the surface level, reminiscent of the different shades of the plaster present. This gave the monument an overall harmony that it had completely lost.

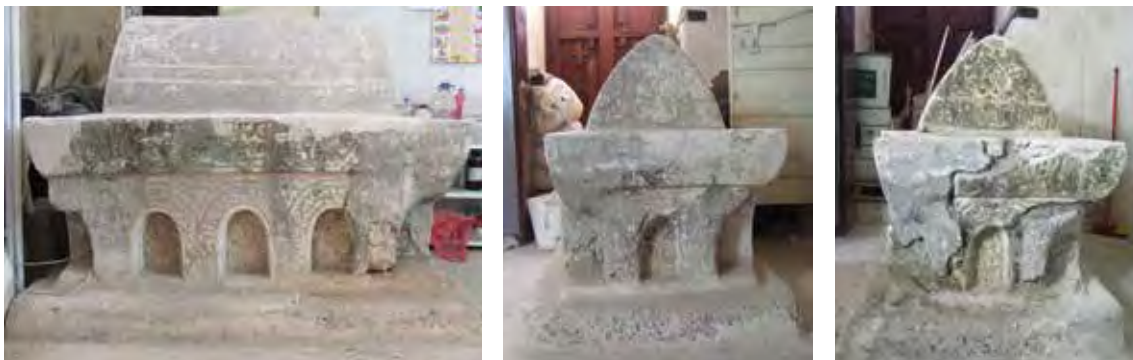
Beautifully decorated, sculptured and painted, this monument stood in the southeast corner of the room to the east of the inner court of al-Ashrafiyyah Mosque and Madrasah. On a base of lime and sand stands an architectural decoration with plays of arches and niches, embellished with painted inscriptions very similar to those in the courtyard. In the upper part, slightly projecting, we find a Qur'anic inscription. Closing the monument is a cover decorated with a bas relief in *qaḍāḍ* richly painted.

Figs. 115, 116 and 117. Views of the cenotaph prior to restoration.

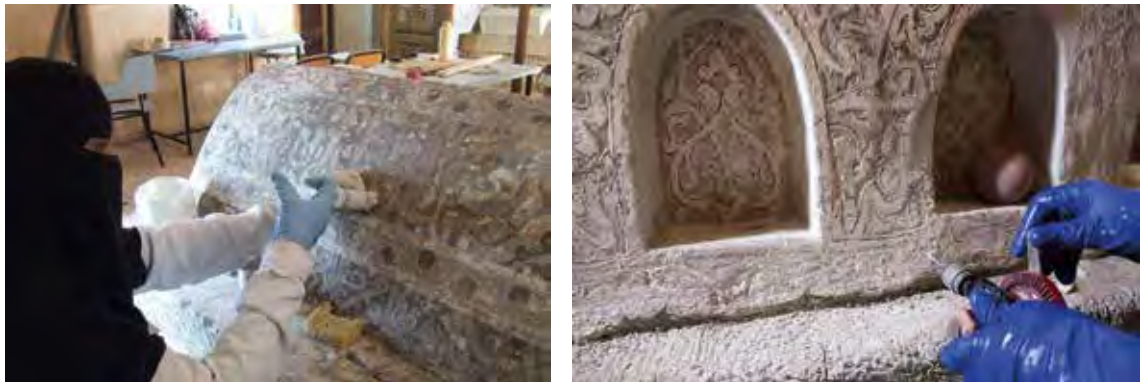
Figs. 118 and 119. Views of various stages of the process of consolidation of the cenotaph.

We proceeded initially to remove the dust with a soft brush and the use of the Wishab sponge. After fixing the border of the original *qadāḍ* with a mortar of lime and fine sand, we removed all the concrete patches and crude stucco applications. Where necessary, injections of a fluid mortar served to consolidate areas where the plaster had become detached.

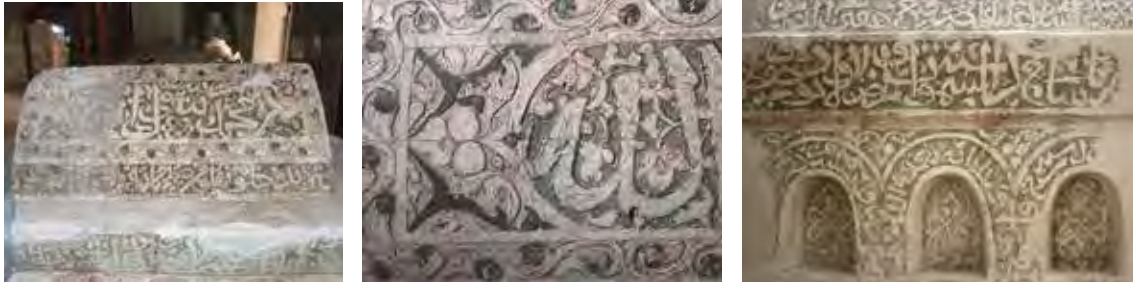
Figs. 122, 123 and 124. Views of various details of the cenotaph during cleaning of the decorated surfaces.

Once the monument had been restored in its basic structure, it was possible to proceed with more thorough cleaning. The greasy substance applied to protect the monument had trapped the dust, forming a thin crust that covered the entire cover and other parts of the decorative design. After various preliminary tests, we opted for cleaning with a cotton pad soaked in a solution of disodium and tetra sodium EDTA in a percentage necessary to obtain a neutral pH, then rinsing with demineralized water. The colors were found to be fairly resistant, with the exception of the red, which been damaged by binder powder.

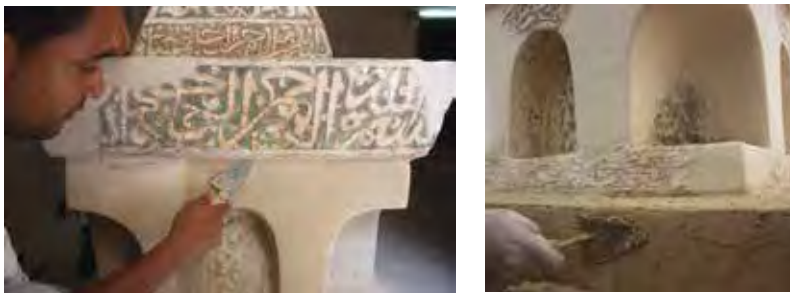
Figs. 125 and 126. Views of different stages of stucco repairs.

On completing the conservative stage, preliminary tests were carried out for the final plastering of the gaps. A fine plaster with developed with a slightly warm shading that resembled the lighter portions of the decorative design. The plastering was done slightly below the surface level.

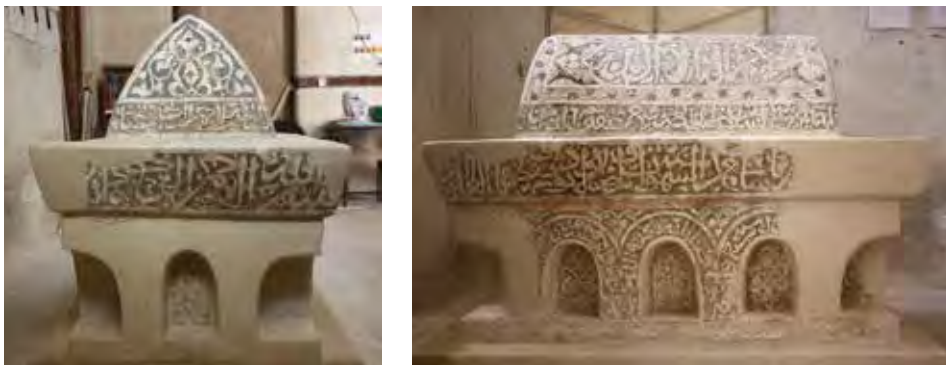
Figs. 127 and 128. Views of the cenotaph after restoration.

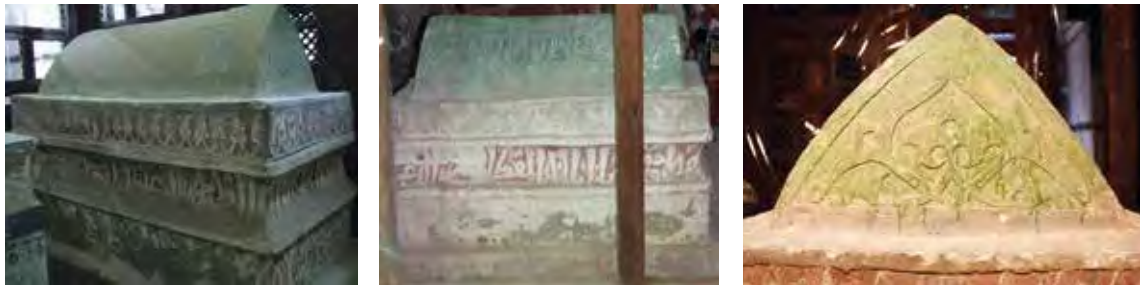
Within the wooden enclosure in the room containing the other cenotaphs, this small cenotaph in *qadād* consisted of a base with a crude plastering of lime on which there were three different levels of decoration with designs in white relief on a red background, framed by horizontal borders showing traces of ochre yellow. Crowning the monument was a cover with a decoration in bas relief that had been covered by the usual green paint. The inscription bore the date 847 h. (1443-1444 CE) of the death of the son of Sultan al-Mufaḍḍal Muḥammad.

Figs. 129, 130 and 131. Views of the cenotaph prior to restoration.

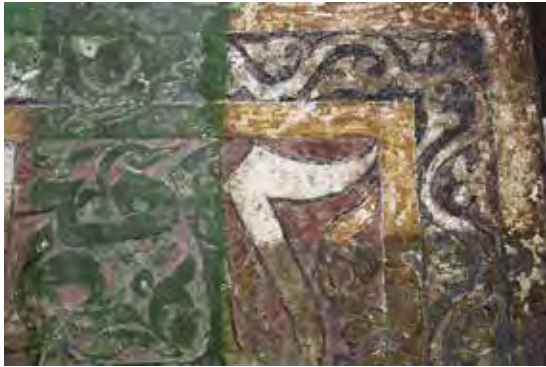
Fig. 132. View of a cleaning sample on the decoration and Qur'anic inscription.

Restoration activities concentrated mainly on cleaning, particularly the removal of the green paint from the cover. After testing various methods, we decided to use a solvent gel that was applied and let stand for a few minutes. This eliminated the green paint from the most stubborn parts without damaging the layer of original decorations. After this first cleaning step the paint was gone, but a blackish oily substance remained on the surface of most of the cenotaph. A second cleaning step was necessary and for this we tested ion exchange resins. As a result, it was possible to remove the oily substance, leaving the decorations visible in their original colors, although badly damaged.

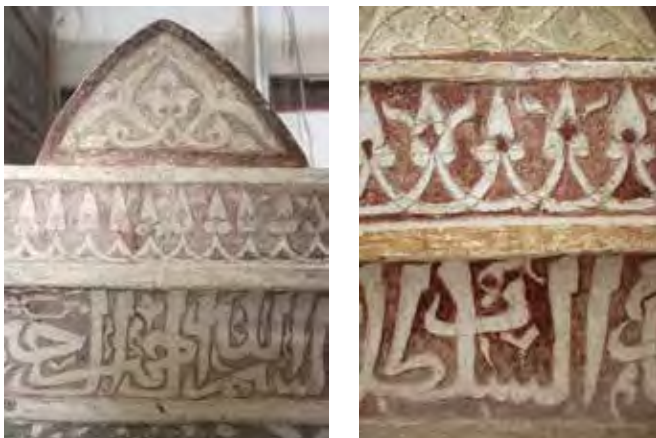
The figures 133-134 clearly show the levels of cleaning on the long sides of the cover: on the left, the state of fact with the green paint coating the cover, at the bottom right the first level of cleaning, revealing the blackened coating produced by the oily substance, while at the top right we can see the second level of cleaning with the remains of the original polychrome design consisting of yellow borders around a central inscription on the red background and around it a floral decoration on a blue background.

Figs. 133 and 134. Views of details of the cenotaph after cleaning.

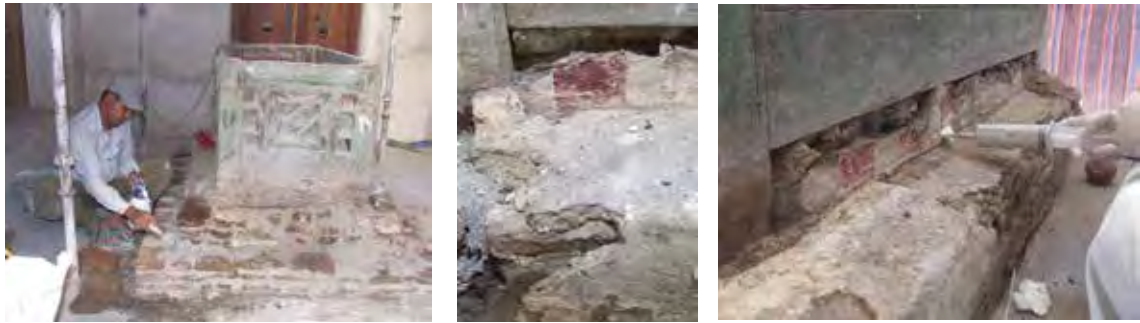
Figs. 135, 136 and 137. Views of various stages of consolidation and cleaning of the base of the cenotaph.

Restoration works on this monument were done in collaboration with the carpentry division. The operators of the “stone sections” worked on restoration of the base. Initially, stratigraphic assays were done to ascertain the presence, under the thick application of concrete, of a wall finished in *qadād*. It was possible to recover large portions of plaster from different periods, the product of many maintenance operations. The base consisted

of two levels, but only the internal core in bricks of the first level remained, and they were out of place and missing in parts. On the second level, we found traces of a decoration of red and white squares painted on a thin coat of plaster. Before proceeding with removal of the restoration *qadād* that covered the oldest part of the decoration, we consolidated the visible parts with injections of a fluid lime-based hydraulic mortar, after carefully removing any loose material on the inside, where possible. The powdery red color was pre-consolidated with Paraloid in acetone at 5% in order to proceed to the subsequent stages.

After fixing all the precarious parts, we proceeded to remove the restoration *qadād*, other faint traces of red color and thin coats of plaster we uncovered on the lower step, as well as faint etching that marked the square.

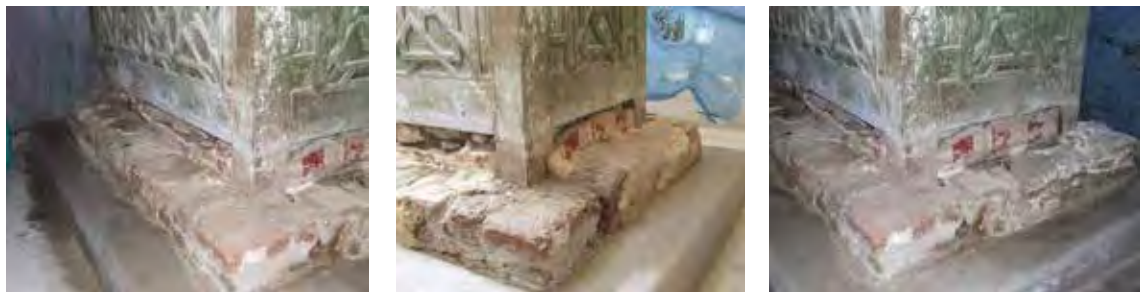
Figs. 138, 139 and 140. Views of the base of the cenotaph after removal of the plasterworks.

the second step, on all four sides, the same level of ancient *qaḍāḍ*, in preparation for the finish in the plaster remaining. After completing the restoration works, we proceeded to fill the gaps in the pedestal to slightly below the original level, before applying a rough coat of lime and sand as bedding for the final plastering applied to match the fragments of red and white decorated band with the structure in wood.

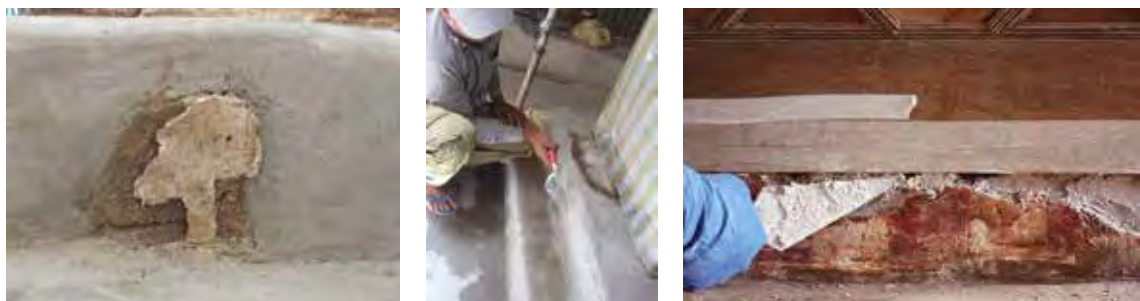
Figs. 141, 142 and 143. Views of the base of the cenotaph after removal of the plasterworks.

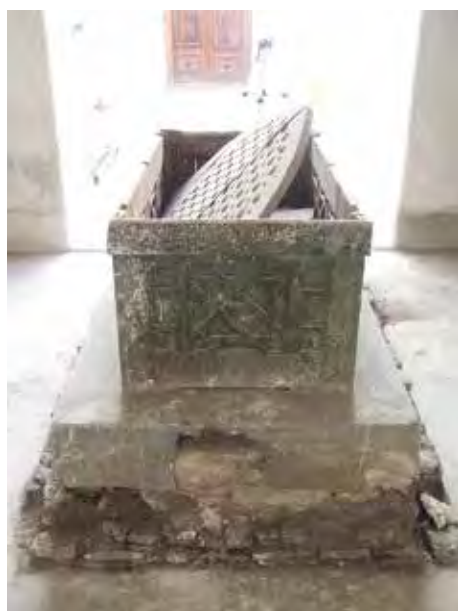
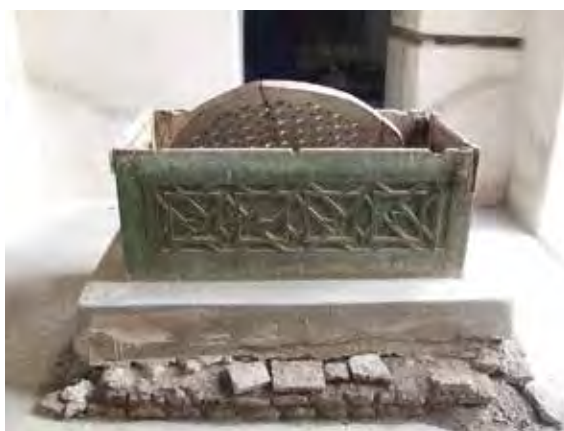
Figs. 144 and 145. The cenotaph before restoration.

The carpentry division handled the cleaning, consolidation and restoration of the missing wooden portions of the cenotaph.

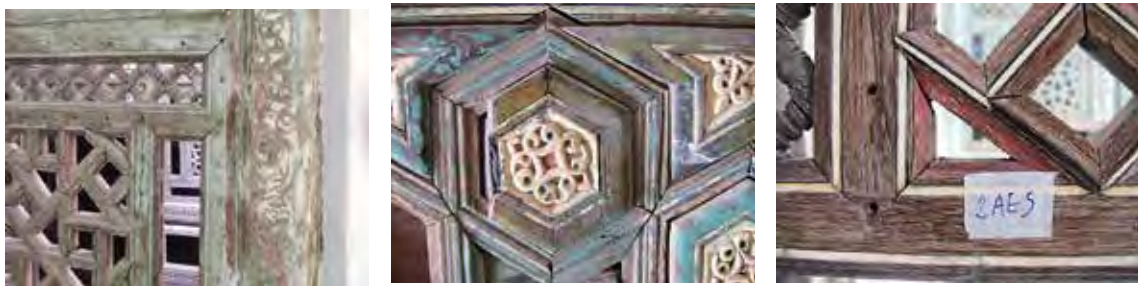
Figs. 5, 6 and 7. A few test sections cleaned to determine the state of any original painted strata.

The tests concerning the green paint applied during previous maintenance, which almost entirely covered the wooden parts, and the residues of the original colors, reveals a green-based pigmentation of phthalocyanine, in use between the Sixties and Seventies of the 20th century. However, from the stratigraphic cross sections and chemical analyses, it became clear that before this painting in the last century, the artefacts had already undergone a preceding painting with Chrome Green. The experts were able to determine that this earlier painting went back to a time that was impossible to specify more definitely than between the mid-19th and the mid-20th century.

Sadly, the coats of green paint had penetrated one another and contaminated the older painting as well, as far back as the original decorations, that were undoubtedly poorly conserved even before this clumsy and deleterious additional damage was done.

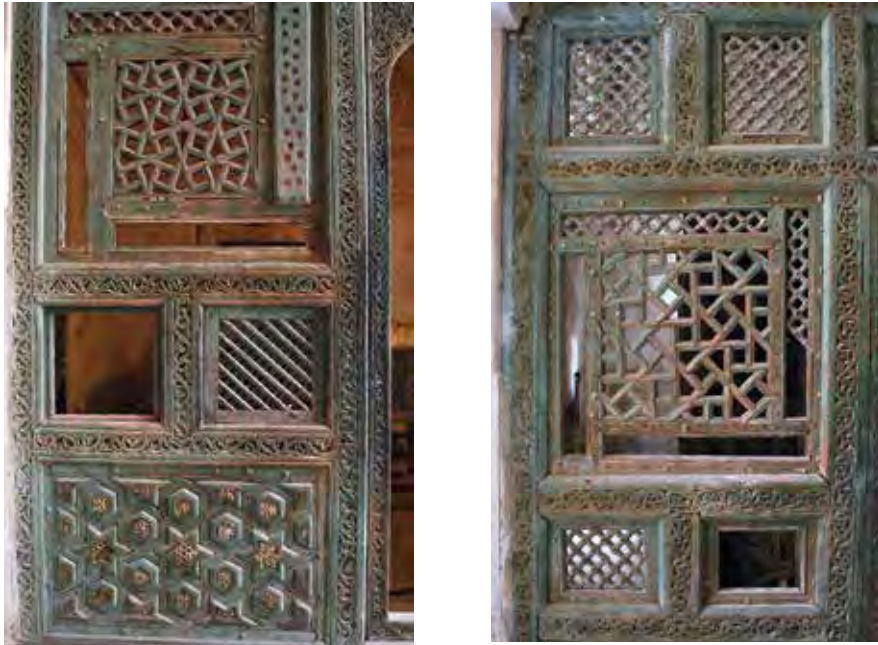
More in general, at the outset of the works, the *mashrabiyyahs* were in a very poor state of conservation. Many elements were missing, the lintels over the doors and other structural parts were, to a large extent, badly eroded internally by termites. For some of these, the situation appeared one of imminent collapse, as the wood was no longer able to support the polylobate arches over the *qamariyyahs*. Many decorative plastic elements of the wooden screens had been detached, others actually removed, probably on purpose. Some of the turned spools of the window gratings were missing. Much of the precious ivory plating in the panels of the lower sections was lost or broken. Many replacements could be observed, and poorly made repairs of wooden elements, some more recent, some remote and not datable. Of the four entrance doors to the main cenotaphs, only two panels remained and they were entirely lacking the lacy geometrical decorative perforations of the windows.

The exterior façade of the *mashrabiyyahs*, relative to the cenotaph dedicated to the son of al-Malik al-Ashraf Ismā'īl, shows a particular surface erosion of the wood species, due to the fact that it faced south. This orientation subjected it to continuous deterioration due to the seepage of rainwater, compared to the other façades with better, steeper roofing.

Figs. 8 and 9. Examples showing the state of conservation of various panels of the *mashrabiyyahs*.

internally by numerous tunnels, we proceeded, after ensuring that the insects had been exterminated and applying adequate termite-prevention treatment, to inject an epoxy resin-based compound, such as Araldite. Surface fissures and holes were plugged with appropriately pigmented epoxy resin.

The damaged load-bearing beam was treated separately. Local consolidation was then done, using syringe and brush, with acrylic resin (Paraloid B72 at 2.5 % in acetone). After re-establishing the cohesion of the wood fibers, the cracks and tunnels were filled with a paste applied using a putty-knife. Long strips of wood were used to reinforce the structure in place of the missing parts. Finally, the reassembled screen was returned to its proper place.

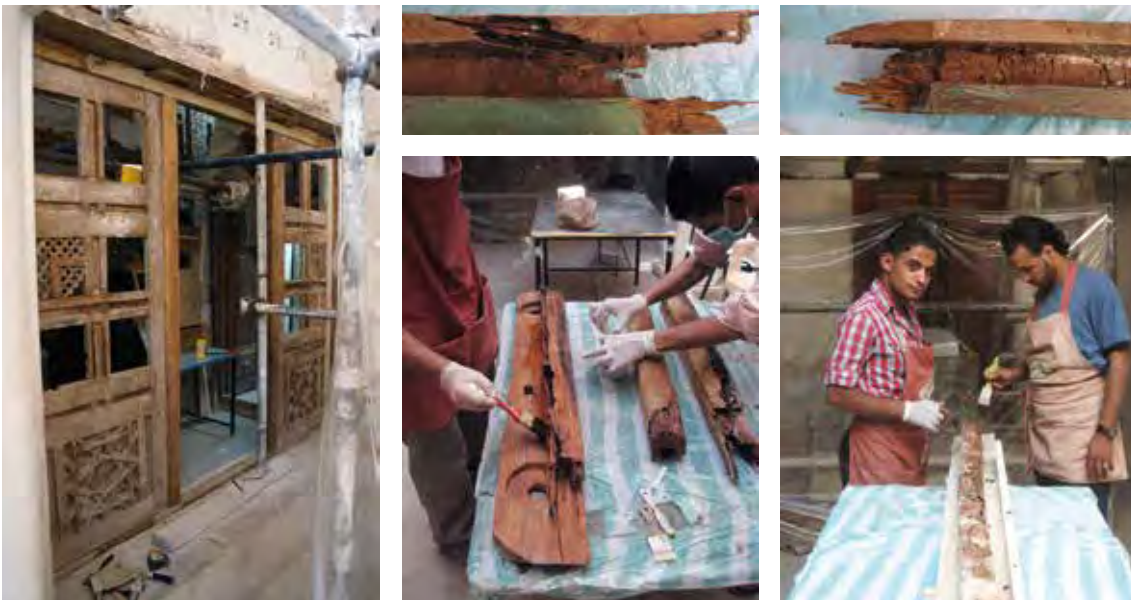
Figs. 20 to 24. Situation and operating steps for consolidation of a load-bearing beam.

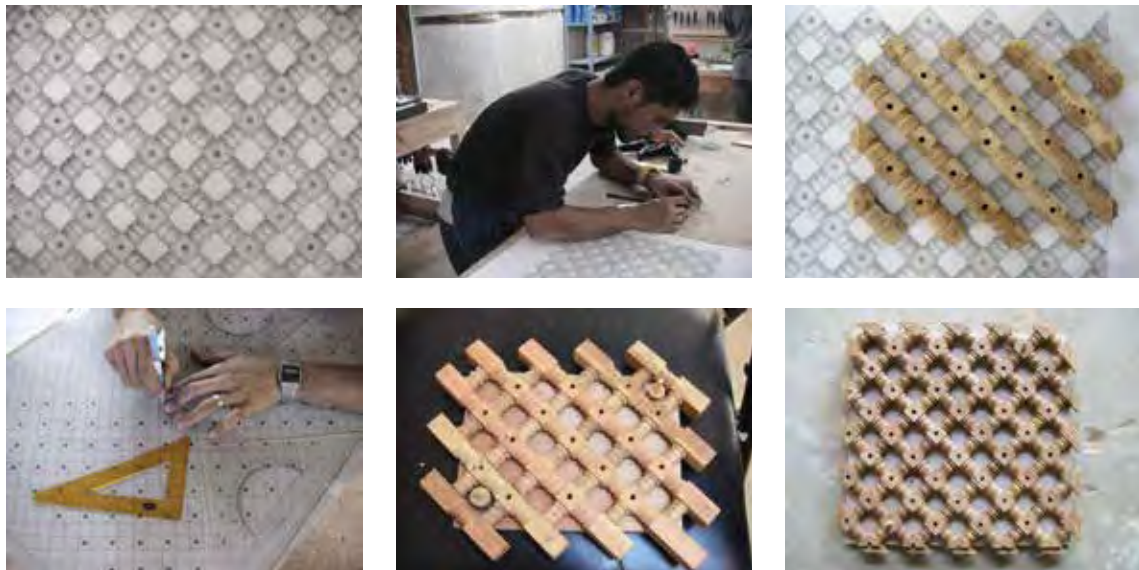
Figs. 25 to 30. Stages of study and construction of two prototypes for two windows of different sizes.

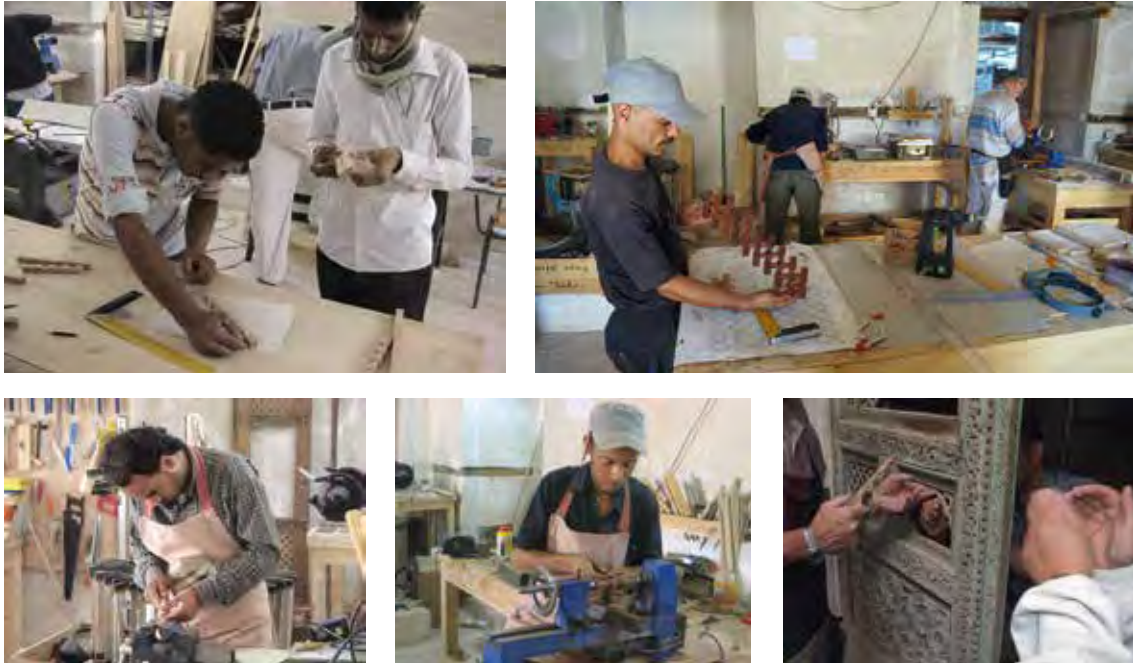
Figs. 31 to 35. Operating stages in the construction of spool windows.

A first stage consisted of having the carpentry workshop produce a series of spools on the lathe. A second stage required cutting fitted cubes and small perforated spools. Bit by bit as the pieces were produced, they were assembled on the bench and checked on the basis of the design configuration. A later stage was carried out on the *mashrabiyyahs* to determine how to handle the final reassembly, piece by piece, inserting wooden pegs along the way to restore the windows.

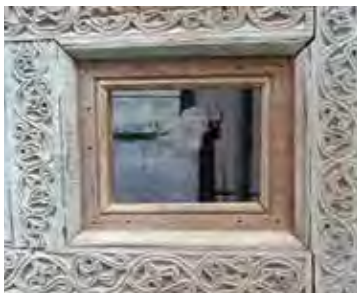
Fig. 36. Prototype of window prior to restoration.

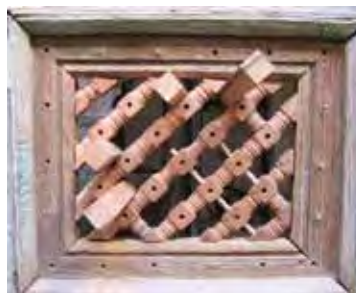
Fig. 37. Intermediate state of assembly of the reconstructed parts.

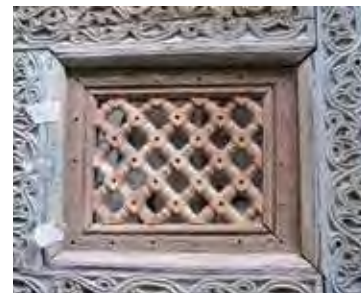
Fig. 38. Prototype of completed window.

The positive outcomes of the constructive method and installation of the first prototype of window grating made it possible to open a specific operating sector for the restoration of all the other missing windows.

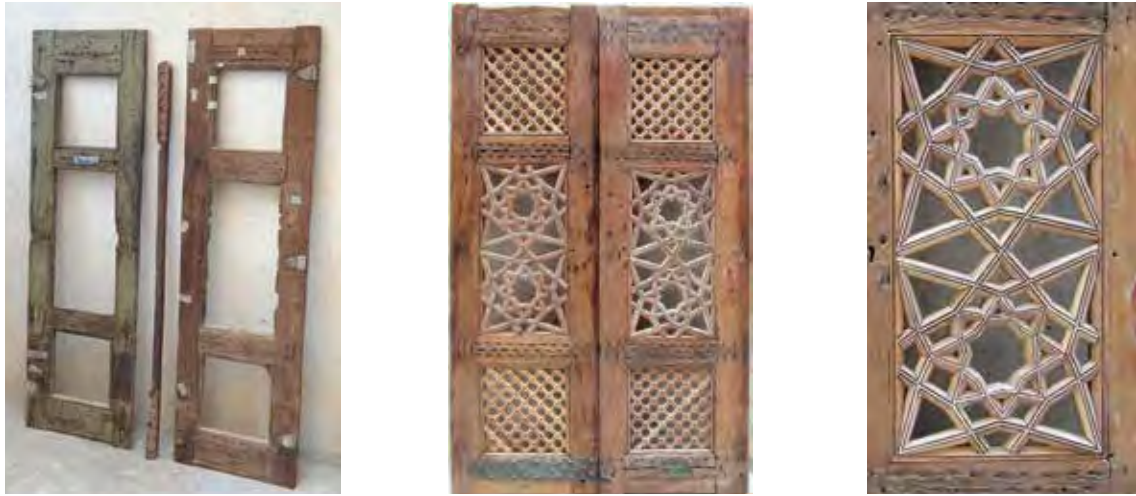
Figs. 39, 40 and 41. Views for the proposed reconstruction of the decorative designs of a door.

missing central windows was necessary, in order to ensure their faithful reconstruction. This work required special resource to find the exact original geometry, since we only disposed of an incomplete design. Restoration of the first two panels of the original doors of the *mashrabiyyah* on the south side of the cenotaph hall erected for al-Malik al-Nāṣir Aḥmad, provided the foundations for reconstruction of the missing doors.

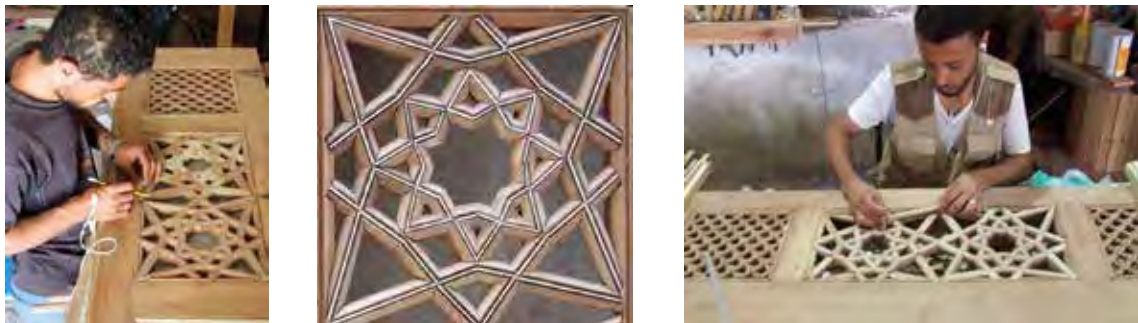
Figs. 42, 43 and 44. Stages in the work of reconstruction of the ornate geometric design of the doors.

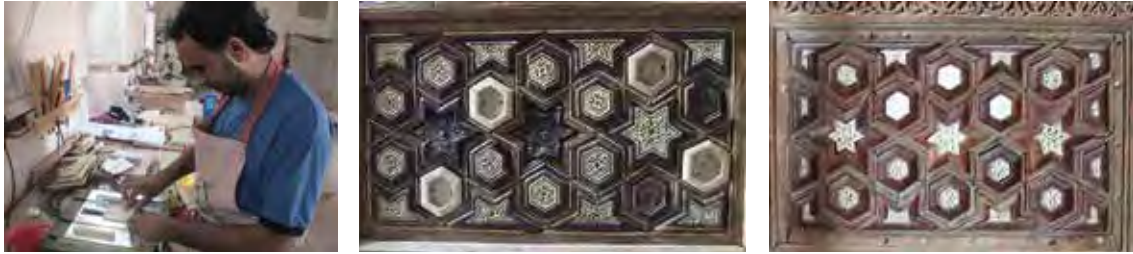
Figs. 45, 46 and 47. Stages in the work of reconstruction of the hexagonal and star-shaped inserts.

was decided. A set of rectangular dies was created, measuring 20 x 15 cm, with a margin around the perimeter 3 mm thick, in which to spread a resin mixture to obtain a compact, flat slab. The mixture used was a bi-component epoxy resin (SV640) specific for wood. A mixture of ochre yellow, red and black was added to the resin, in adequate proportions to arrive at a tint similar to that of ivory. The sheets thus obtained were then cut into the shapes agreed for insertion into the gaps on the panels.

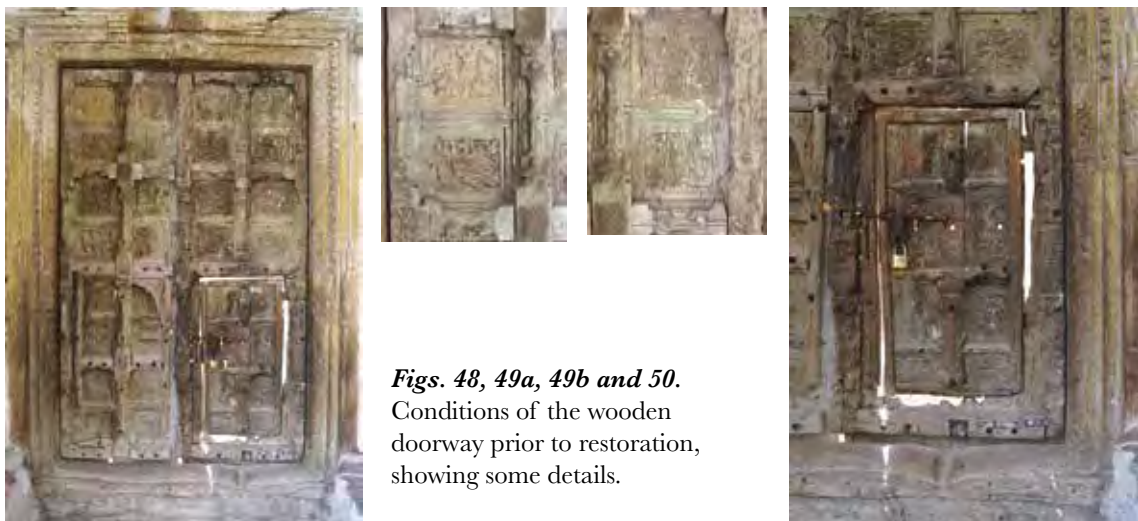
Figs. 48, 49a, 49b and 50.

Conditions of the wooden doorway prior to restoration, showing some details.

In the front-facing aspect of the doorway, the vertical and horizontal boards framing the coffers were originally molded with geometrical carvings. In time these eroded and wore down, so that the plasticity of the skillfully sculpted designs was no longer legible. The panels themselves, with refined indentations and vegetable designs, show the same erosive phenomena. More in general, the entire doorway and undergone various cursory applications of oily paint in the past. A base coat of yellow paint is still identifiable, in contact with the wood, and another over it in green. These paints are badly worn, for the most part, on the lower sections of the doors.

Even the sculptured wooden jambs surrounding the doorway had been covered over, first by a whitewash of lime and later by a greenish paint, then again by whitewash, which has worn off in places.

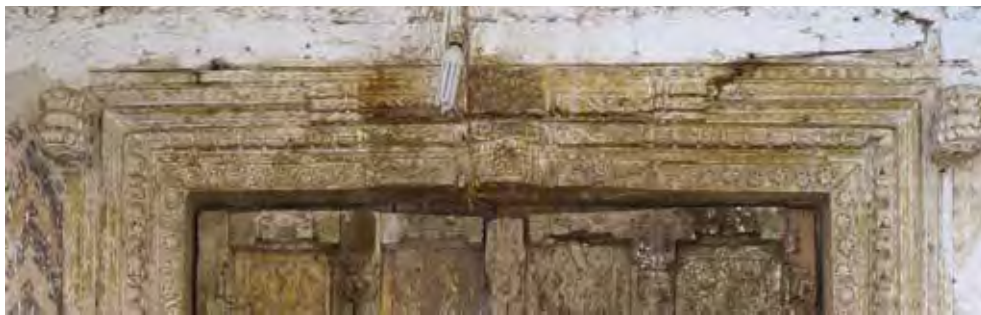
Fig. 51. Conditions of the carved lintel prior to restoration.

Despite these repeated coats of paint, the three-dimensional carving is still recognizable, with the shapes of tiny buildings, miniature replicas of the perimetral battlements of al-Ashrafiyyah Mosque and Madrasah. However, the lower section is eroded or worn down almost entirely and has lost its clarity and plastic value.

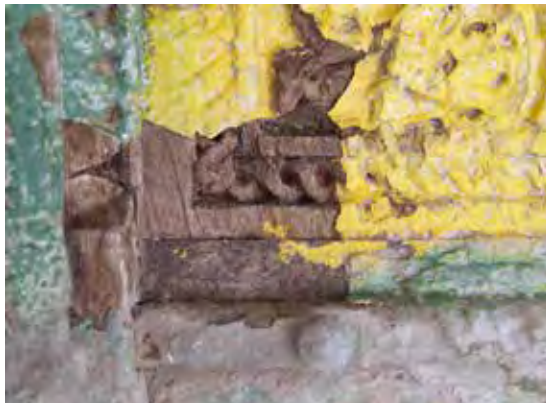
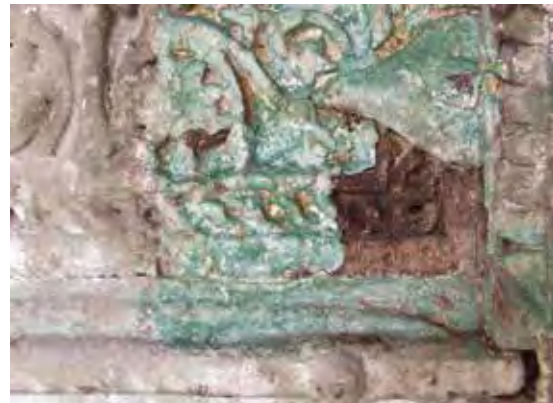
Figs. 52 and 53. First tests of cleaning methods.

The outcomes of the tests confirmed that only the carved panels with refined indentations and vegetable designs of the door had been painted originally. Several surviving traces were found in the apertures and indentations of the moldings. The painting done at the time was designed on a gypsum base, a material very sensitive to moisture. Probably, when the surface of the door was painted over in the past, the decorations were already probably almost entirely lost.

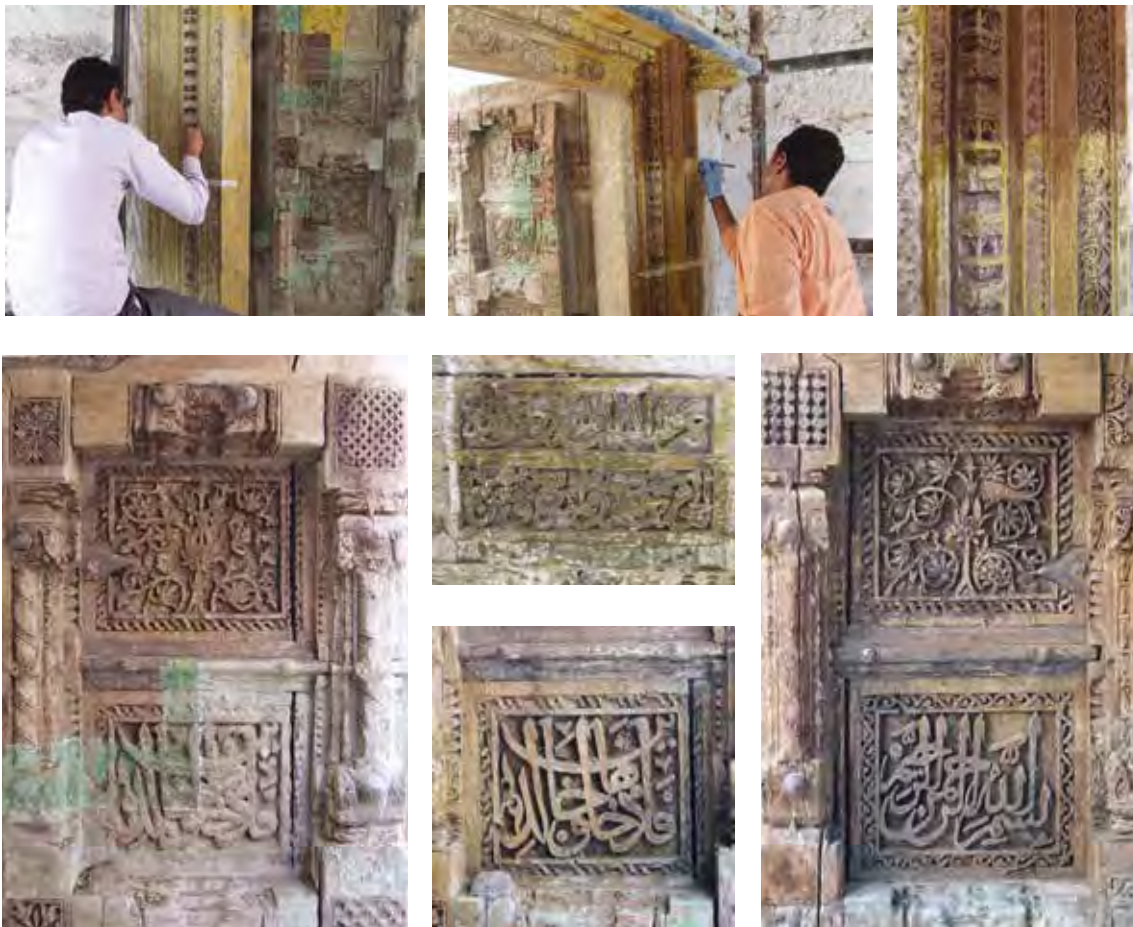
Figs. 54 to 60. Stages in the work of cleaning the doorway.

The method, on each separate block, required three different passages, each technically different from the previous, on small areas at a time. A first passage was dry, done mechanically with scalpels, to remove the film of the thick coat of oil-based paint, yellow in some places, green in others. A second passage with the same method used to clean the *mashrabiyyahs*, i.e. the mixture of solvents with interposition of Japanese paper and removal by padding to remove the second coat of green paint. A third passage, with scalpels and tufts of cotton, served for a final finish.

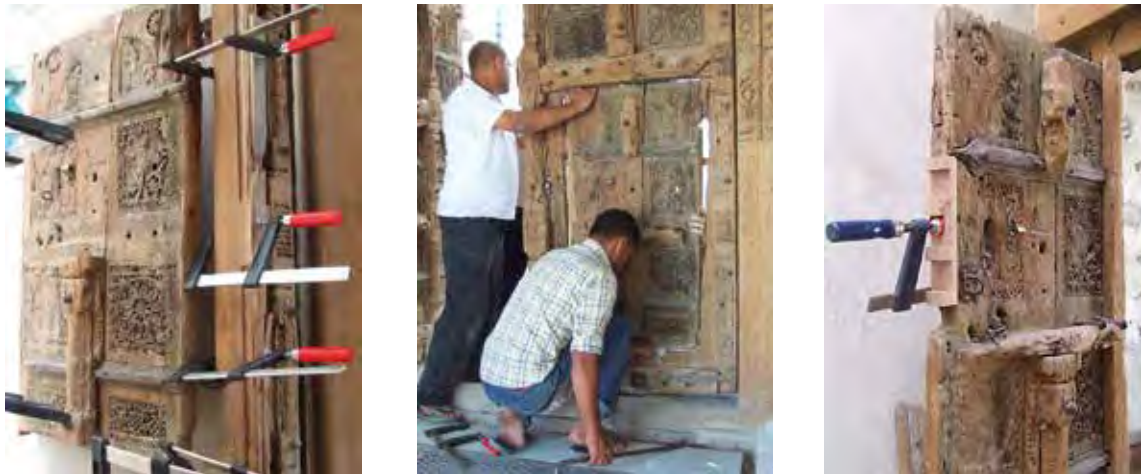
Figs. 61, 62 and 63. Stages in repairing the static conditions of the small service door in the right door panel.

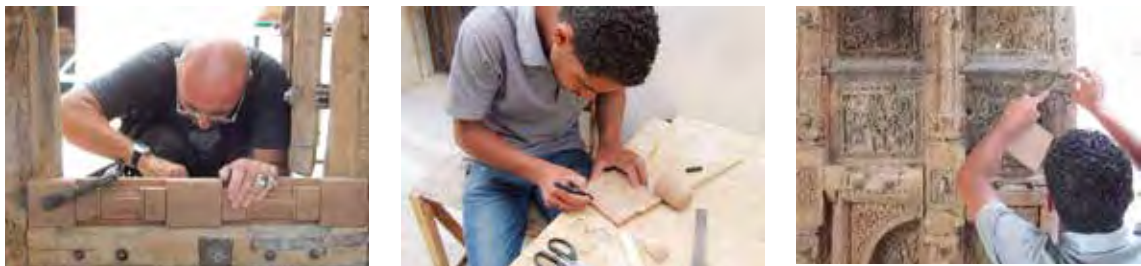
Figs. 64 to 69. Stages in reconstruction of the crosspieces and insertion of pegs.

A few vertical and horizontal beams, originally molded with geometrical carvings and having the function of framing the coffer panels were missing. With the Works Directorate it was decided to reconstruct only those missing in the lower portions, for the dual function of reinforcing the original parts and restoring the plastic-formal values. In respect of the principle of recognizability, the added parts had been simply modeled in their external shape, but not in the carvings.

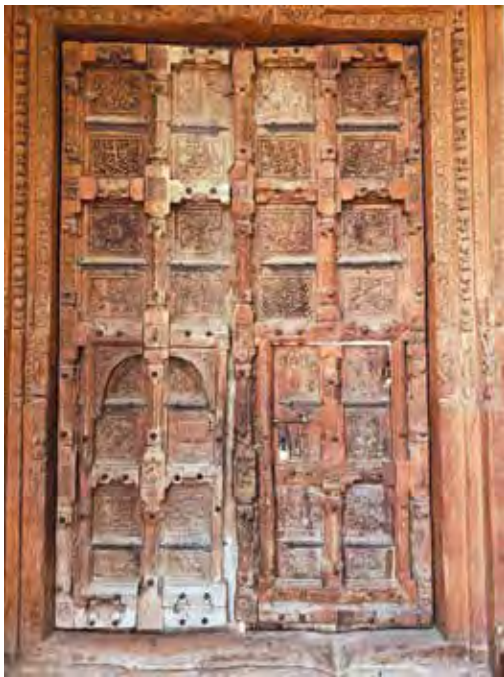
Fig. 70. The doorway after restoration.

On conclusion of the works, a specific protective treatment for wood was applied on the entire doorway.

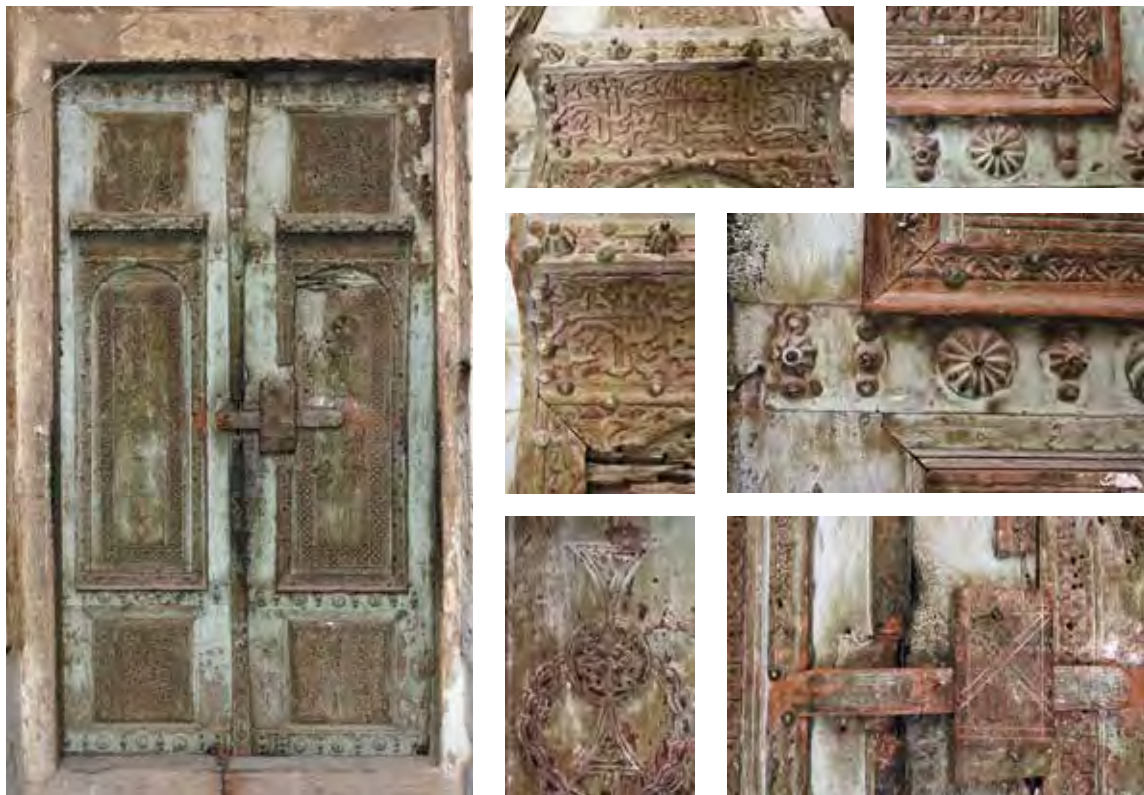
Figs. 71 to 77. State of conservation of the doorway, showing some details.

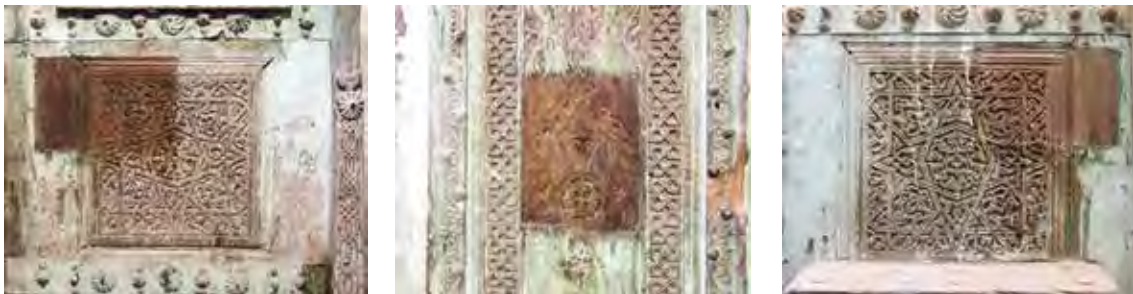
Figs. 78, 79 and 80. Cleaning tests.

The assays did not reveal any colors that could be considered original. The type of artefact led us to believe that the only decoration contemplated were the carvings.

To remove the green paint the method used consisting of applying a gentle water-based paint remover that would not damage the surface of the wood. This was left for a few minutes to soften the green paint, so that it could then be removed mechanically with small putty knives. Removal of any residue was accomplished using cotton pads soaked in 3A solvent solution (water, acetone and ethanol) and scalpels.
