AL-ASHRAFIYYAH MOSQUE AND MADRASAH IN TA'IZZ

Conservation intervention (2008-2015)

The subject of this volume is the work of restoration of the paintings, stuccoworks and woodwork, and the structural consolidation of the al-Ashrafiyyah Mosque and Madrasah in Ta'izz (Yemen, 13th-14th century), carried out by the Istituto Veneto per i Beni Culturali (IVBC, 2008–2015) thanks to the support of the Social Fund for Development (SFD – Culture Heritage Unit). It follows the previous volume *The Great Mosque of Ṣan'ā'. Conservation intervention (2005–2015)*, published in June 2022.

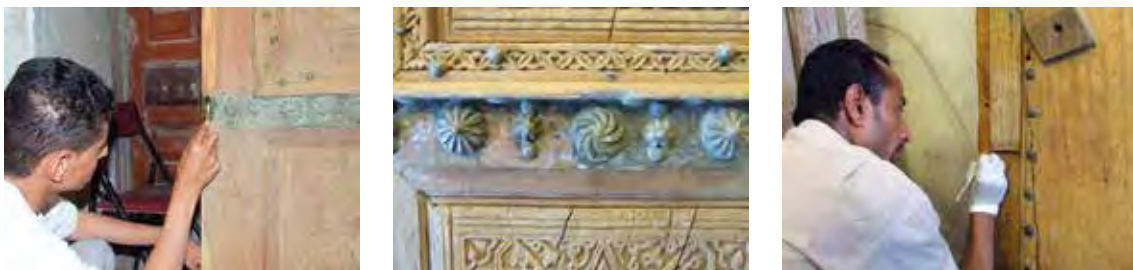
Figs. 81, 82 and 83. Steps in the cleaning of decorative elements in brass.

natural patina acquired over the centuries with the oxidation of the metal. For this reason, the method chosen called for the use of a solution of surfactants after interposing sheets of Japanese paper, then rubbing the surface with semi-dry cotton pads.

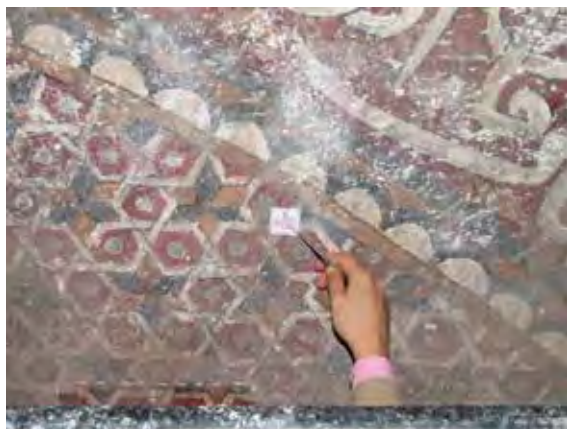
Fig. 1. Sampling point of the fragment of plaster T1 taken from lateral dome 1d - south side, under the concrete band - al-Ashrafiyyah.

For the lateral domes, the painted decorations were produced using a support of plaster mixed with an aggregate with a basis of volcanic rock fragments (90%) and carbonate granules (10%) (Figs. 1-2). In the stratigraphy of the plaster it is not possible to distinguish a sequence of layers (such as *rinzaſſo*, *arriccio*, etc.), probably because of the particular technique used to produce the plaster, known as *qadāḍ*, which calls for application of plaster “fresh on fresh” combined with constant pounding of the surface to ensure penetration of each succeeding layer in the others. The samples tested were found to be extremely strong and compact and were thus in an excellent state of conservation.

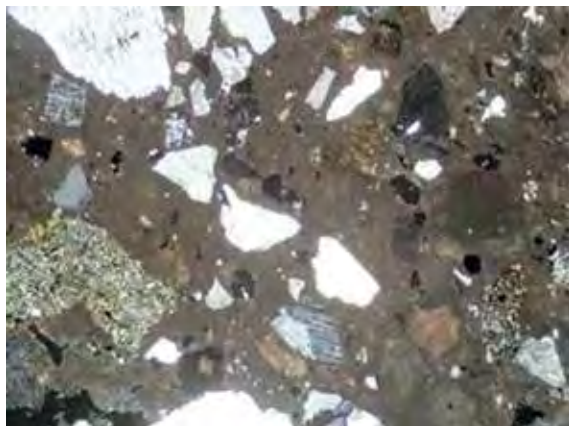
Fig. 2. Microphotograph under polarized transmitted light of sample T1, N+, 20X, mounted in a thin section.

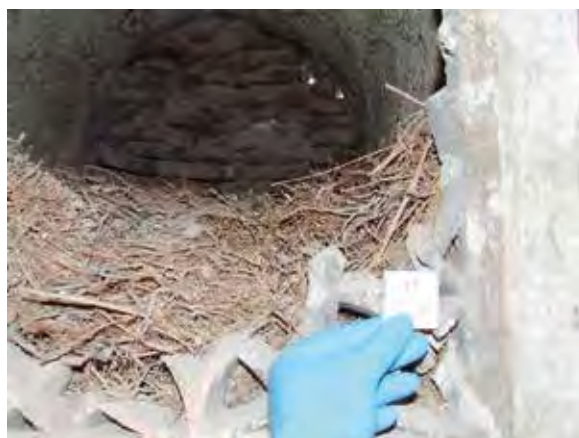
Fig. 3. Sampling point of the fragment of stuccowork T17 taken from lateral dome 1f - north side, from the window grid - al-Ashrafiyyah.

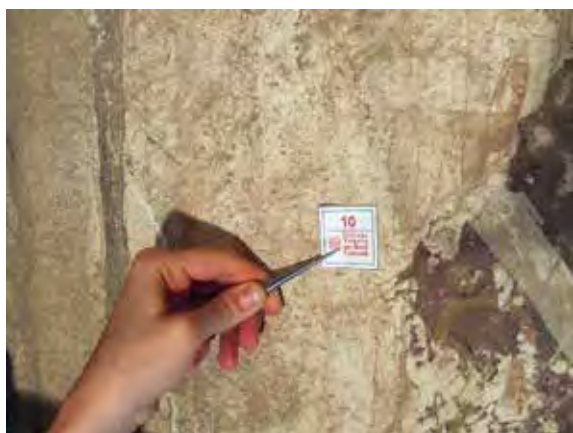
Fig. 5. Sampling point of fragment of surface whitewash T10 taken from lateral dome 1d - east side - al-Ashrafiyyah.

Part of the surfaces of the mosque were coated in whitewash and the petrographic analyses carried out on this type of sample revealed that this consisted of the application of several layers of lime, weakly pigmented with ochre which gave it a yellow-brownish colour (Figs. 5-6). No inert materials were found in the layers.

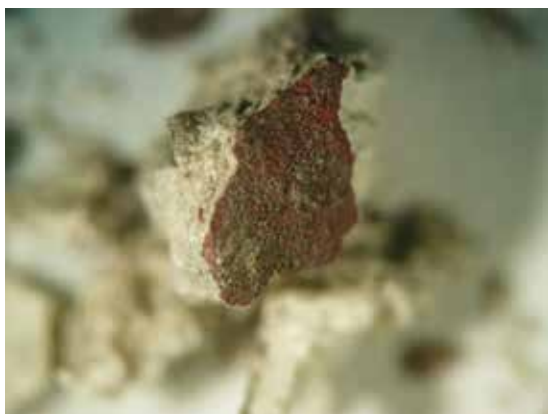
Fig. 7. Stereomicroscope image of the front of paint sample T4 where the red colour of the paint and the presence of surface deposits are observed.

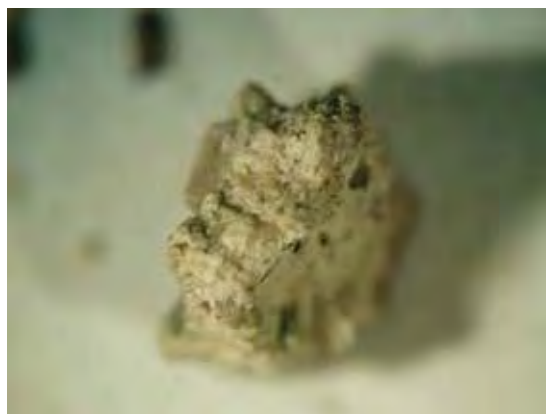
Fig. 8. Stereomicroscope image of the back of mural paint sample T4 where the plaster support made from lime is observed.

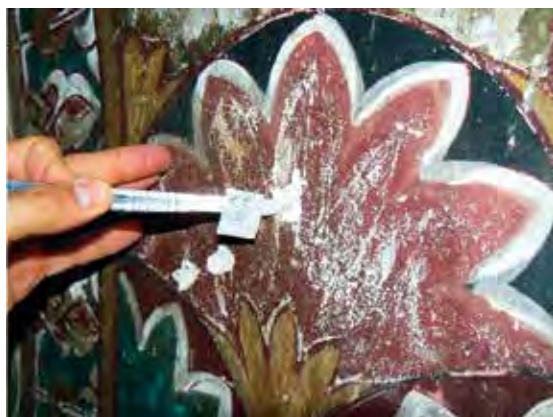
Fig. 14. Sampling point of the microfragment of mural painting CC3 with red paint taken from the central dome - al-Ashrafiya.

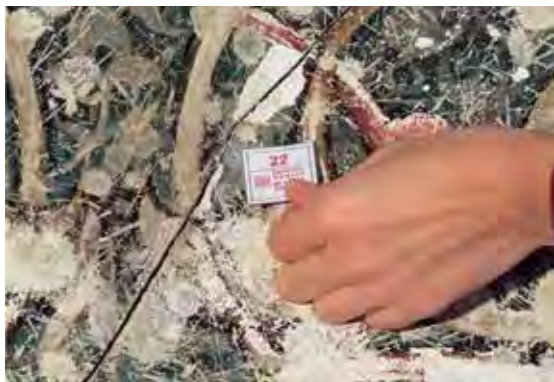
Fig. 22. Sampling point of the microfragment of mural painting T22a with blue/green paint taken from lateral dome 1e, southwest side, al-Ashrafiyyah.

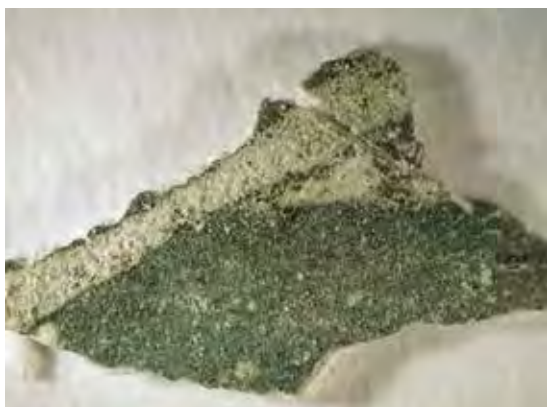
Fig. 23. Stereomicroscope image of the front of paint sample T22a where the blue/green colour of the paint and the presence of surface deposits are observed.

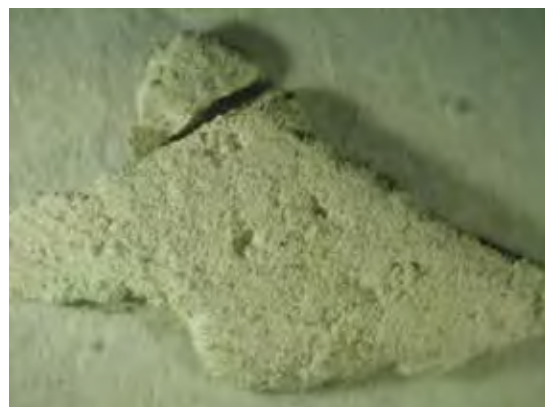
Fig. 24. Stereomicroscope image of the back of paint sample T22a where the white supporting plaster is observed.

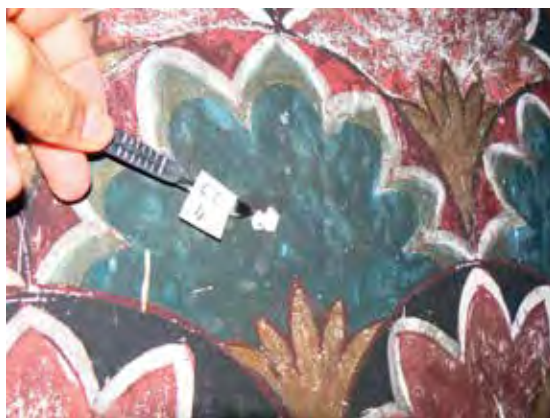
Fig. 31. Sampling point of the fragment of mural painting CC4 with blue/green paint layer taken from the central dome - al-Ashrafiyyah.

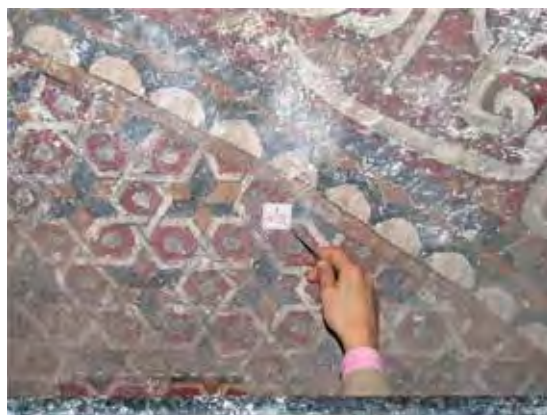
Fig. 36. Sampling point of the microfragment of mural painting T3 with yellow paint taken from lateral dome 1d - south side - al-Ashrafiyah.

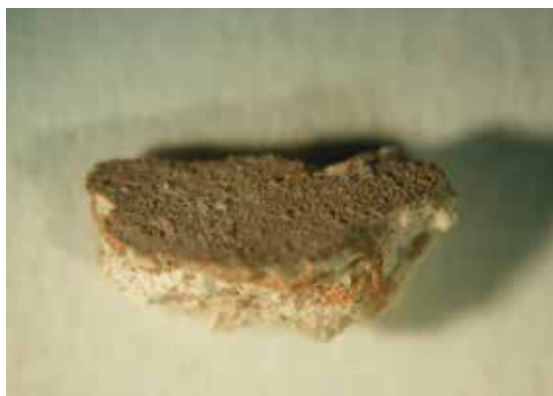
Fig. 37. Stereomicroscope image of the front of paint sample T3 where the yellow colour of the paint and the presence of surface deposits are observed.

For the realization of the yellow paints in the lateral dome, Yellow Ochre was used (Figs. 37-43), while in the main dome in the yellow/gold paints (in particular in the Qur'anic inscriptions that were apparently gilded) the pigment Orpiment has been identified in a gypsum binder (Fig. 44).

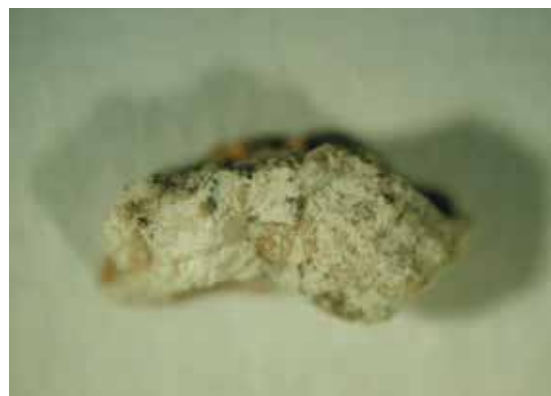
Fig. 38. Stereomicroscope image of the back of paint sample T3 where the lime-based plaster is observed.

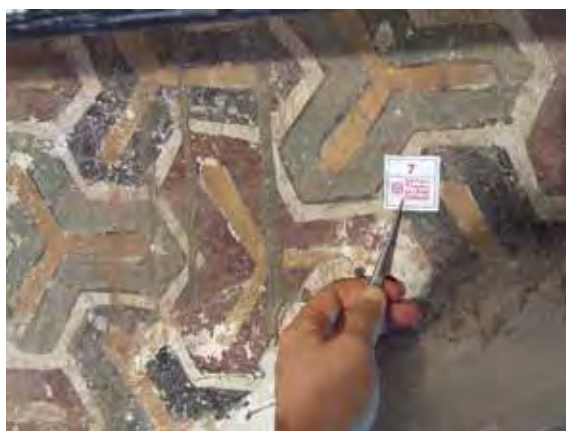
Fig. 44. Sampling point of microfragment of mural painting T7 with green paint taken from dome 1d - east side - al-Ashrafiyyah.

The green paint of fragments taken from the lateral domes was producing using Green Earth pigment (Figs. 44-50).

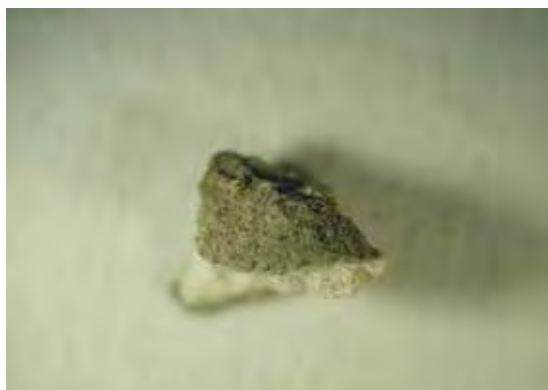
Fig. 45. Stereomicroscope image of the front of paint sample T7 where the green colour of the paint and the presence of surface deposits are observed.

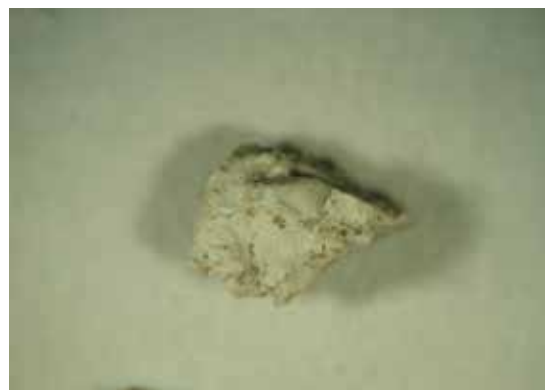
Fig. 46. Stereomicroscope image of the back of paint sample T7 where the supporting plaster made with lime and sand is observed.

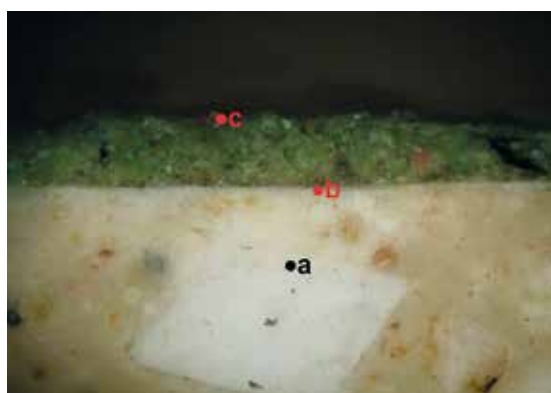
Fig. 47. Image at the optical microscope of the cross section of paint sample T7 viewed in reflected visible light showing the green paint layer (c) containing Green Earth and small quantities of Ochre.

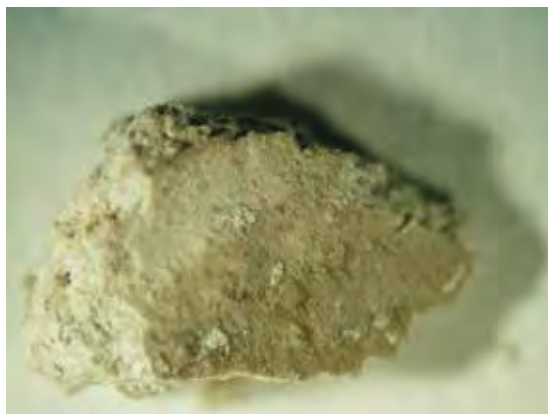
Fig. 56. Stereomicroscope image of the front of paint sample T6 where the white colour of the paint and the presence of surface deposits are observed.

In the main dome, the layers of white paint were produced using Calcium Sulfates (gypsum partially hydrated and water-soluble anhydrite). Kaolin was also detected and, as it is a highly resistant material, it was suitable for mural painting (Figs. 55-61).

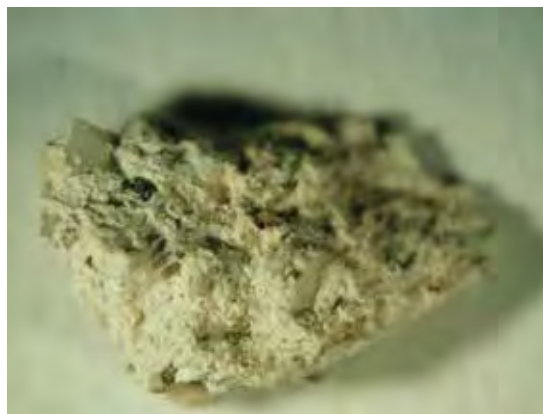
Fig. 57. Stereomicroscope image of the back of paint sample T6 where the supporting plaster made with lime and sand is observed.

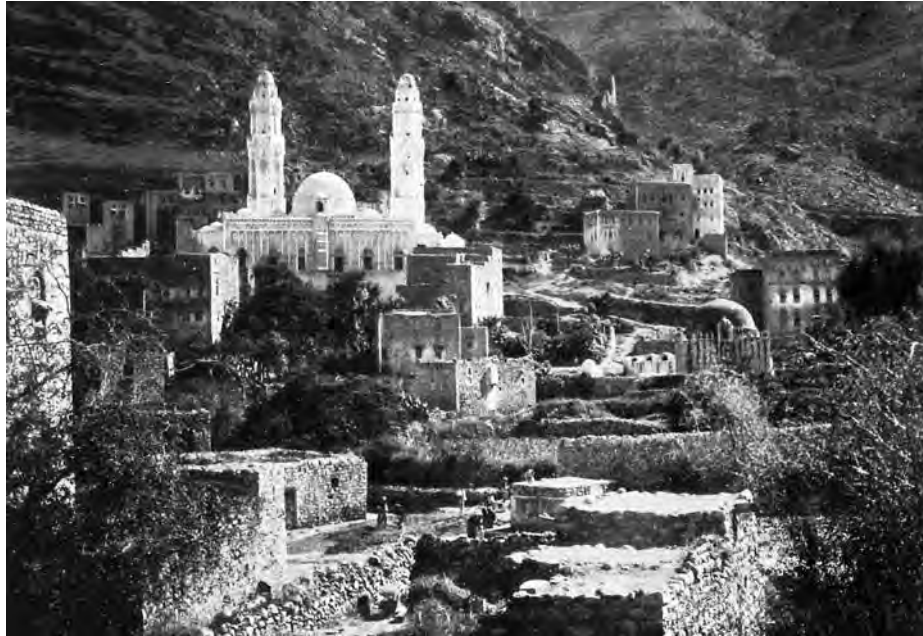
Fig. 6. Al-Madrasah al-Ashrafiyyah (after Burchardt, 1907?).

city below him. The volume is accompanied by 28 tables of original photographs; among these, two that show al-Madrasah al-Ashrafiyyah.¹⁴

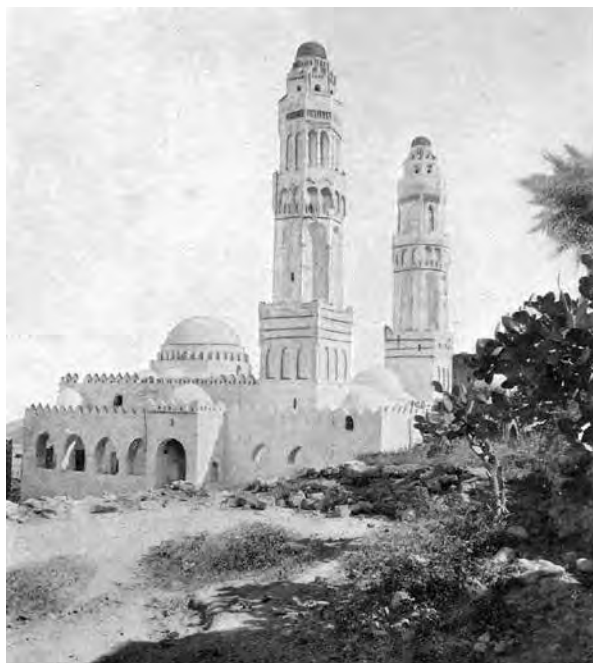
Fig. 7. Al-Madrasah al-Ashrafiyyah (after Burchardt, 1907?).

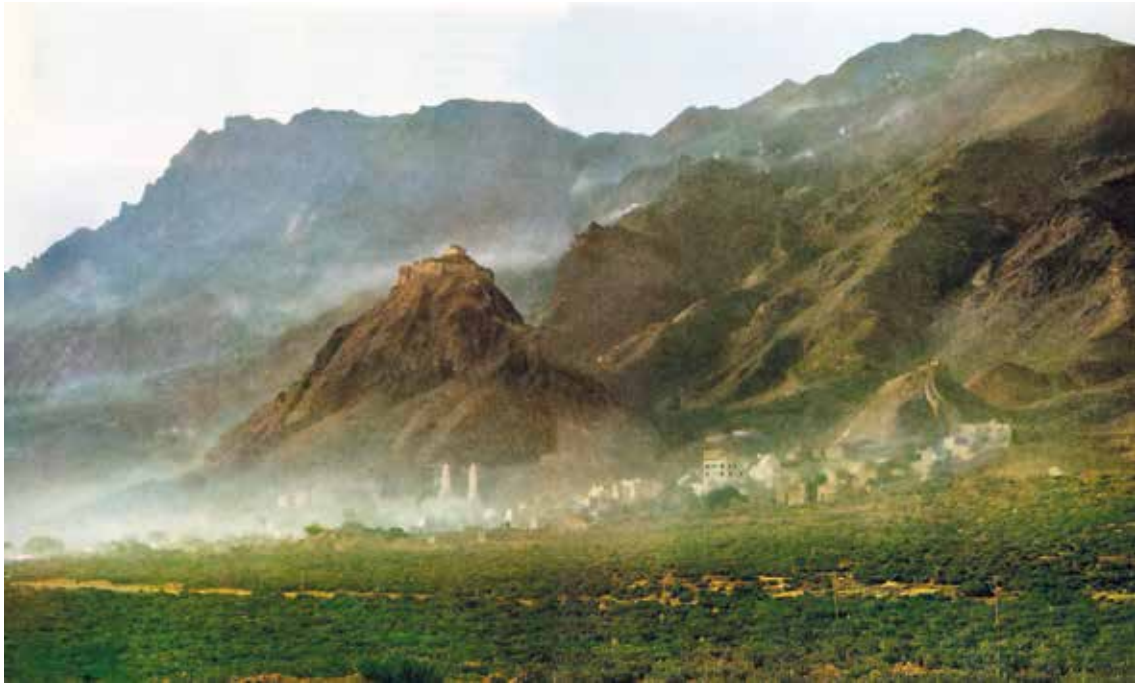
Fig. 13. Ta'izz: al-Madrasah al-Ashrafiyyah with its two minarets, the Fortress al-Qāhirah and Mount Şabir (After Abercrombie 1964: 424-425.)

Sons of sheiks lived as hostage in this grim eyrie to ensure their fathers' loyalty to the Imams. Twin minarets cap the Al-Ashrafiyyah Mosque, a Ta'izz landmark. Farm villages dot the slopes of the 9,859-foot (3008 m) Jabal Sabir.

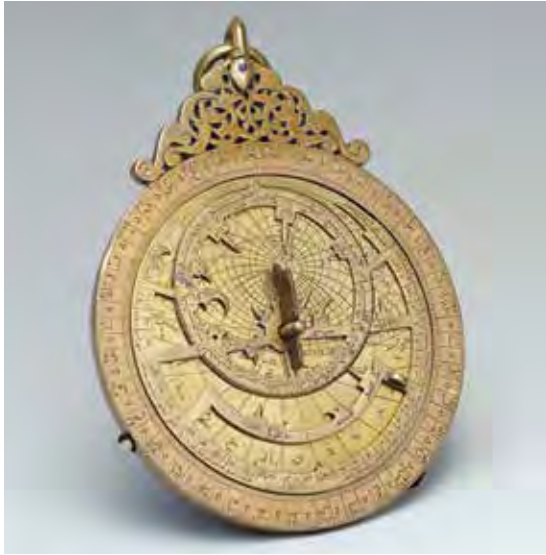
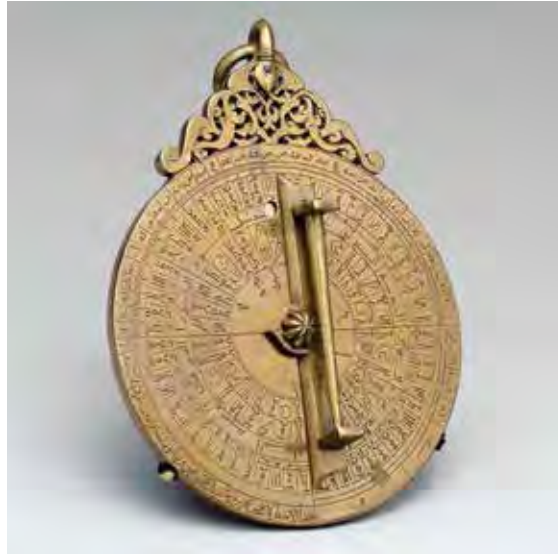
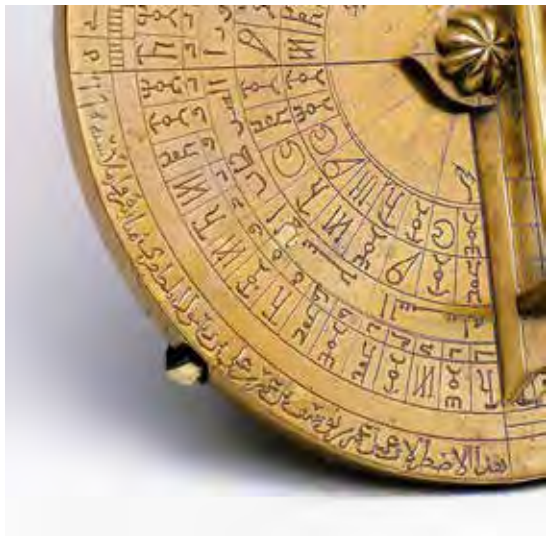
Figs. 9, 10, 11. Front and back of the astrolabe. In the detail we can see the signature of the prince ‘Umar ibn Yūsuf ibn ‘Umar ibn ‘Alī ibn Rasūl al-Muẓaffarī. Metropolitan Museum of Art, New York, Edward C. Moore Collection.

Alongside his profound theoretical study, he liked to put his studies into practice with the construction of technical instrumentation he himself designed. Among the most significant objects developed by al-Malik al-Ashraf there is an astrolabe, currently displayed at the Metropolitan Museum of Art in New York (Figs. 9, 10). An inscription on this astrolabe bears the name ‘Umar ibn Yūsuf ibn ‘Umar ibn ‘Alī ibn Rasūl al-Muẓaffarī (Fig. 11).

This astrolabe is the work of ‘Umar ibn Yūsuf ibn ‘Umar ibn ‘Alī ibn Rasūl al-Muẓaffarī by his own hand and (also) under his supervision in the year 690 Hijra (1291).¹²
