THE GREAT MOSQUE OF ŞAN'Ā'

Conservation intervention

(2005-2015)

FOUNDATIONS OF THE GREAT MOSQUE IN ŞAN‘Ā’

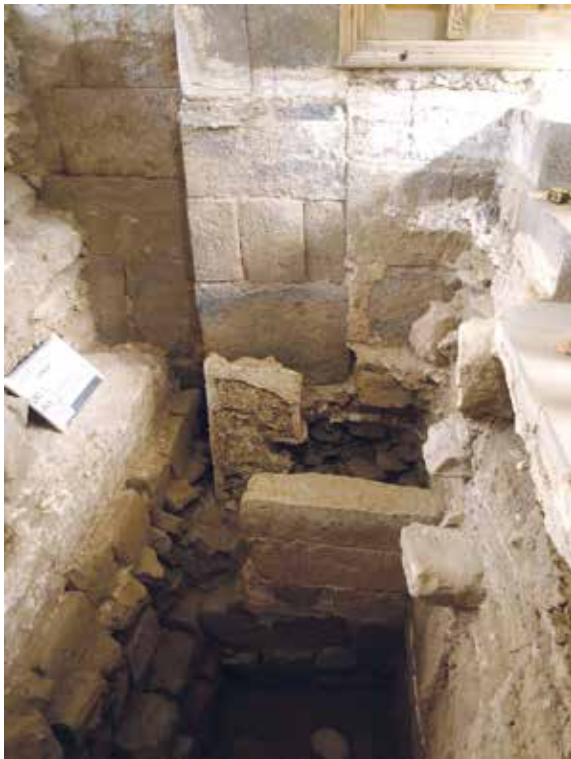
Fig. 2. Exterior face of the north wall, the surround of the imam's doorway, and remains of the earlier formal entryway. Note the large size of the facing blocks of the wall.

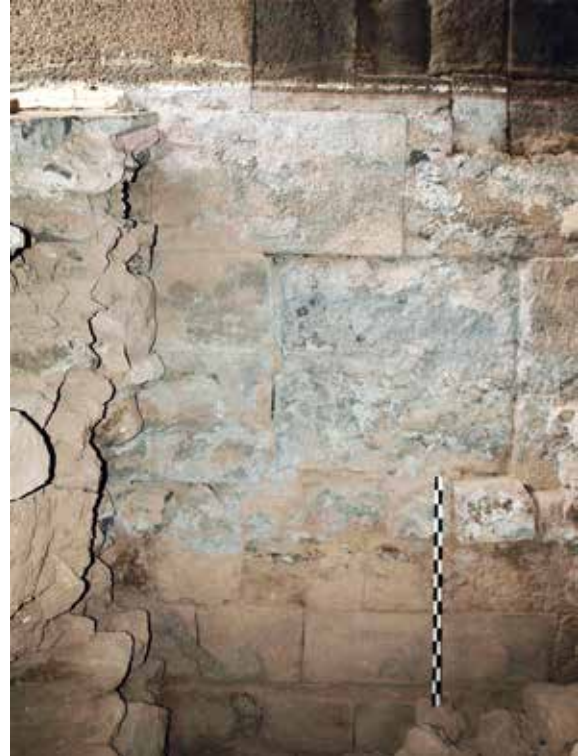
Fig. 4. Interior face of the north wall at the western doorway. The wall plaster visible at the top of the photograph is the original plaster of the north *riwāq* and it covers the wood slot. The wider footing of the foundation is visible at the bottom of the photograph.

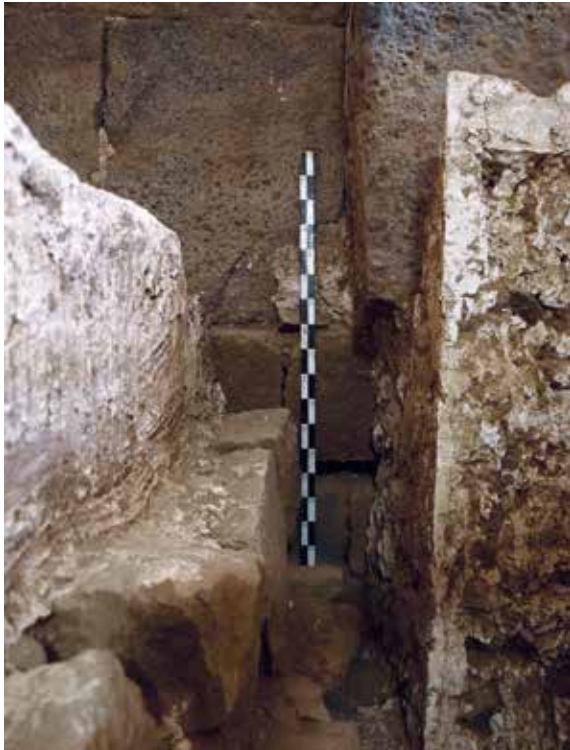
Fig. 5. Detail of the north wall and bottom of the surround at the imam's doorway. The wood slot is visible near the bottom of the scale (each bar is 5cm). The plastered structure in front of and below the surround belongs to an earlier entry structure.

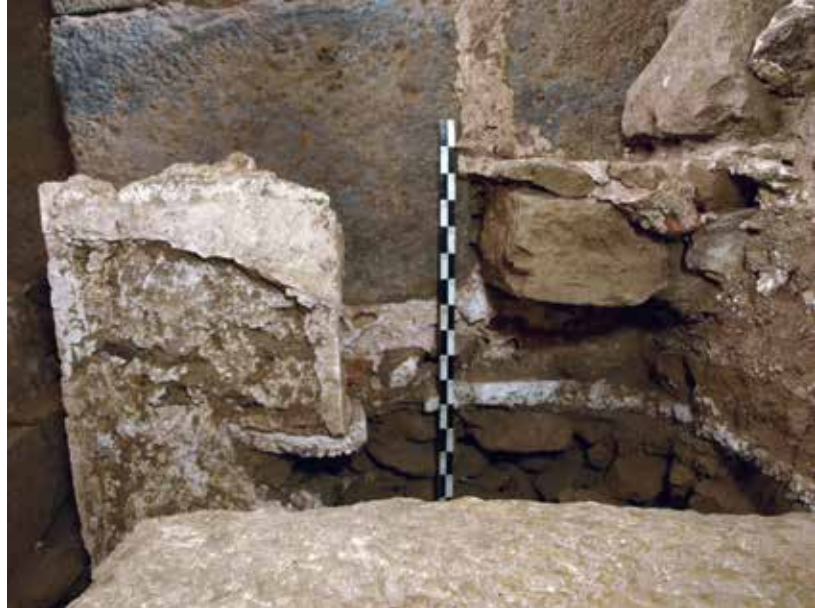
Fig. 7. Bottom of the surround at the imam's doorway, with the plastered remains of the earlier entry in front. The bottom of the surround sits upon an accumulation of plaster floors and stone rubble of the earlier entryway, but the surround has no foundations proper to it.

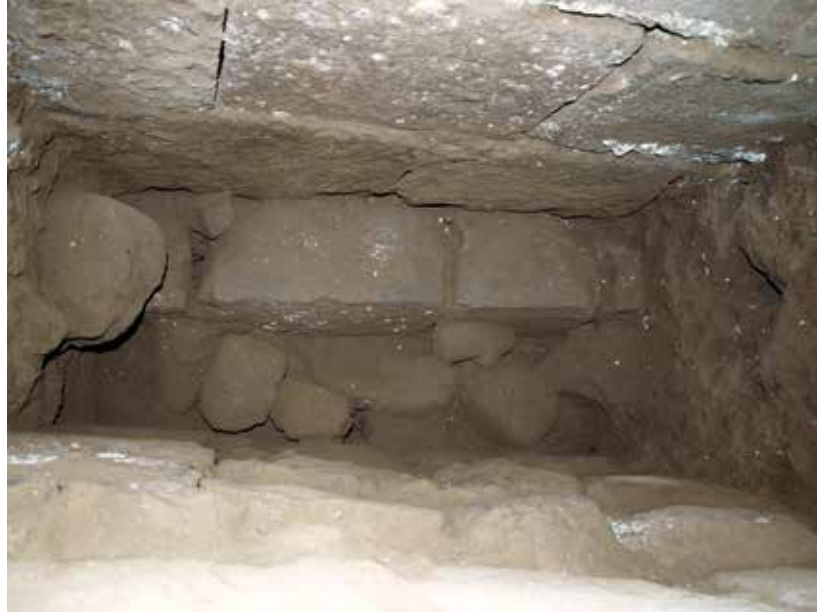
Fig. 8. Interior face of the west wall near the west minaret. The wider course and the rubble bed at the bottom of foundations are in the center of the photograph. The plaster adhering to facing stones suggests that many of these stones were recycled from older structures.

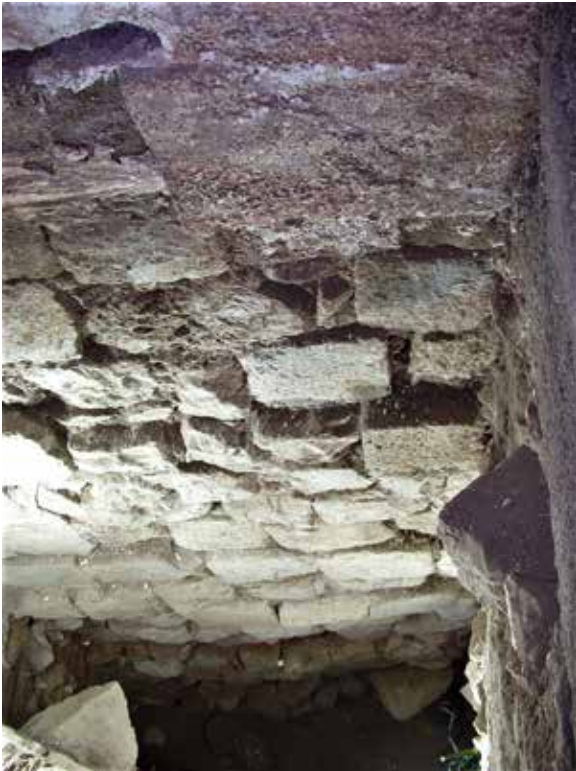
Fig. 10. Interior face of the south wall, just east of the south entrance. Note that the stones become less regular with depth.

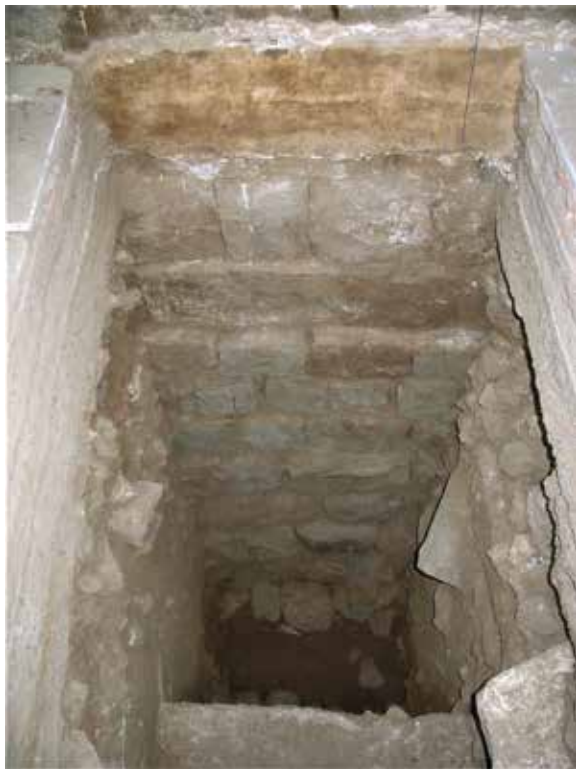
Fig. 11. Interior face of the east wall near the northeast corner of the Mosque. The wider course of stones at the bottom of the foundation may belong to an earlier structure. The wall plaster is the original plaster of the east *riwāq* and its bottom corresponds to the initial floor of the east *riwāq*.

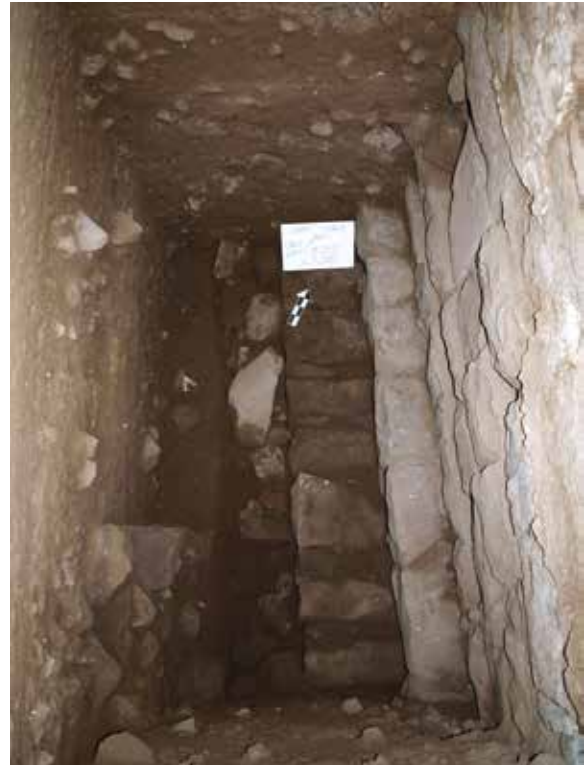
Fig. 12. Interior face of the east wall near the southeast corner of the Mosque. The wider courses at the bottom of the foundation are intended elements of the foundation design. Notice the irregular blocks used for the foundation facing.

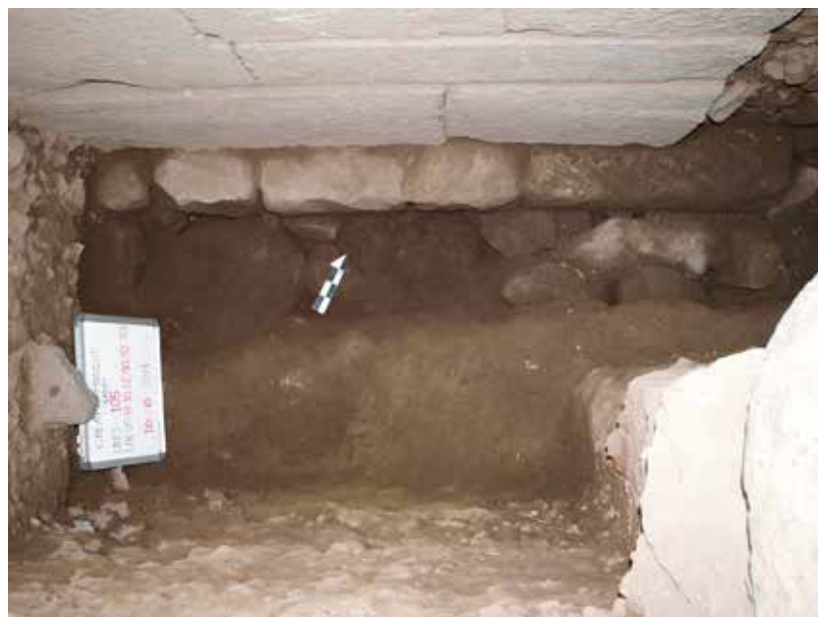
Fig. 13. Exterior face of the east wall at the southeast corner of the Mosque. The facing blocks are well shaped and the coursing is very regular down to the rough stone seat. Note the rubble packing that fills the gap between the seat and the edge of the foundation trench.

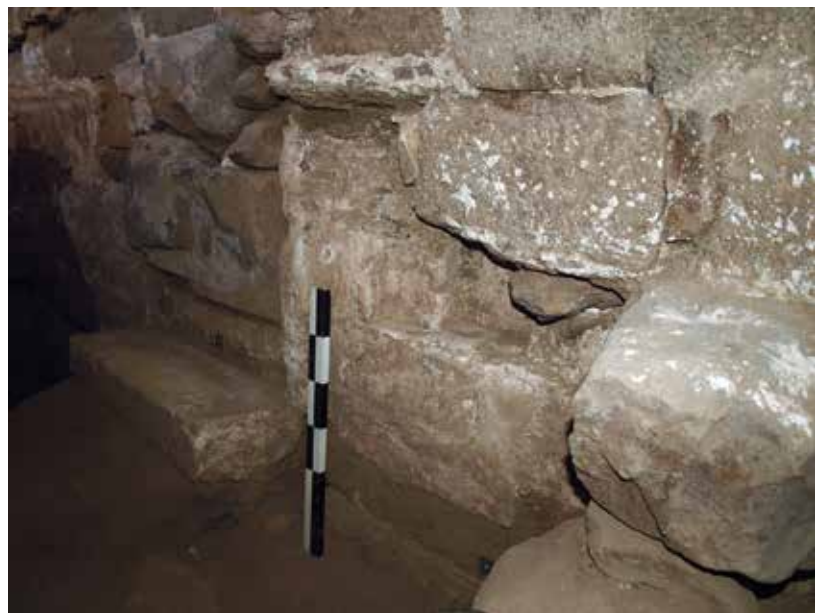
Fig. 16. Original doorway, stone step and recessed shelf at the northwest corner of the east minaret. The stones visible in the lower right corner of the photograph belong to the north-south pillar foundation that was inserted when the early east *riwāq* was renewed. The stone blocking within the minaret doorway belongs to the same episode of renewal.

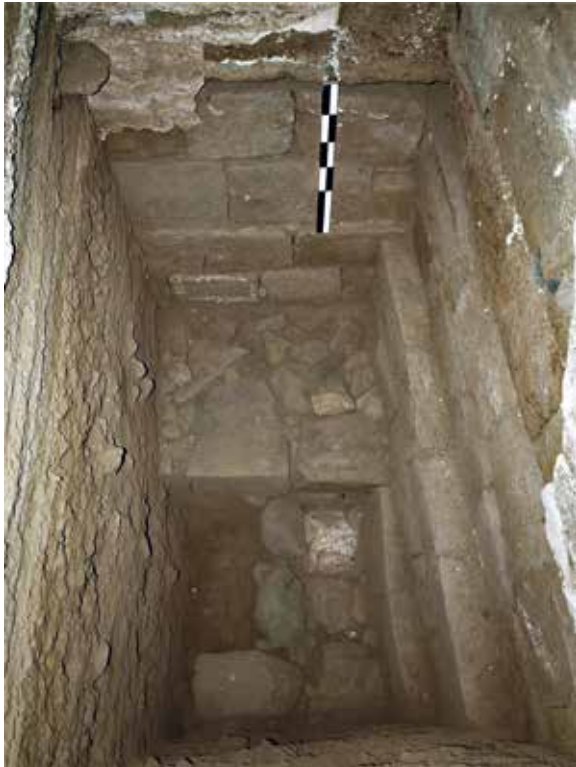
Fig. 17. Oblique view of the corner formed by the east minaret (along the right side of the photograph) and the early south wall of the Mosque (along the top of the photograph).

The original wall plaster has been largely removed, revealing the wood slot. Note the very wide seat at the bottom of the early east wall foundation (perhaps the stub of an earlier wall), the progressive widening of the minaret foundation, and the mass of roughly shaped stones lateral to the bottom of the minaret foundation.

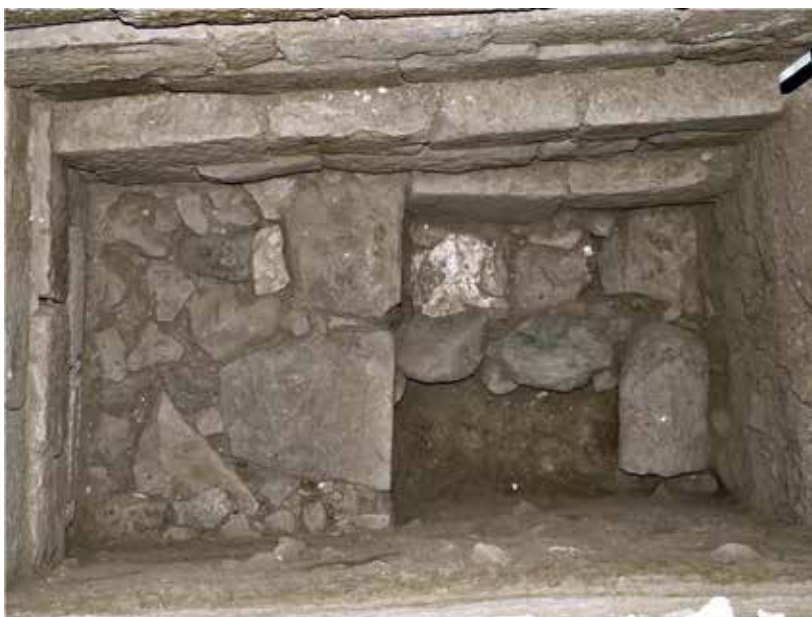
Fig. 18. Vertical view of the corner formed by the east minaret (along the top of the photograph) and the early south wall of the Mosque (along the left side of the photograph). Note the very wide seat at the bottom of the early east wall foundation (perhaps the stub of an earlier wall), the progressive widening of the minaret foundation, and the mass of roughly shaped stones lateral to the bottom of the minaret foundation.

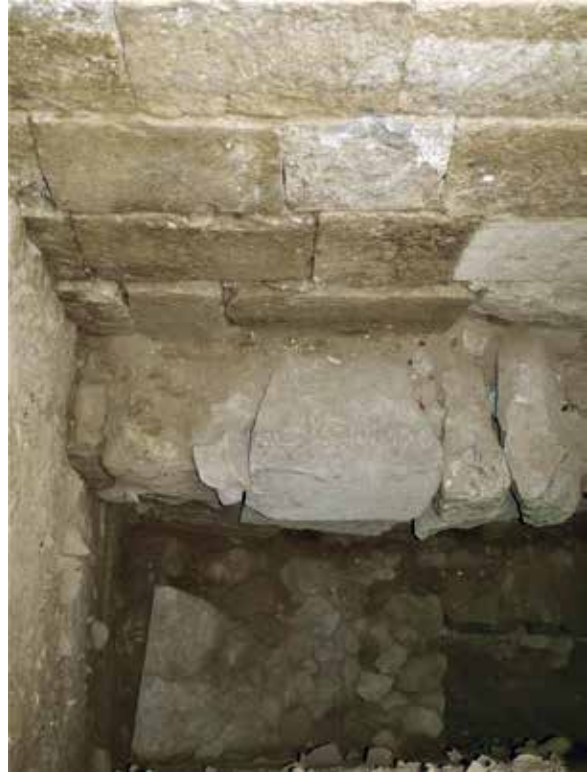
Fig. 19. Foundations below the east face of the east minaret, upon the wider rough stone seat. The wall visible at the bottom of the photograph is the stub of an earlier wall above which the minaret foundation sits.

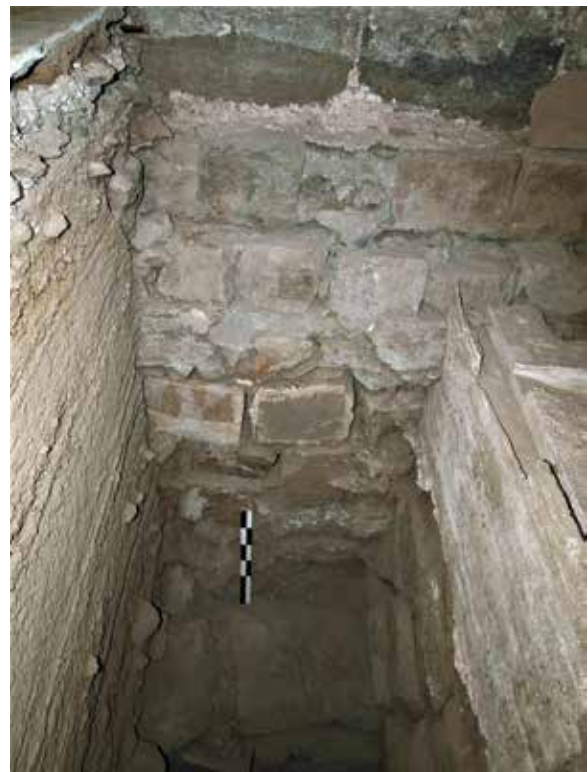
Fig. 20. Foundations below the south face of the east minaret, sitting upon the stub of an earlier wall. Remains of the early south wall (wall plaster and foundations) are visible on the right side of the photograph.

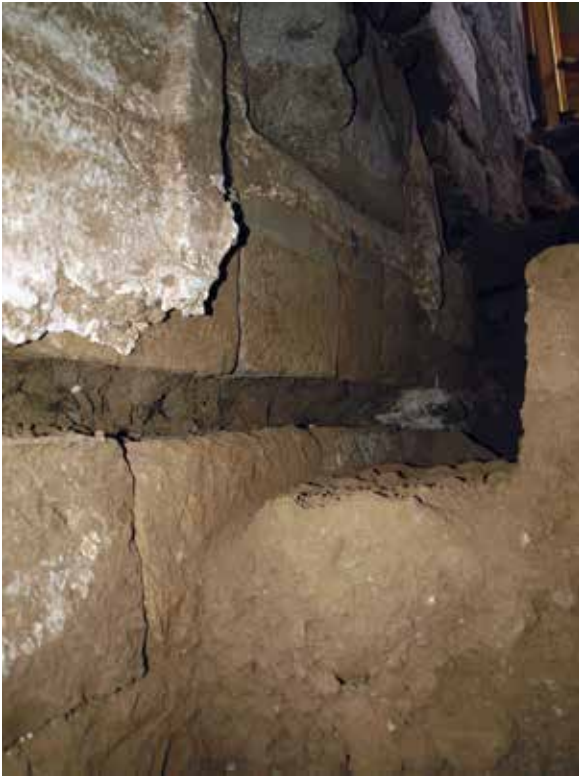
Fig. 21. Detail of the wood slot in the north face of the east minaret, below the original doorway (after removal of the stone step).

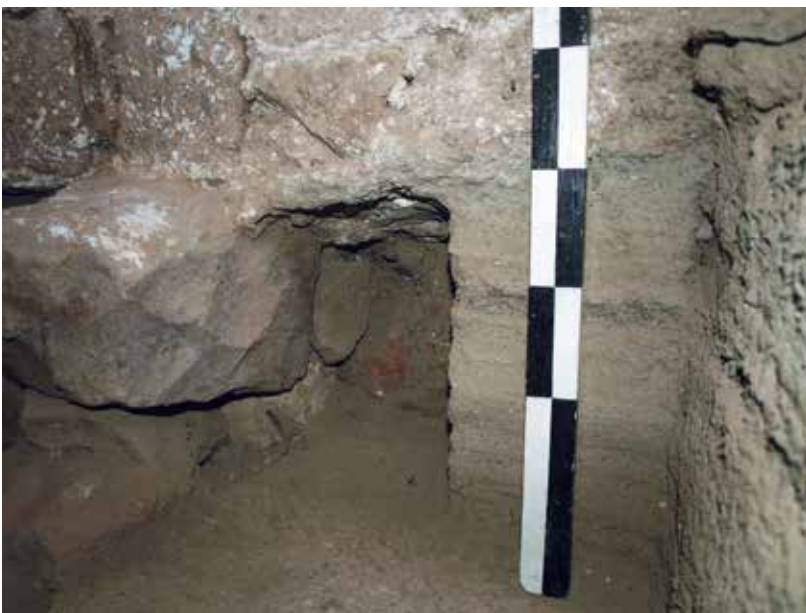
Fig. 22. Detail of the horizontal probe below the present northwest corner of the east minaret. The large stone on the left side of the photograph corresponds to the stone visible on the right side of Fig. 16. The plaster visible below this stone is the west side of the recessed shelf. Behind the scale is visible the stack of floors upon which the northwest corner of the enlarged minaret sits.

western face of the recessed shelf, and furthermore that the northwest corner of the enlarged minaret rested directly upon the succession of *riwāq* floors (Fig. 22).

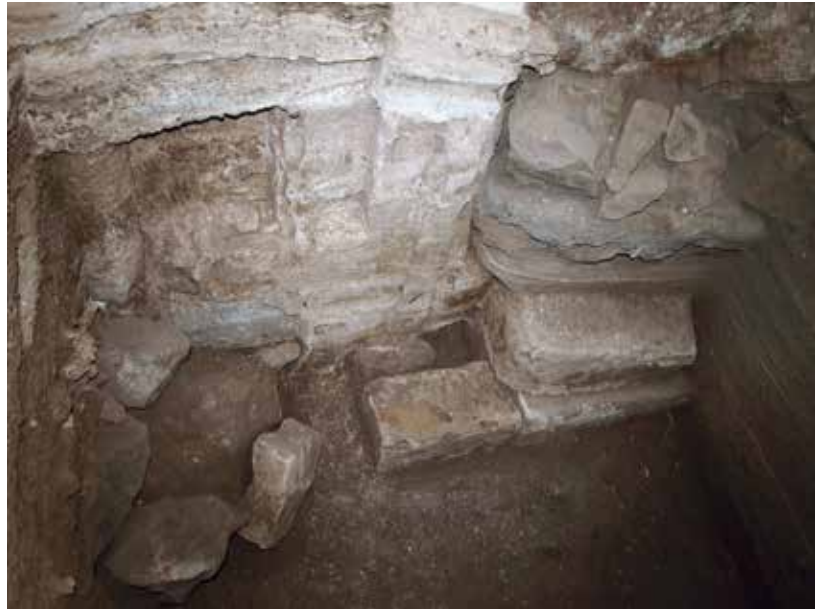
Fig. 25. The original northeast corner of the west minaret. The original step is partially covered by a later higher step (made necessary by raising the level of the door sill as the level of floors rose). The group of stones in the upper right corner of the photograph is blocking in the doorway. The vertical stone at the left side of the photograph is the bottom of pillar A14, set upon the exposed stone of the recessed shelf. The group of rough stones in the lower left is the rubble buttress for pillar A14.

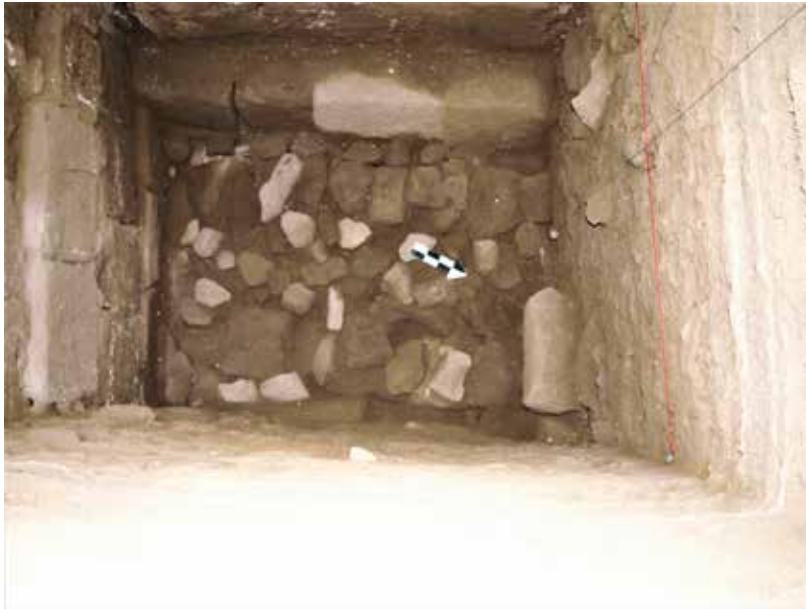
Fig. 27. The corner formed by the foundation for the north face of the west minaret (to the left) and the foundation for the west wall of the Mosque (to the top). Note the bed of rubble that abuts and underlies these foundations.

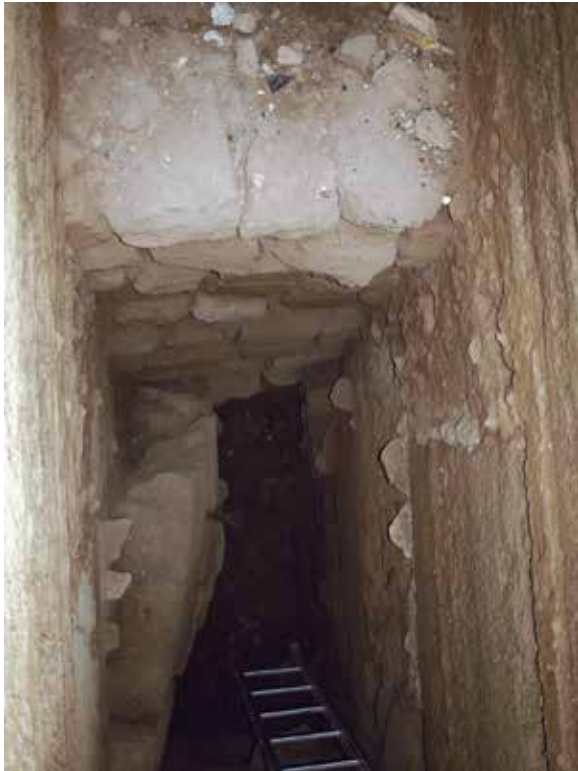
Fig. 28. The ribbon foundation between pillars B3 and C3 in the north *riwāq*. The foundation cuts through a pre-Islamic wall visible at the left side of the excavation.

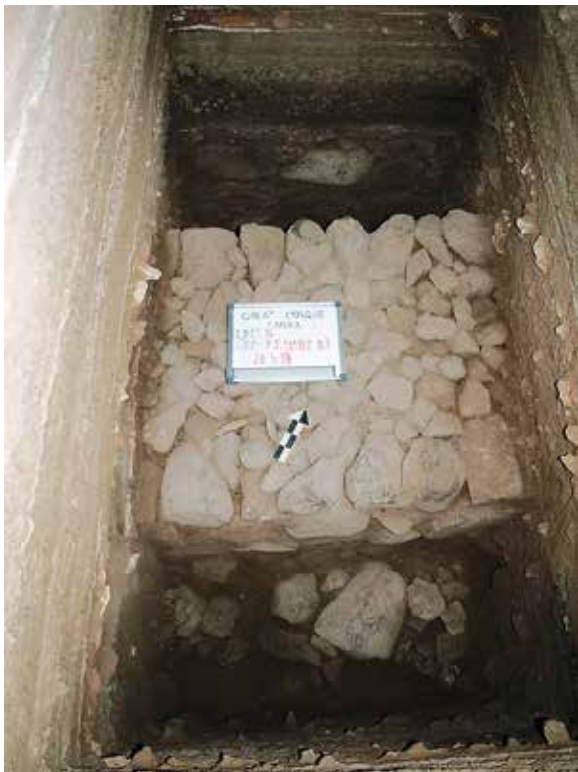
Fig. 29. The ribbon foundation between pillars H16 and I16 in the south *riwāq*. The foundation is draped over the stub of a pre-Islamic wall (visible at the bottom of the photograph).

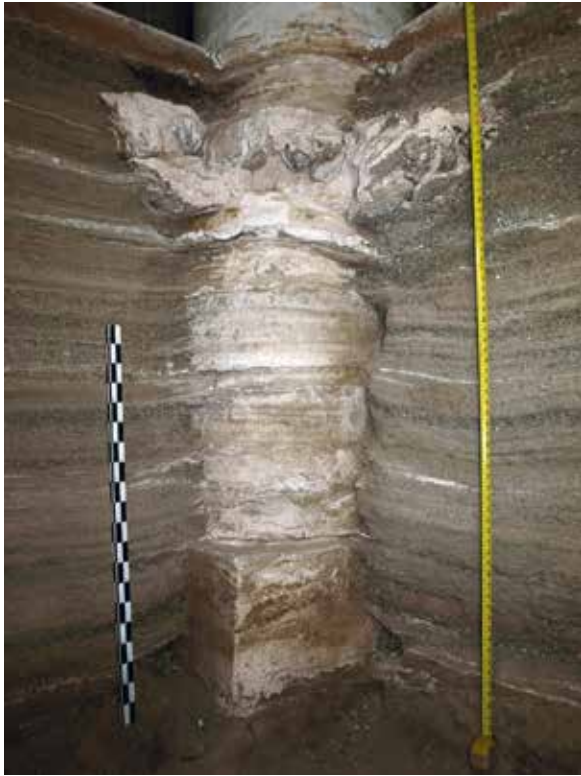
Fig. 31. Pillar E1 in the north *riwāq*.
The ribbon foundation is visible at the bottom of the photograph. The original pier, with multiple replasterings, sits on a large plastered base. The present pillar is also a pier, established on a bed of large rough stones embedded upon the stub of the original pier.

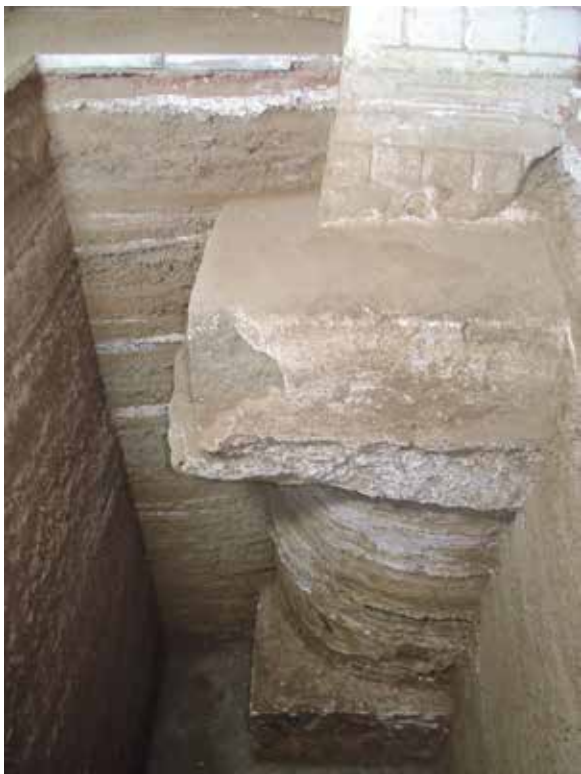
Fig. 32. Pillar L3 in the north *riwāq*.
The original plinth and pier are covered by a second stone base set in *qutrah*, with the present pillar (a recycled pre-Islamic pillar set up-side down) on the secondary base.

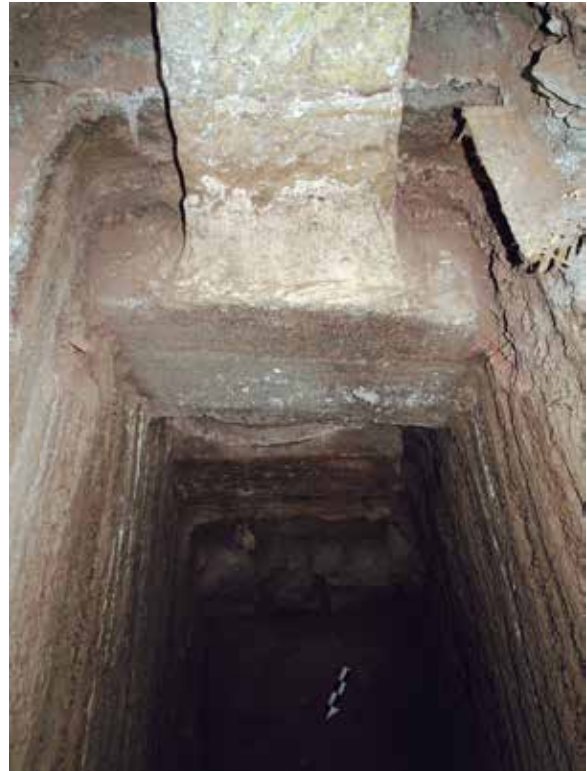
Fig. 34. Pillar K17 in the south *riwāq*. The pillar stack consists of (from bottom to top) the foundation ribbon, the original plinth, the original base, two secondary bases, and the present pillar (a lintel with a South Arabian inscription, see Fig. 30d). At the bottom of the photography is visible a ribbon foundation and the stub of a square pillar belonging to the *zullah* (see Section 2.3).

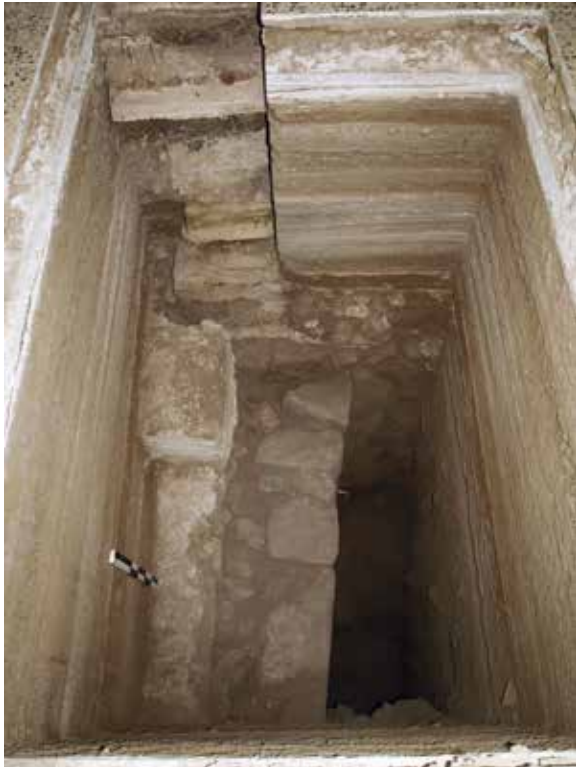
Fig. 35. Pillar L17 in the south *riwāq*. The pillar stack visible in the upper left corner of the excavation consists of (from bottom to top) the foundation ribbon, the original plinth, the original base, the low stub of the original pier, a narrow secondary stone base, and a wider secondary stone base framed in brick; the present pillar (not visible in the photograph) is a multiple drum pillar of relatively recent date. The square base and walling along the left side of the excavation belong to the *zullah* (see Section 2.3), whereas the wider wall below these two structures antedates the Mosque.

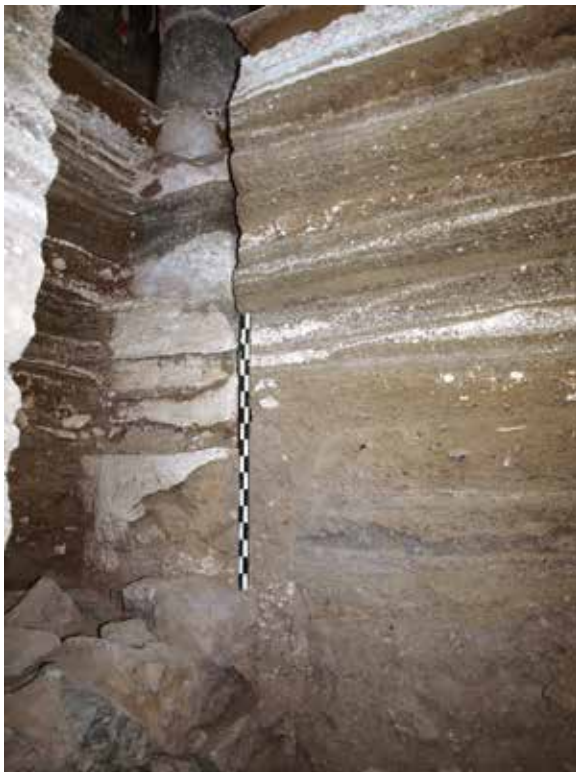
Fig. 36. Pillar J18 in the south *riwāq*. The pillar stack consists of (from bottom to top) the ribbon foundation, the original plinth, the original base (with two coats of plaster), a stack of three secondary bases, and the present pillar (multiple drums). Note that the top of the foundation trench (visible in the section to the right of the foundation ribbon) is cut from a level above the top of the plinth.

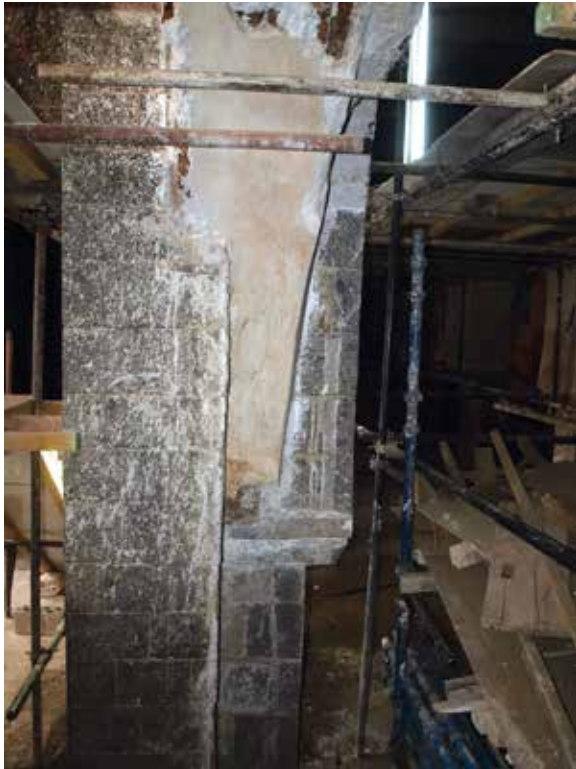
Fig. 38. Pillar I16 in the south *riwāq*, from the west. The vertical stonework on the left half of the compound pillar is the pier supporting the southeast corner of the western library (section 6.1.2.5(c)) while the stonework on the right half is the buttress with the wood beams separating its two parts (section 6.1.2.5(b)). The plaster visible between these two components covers the arcading brickwork. The original pillar is not visible from this side.

Distortion of arcading brickwork and its position over pillars is perhaps most severe at pillar I16, in the third (inner) arcade of the south *riwāq*. This position forms the east side of the partially demolished *mihṛāb* of the south *riwāq*; it is also below the southwest corner of the eastern library and the southeast corner of the western library (see section 7.2.2). In its present form (Fig. 38), pillar I16 is a compound structure of three distinct parts.

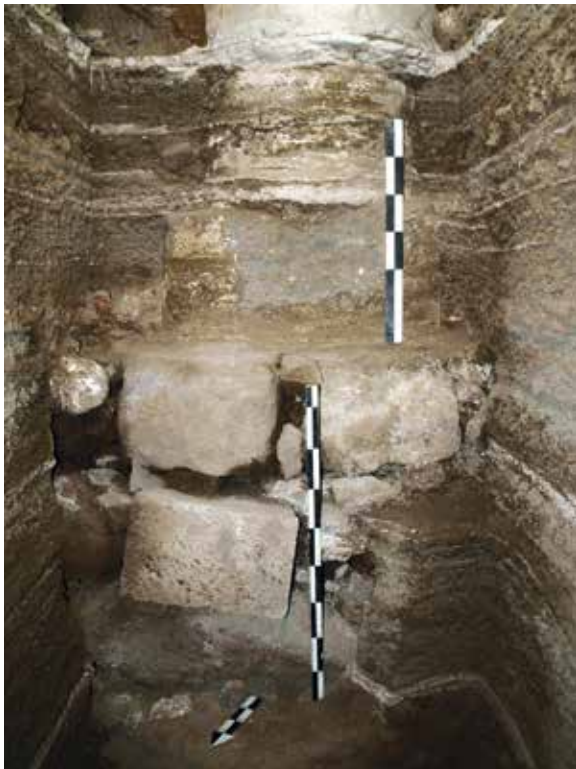
Fig. 39. Upper portion of the foundation piling, the base and pier at pillar A7 in the west *riwāq*. Note the recycling of dressed facing stones in the piling.

Pillars of the outer and central arcades of both *riwāq* are cylindrical “piers” about 80cm in diameter. The piers are constructed of irregular stone blocks encased in plaster, and set upon a block-like base (Fig. 39). The bases are roughly dressed rectilinear blocks of stone that are approximately 80cm by 80cm in area, and around 30cm high.

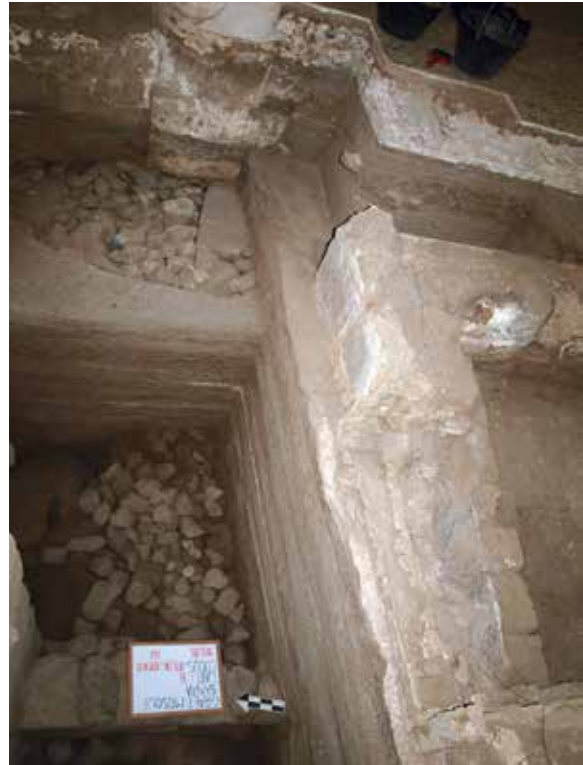
Fig. 41. Top of the foundation piling at pillar N1 (bottom of the photograph) and the base of pillar M1 set upon the stub of the early east wall (top of the photograph) in the east *riwāq*. The wood slot in the exterior face of the early east wall is visible.

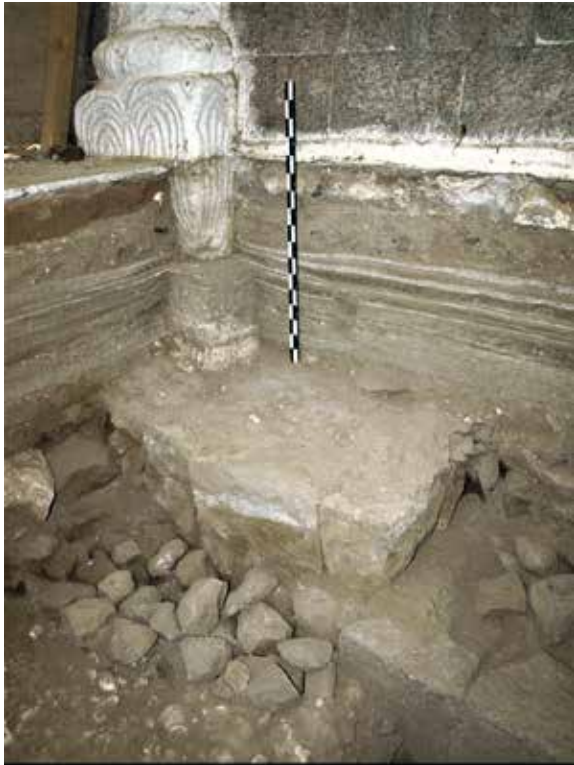
Fig. 42. Pillar M9 in the east *riwāq* (east edge of the courtyard). The pillar base sits directly on rearranged blocks of the early east wall stub, and is buttressed by the rubble piling set against the early east wall stub. The pillar itself is a recycled pre-Islamic (Axumite-style) pillar. The stonewall set against the pillar is the present courtyard edging wall.

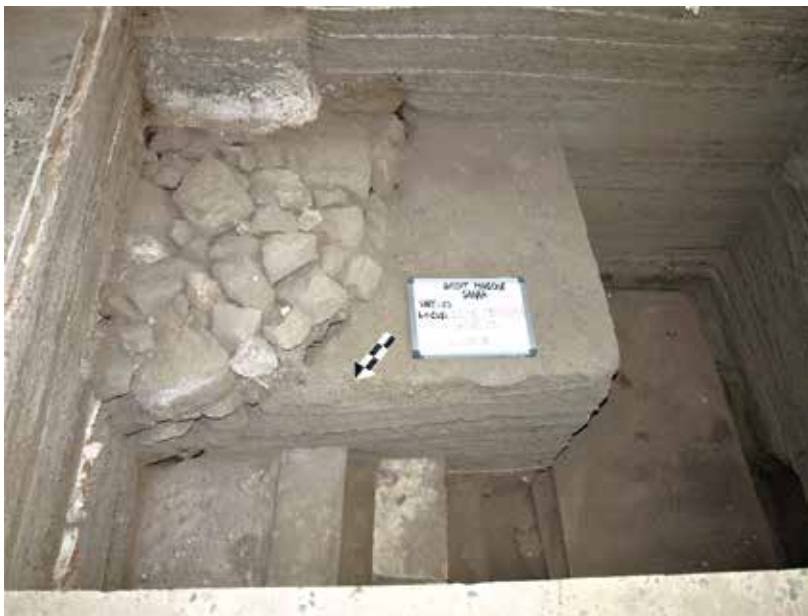
Fig. 43. Top of the foundation piling and the base of pillar M5 in the east *riwāq* (northeast corner of the courtyard). The structure visible at the bottom of the photograph is a doorway through the early east wall, the inner face of which is below the second step up to the doorway. The board visible in the right side of the photograph covers a large pre-Islamic well (see Section 2.1).

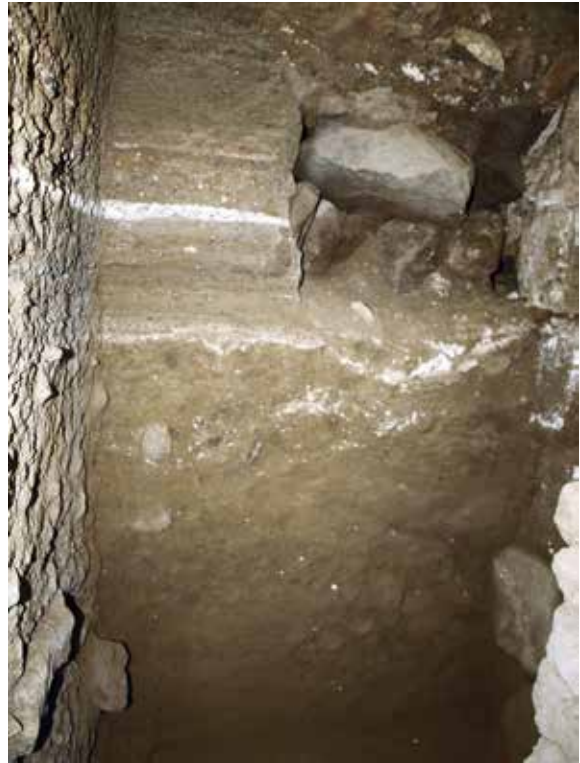
Fig. 44. Shallow buttressing piling set against the northeast corner of the west minaret, to buttress pillar A14.

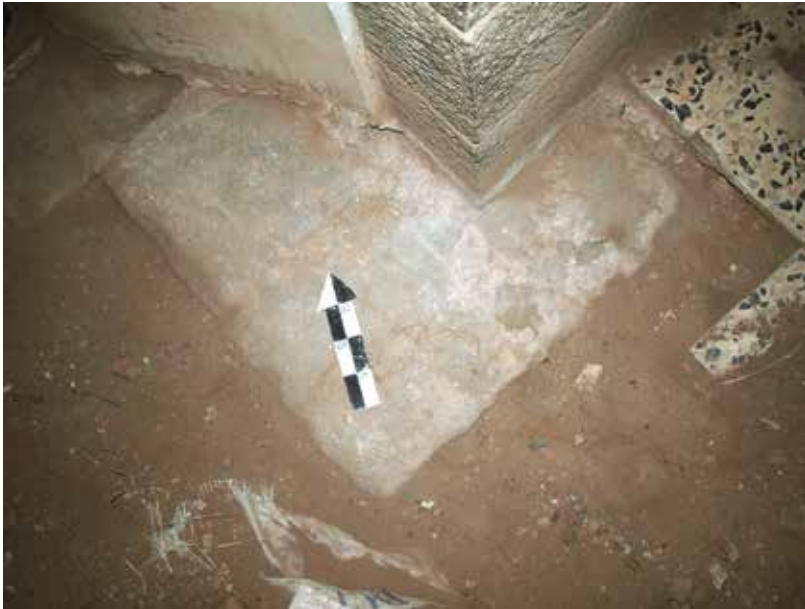
Fig. 45. Paves of the “Ottoman pavement” serving as foundation for the pier K15, which supports both the northwest corner of eastern library 1 and the northeast corner of eastern library 2.

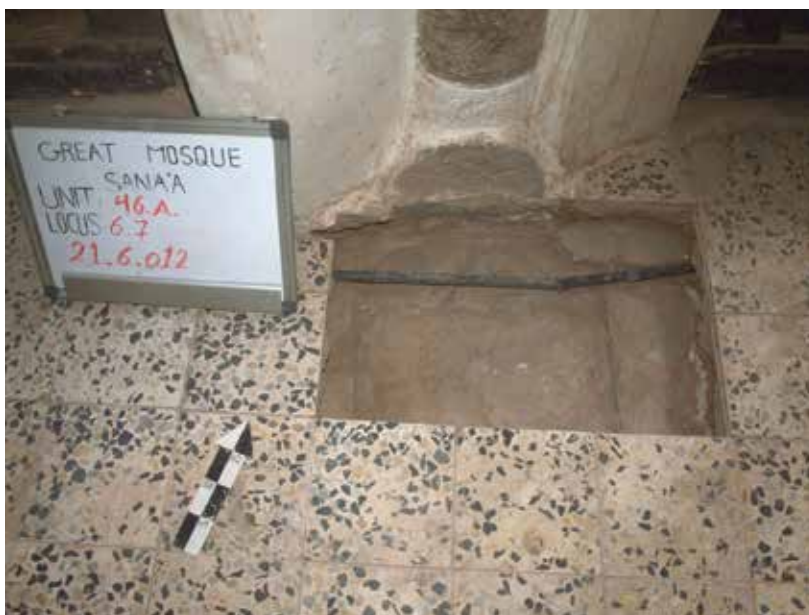
Fig. 46. Paves of the “Ottoman pavement” serving as foundation for the pillar J15W, which supports pointed arches in the north façade below eastern library 2.

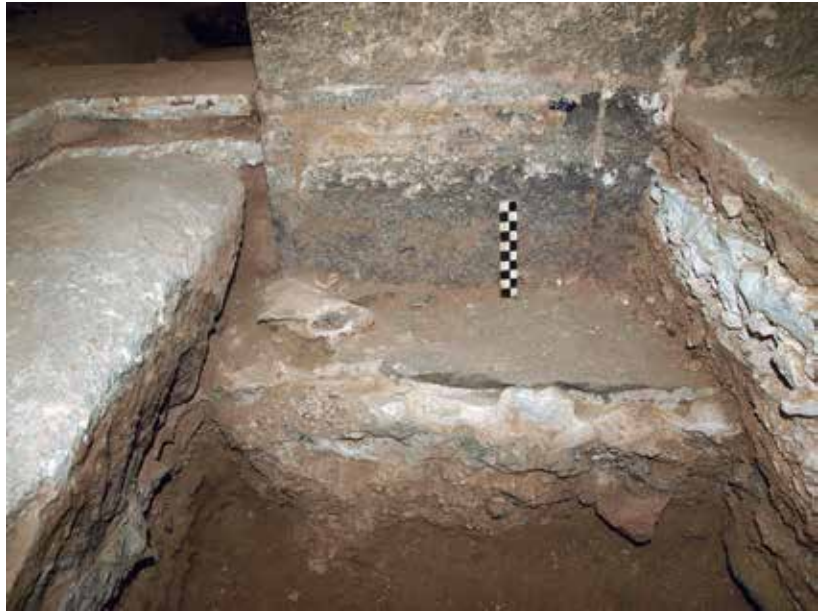
Fig. 48. Pillar H15 sitting upon a piling of rubble and cement. The pillar supports arches in the north façade below the western library.

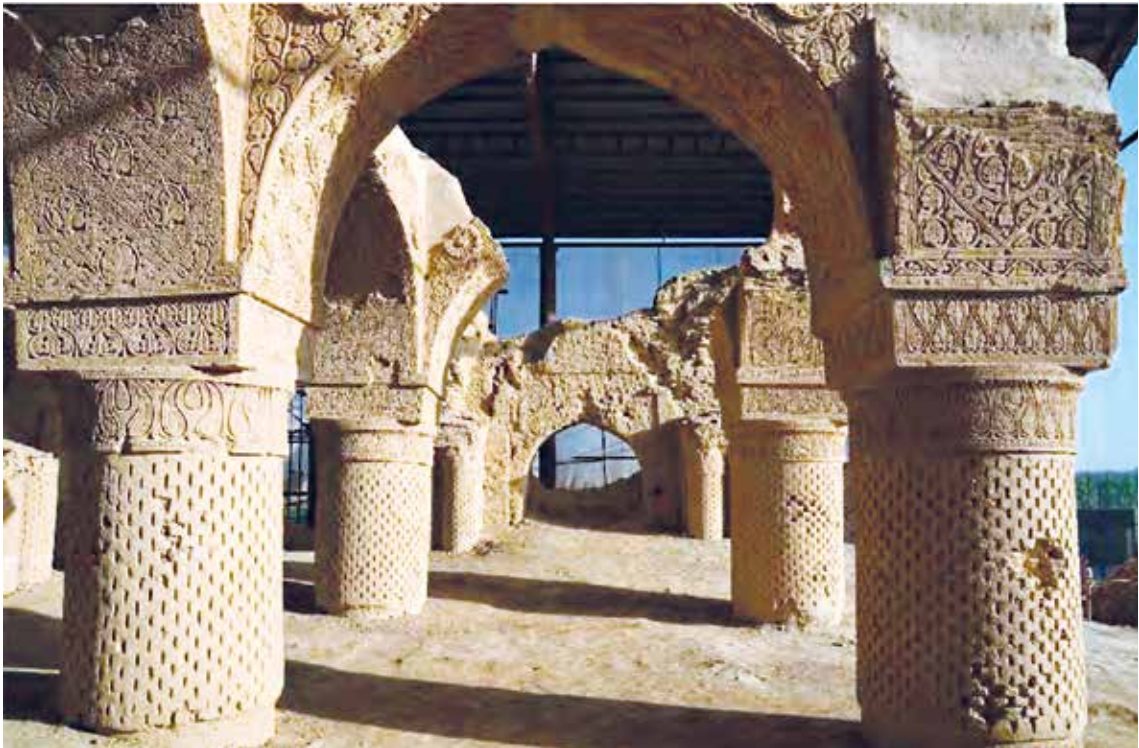
Fig 1. The Mosque of Balkh in Afghanistan. 2-3/8-9 c. AD.

There is documentary evidence that the early Great Mosque(s) were richly decorated. (An imam in the 10th century had the decoration on the *qiblah* wall, which he thought excessive in the then mosque, removed). Early mosques in Persia and Afghanistan (the latter an old part of the Persian empire) give evidence of overall decoration of the walls in styles that are not very dissimilar from those on some of the column shafts in the Great Mosque (Fig. 1).

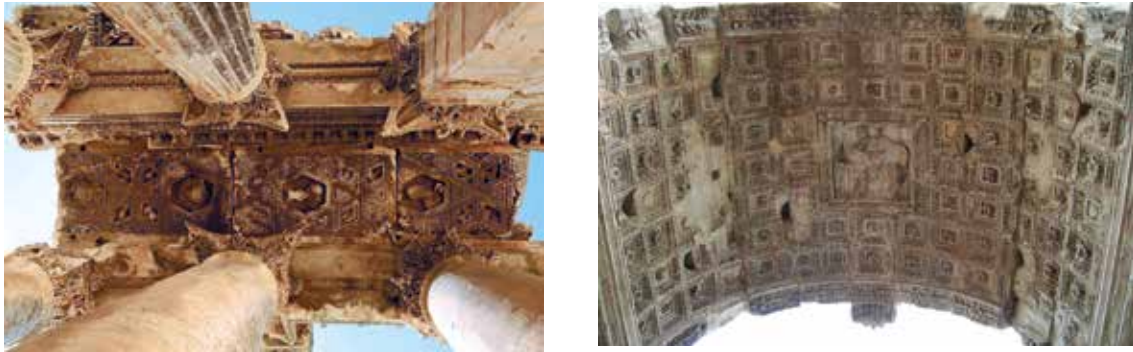
Fig. 2A Baalbek, Syria. Coffering on a fallen stone cornice of an entrance porch. 2nd c. AD.

2B Coffering, Arch of Titus, Rome. 2nd c. AD.

All the ceilings were originally decorated with paint – often in bright colours. The lower faces of the beams were enriched with longitudinal patterns running from one end to the other. The patterns in adjacent rows of beams were often repeated to create a pleasing overall effect from below. To increase their richness, the patterns might be carved in the surface of the beam in low relief before they were painted. The sides of the beams were usually painted in running patterns. The flat ceiling panels in between them were generally each made up of a square frame containing a square field or one composed of triangles; in either case there was usually a square or circular central panel, in later styles this was carved in low relief before being painted in gold and rich colours. This system of ceiling construction was an ancient one, evidence for it surviving in stone copies of the ceilings like those of Baalbek and Palmyra (Fig. 2A-2B).

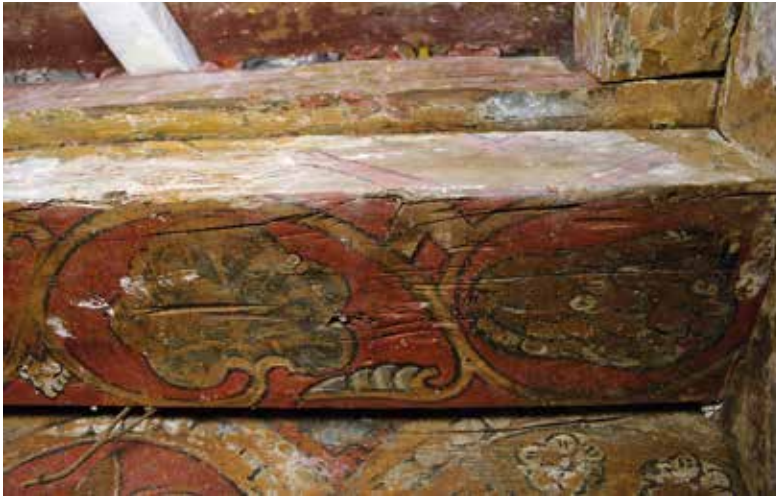
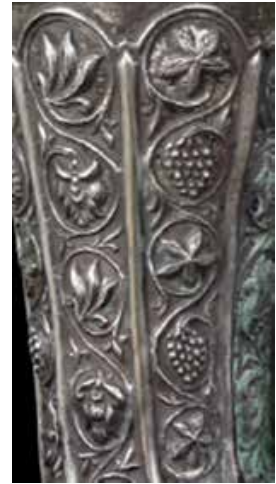
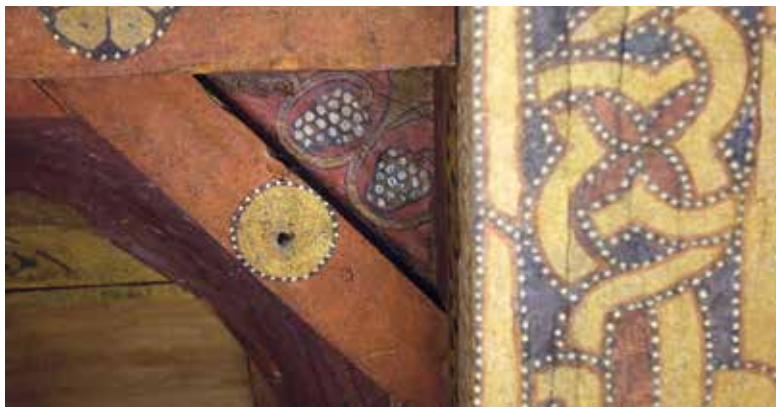
Fig. 3. On the left some sample of lowest layer of painted decoration in the north prayer hall. On the right: Sassanian relief decoration on silver cup 5th to 6th century.

During the cleaning process, at least four to five stages of decorative painting have, on average, been found (in some areas considerably less, only one or two layers, in a few areas even more layers). These may briefly be characterized as follows (Fig. 3).

The lowest, and oldest, paintings involve patterns of high quality related to Sassanian Persian coats of arms, resembling those characteristic of the decorations in the Dome of the Rock. They are drawn in black, with touches of other bright colours on white or red backgrounds. These patterns are paralleled by painted wooden panels and carved brackets, later reused in situ or moved into the four high bays on the western edge of the northern prayer hall.

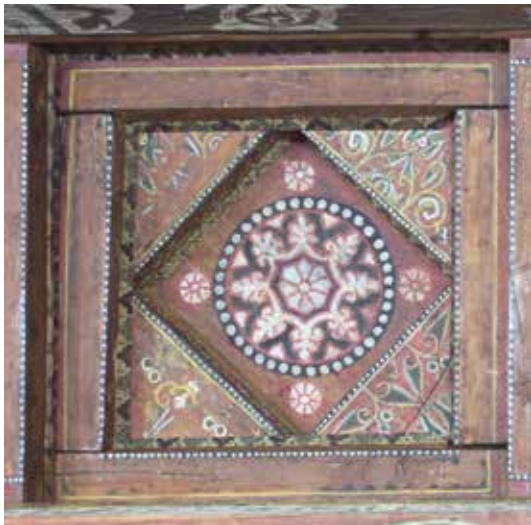
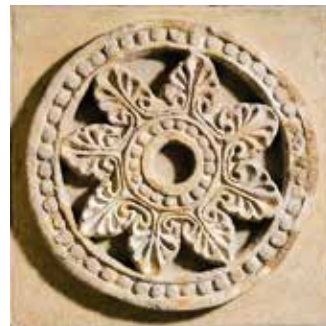
Fig. 4. Central coffer motif. northern prayer hall, first (qiblah wall) aisle.
On the right Sassanian stucco relief from Ctesiphon, Mesopotamia. 5th-6th c. (Metropolitan Museum).

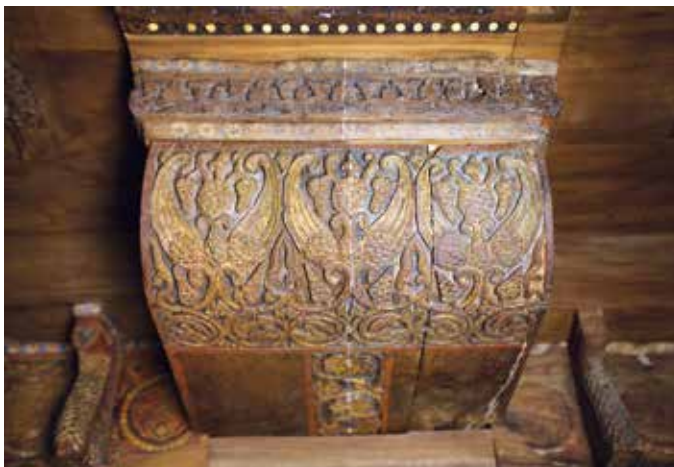
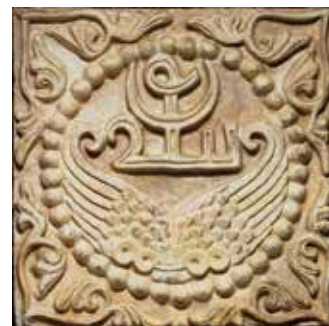
Fig. 5. Carved wooden brackets in one of the four raised ceiling bays on the western side of the northern prayer hall.
Inset: Sassanian stucco relief from Ctesiphon, Mesopotamia. 5th-7th c. AD (Berlin Museum).

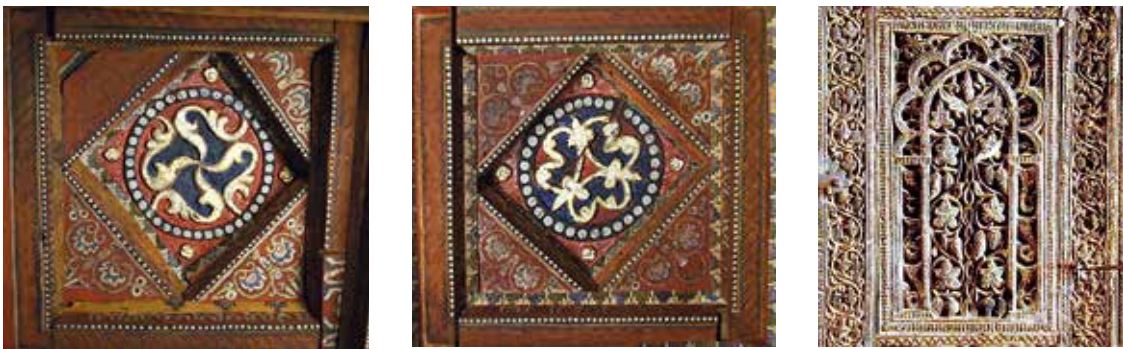
Fig. 7. Left: Typical painted decoration on coffers in the western prayer hall.
Right: Carved wooden decoration from the *minbar* of Great Mosque of Kairouan.

In some places these were later retouched, often incompetently or hurriedly. But occasionally the retouching was of high quality, in black lines of brushwork on a yellow ochre or blue background (Fig. 7).
