THE GREAT MOSQUE OF ŞAN'Ā'

Conservation intervention

(2005-2015)

FOUNDATIONS OF THE GREAT MOSQUE IN ŞAN‘Ā’

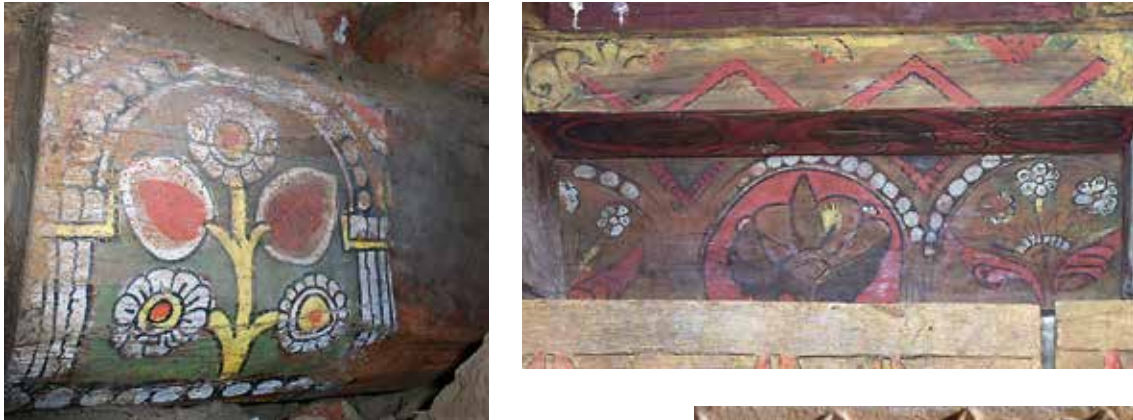
Fig. 8. Typical early Islamic painted decoration on the raised coffers in the first (qiblah wall) aisle of the northern prayer hall.

Inset right: Fragment of a Sassanian relief exhibited in the Metropolitan Museum, possibly 6th-8th c. AD.

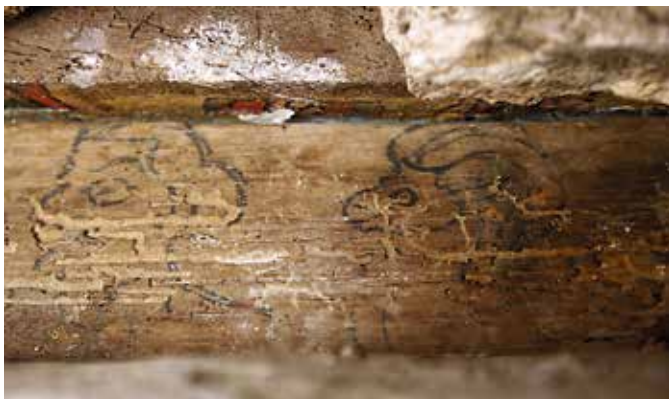
Fig. 9. Painted drawings on the hidden part of a beam in the north prayer hall.

Inset right: Fragment of a Sassanian relief.

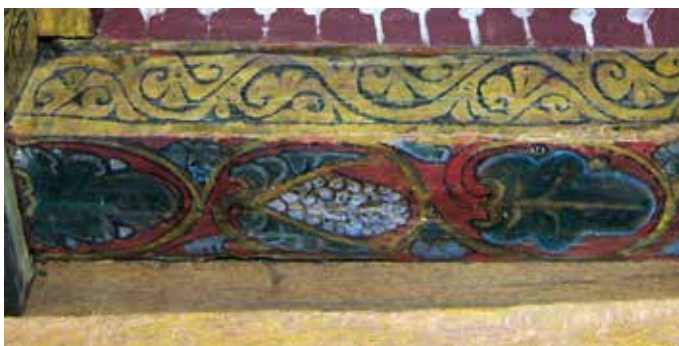
Fig. 10. Painted decoration on a beam in the northern prayer hall, first (qiblah wall) aisle.

Inset right: Fragment of a plaster wall mural, Samarra. 9th c. AD.

In other places, the motifs of the lowest two types of decoration was rather crudely copied by unskilled painters (Fig. 10).

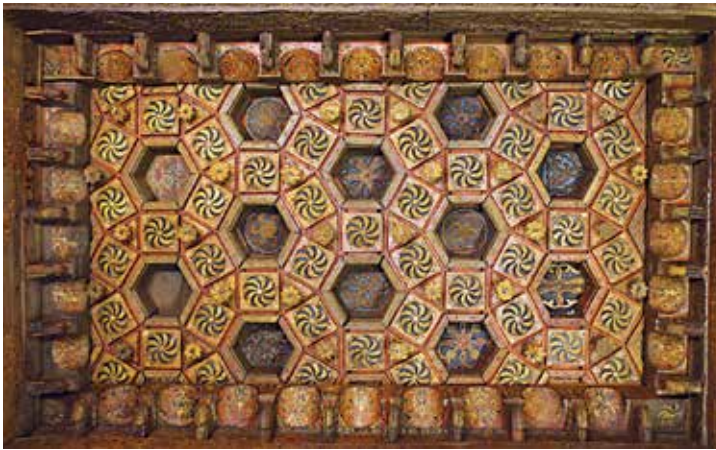
Fig. 11. Parts of early ceilings from two the four high north-western bays. Above: Part of a Roman mosaic floor (Conimbriga, Portugal).

By contrast, at some time, probably under the Yufirids in the 3rd to 4th/9th to 10th centuries, completely different, more conservative styles apparently began to dominate the decorative work in the Great Mosque. These closely resemble styles of ceilings introduced in several different phases in the Mosque of Shibam-Kawkaban, the original capital of the Yufirids. The styles were derived from Hellenistic Greece and Rome, via Byzantium. They were characterized by the use of elaborate geometrical patterns, predominantly based on circles and squares – which had become symbolic in meaning for the monotheistic religions (Figs 11-12).

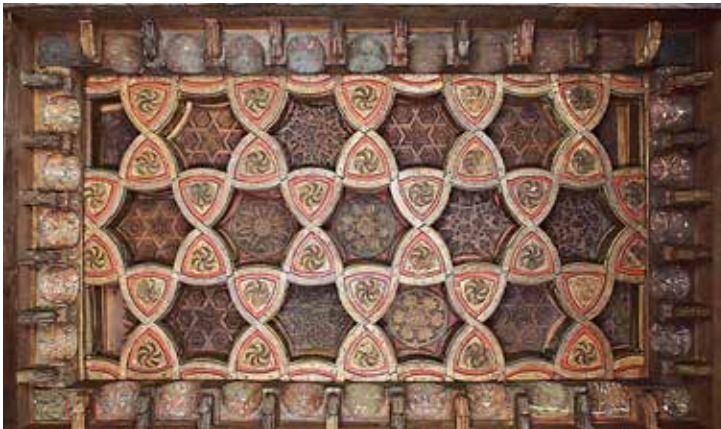
Fig. 12. Parts of early ceilings from two the four high north-western bays. Above: Part of a Roman mosaic floor (Palestine).

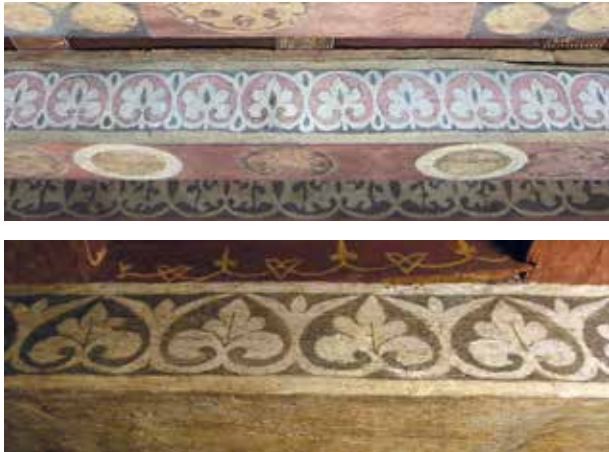
Fig. 13. Painted decoration on the side of a beam in the northern prayer hall, first (*qiblah* wall) aisle. Inset above: Decoration on the inside rim of a bowl from Nishapur, Khurasan. Early 10th c. (Metropolitan Museum, NY.)

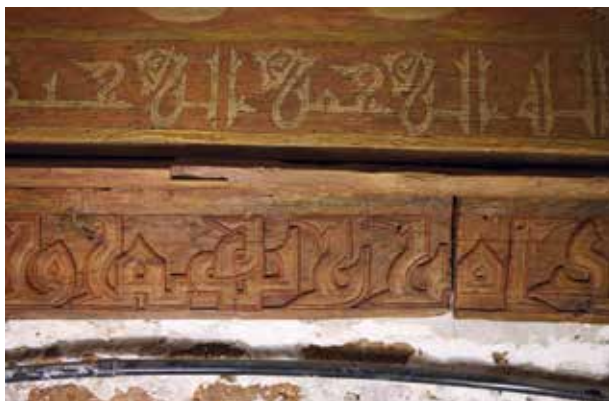
Fig. 14. Painted decoration on a beam in the second aisle of the northern prayer hall. Inset above: Three incised bricks from Nishapur, Kurasan; tentatively dated to 11th/12th c. AD. But the fine painted decoration here could well be earlier, as it also resembles decoration in al-Azhar mosque, Cairo, from the late 10th c. AD.

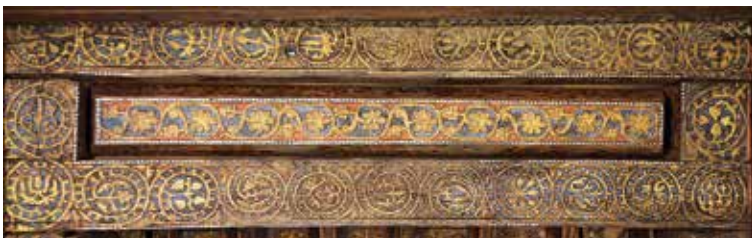
Fig. 15. Relief decoration in wood preserved in one of the four raised western bays of the northern prayer hall.

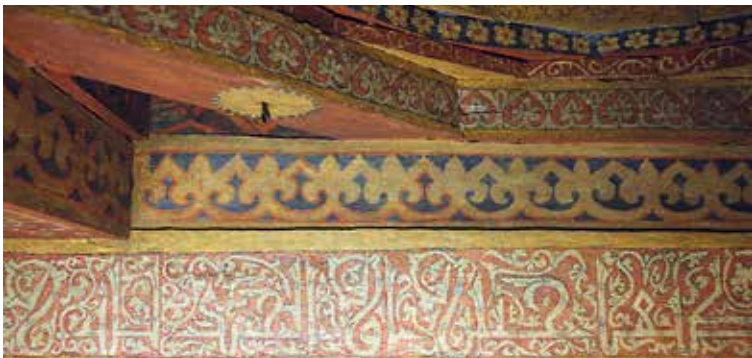
Fig. 16. Inscription on a beam in the second aisle of the northern prayer hall – characteristic of a number of inscriptions on beams painted and at about the same time.

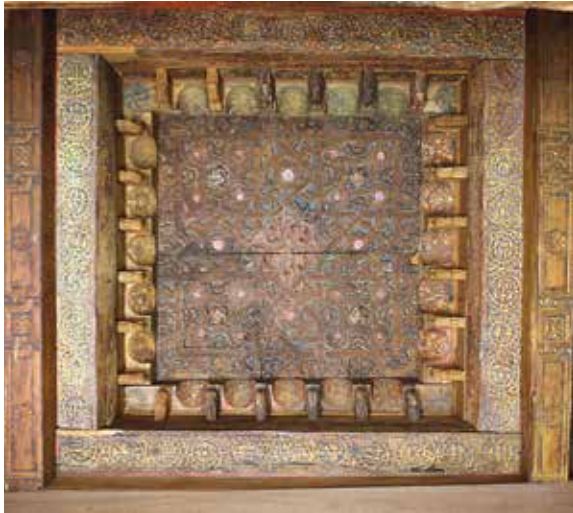
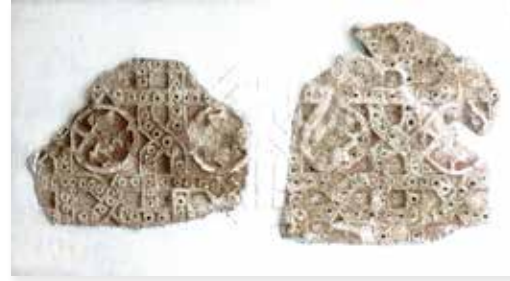
Fig. 17. Carved and painted wooden panel in one of the four raised western ceiling bays in the northern prayer hall.

Inset above: Fragment of stucco decoration from the Qal'a of Beni Hammad, Algeria. C. 398 H./1007 AD.

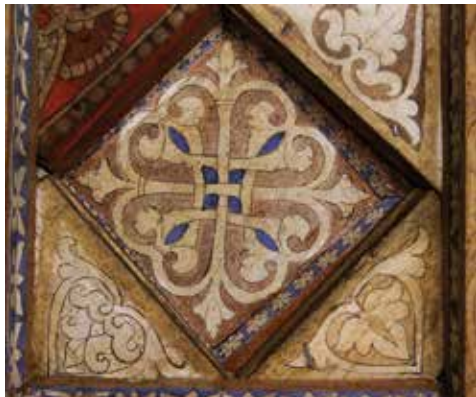
Fig. 18. Central panel decoration of typical design from the coffers of the western prayer hall.
Inset: Ceiling panel between the corbels of Bab al-Futuh, Cairo. 480 H./1087 AD.

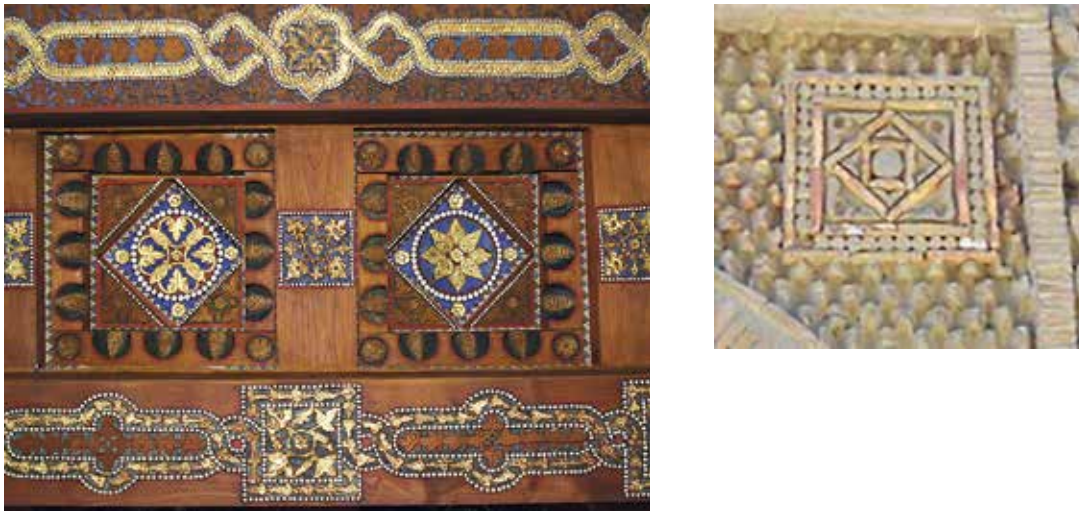
Fig. 19. General view of part of the ceiling in the eastern prayer hall, showing the square panels. Inset right: square panel from the facade of the Mausoleum of Samanid Ismail, Bukhara, end of 3rd / beginning of 10th c. AD.

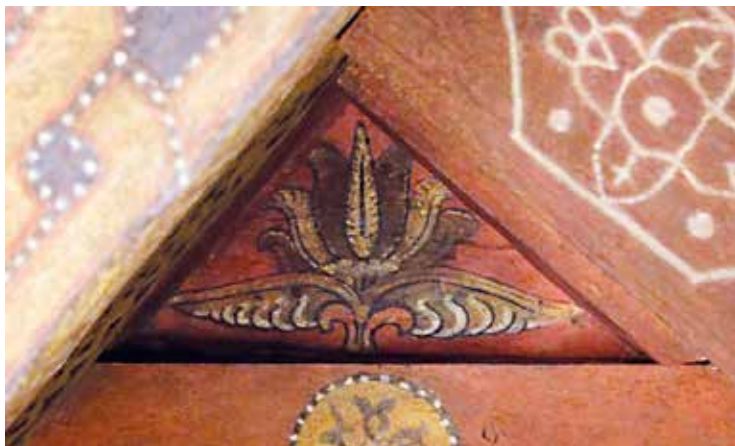
Fig. 20. Preparatory drawing - and apparently unfinished painted decoration - of fine Sassanian style, on a beam in the third aisle south of the *qiblah* in the northern prayer hall.

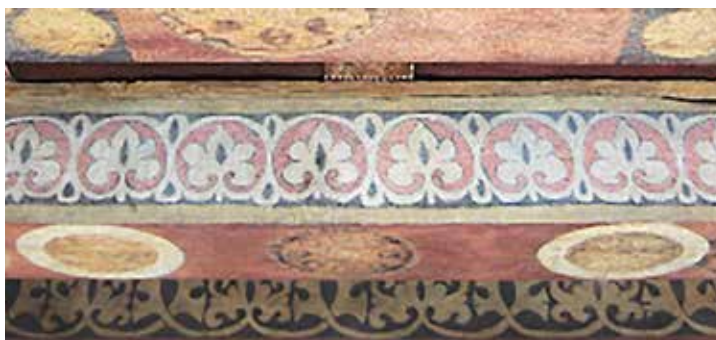
Fig. 21. Detail of painted decoration on a beam in the second aisle of the northern prayer hall. Inset above: luster-painted bowl. 4th/11th c. (Museum of Islamic Art, Cairo).

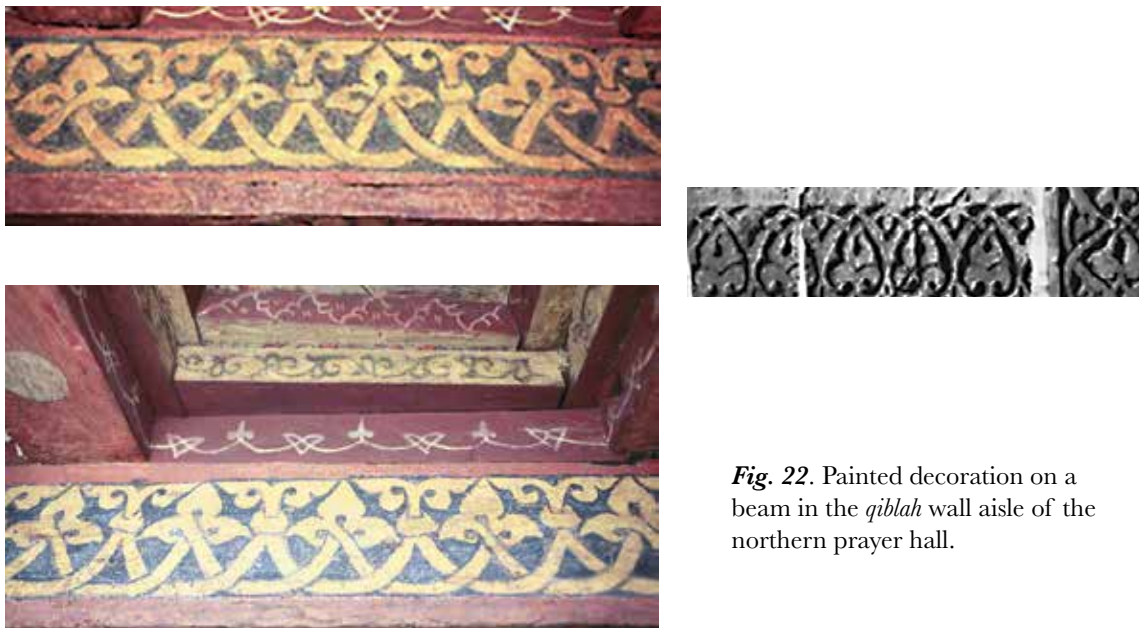
Fig. 22. Painted decoration on a beam in the *qiblah* wall aisle of the northern prayer hall.

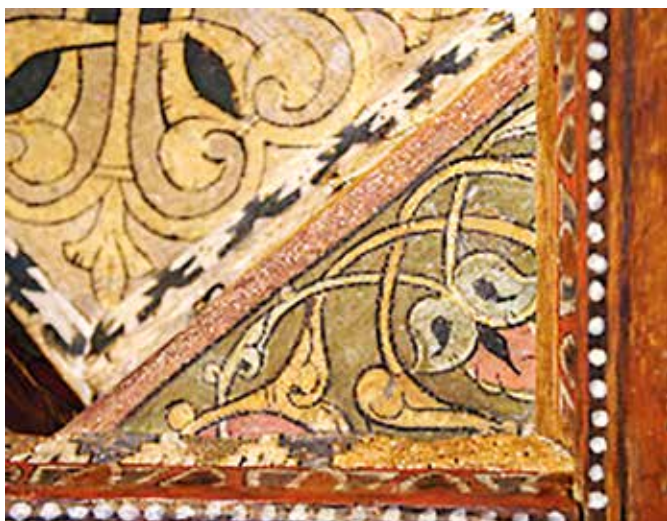
Fig. 23. One of the re-used fragments of painted decoration to be seen in some of the ceiling bays of the western prayer hall.

Inset above: pattern of the stone grillework from the Madrasa-Mausoleum of Salar and Sangar al-Gawli'. Cairo. 703 H./1303-4 AD.

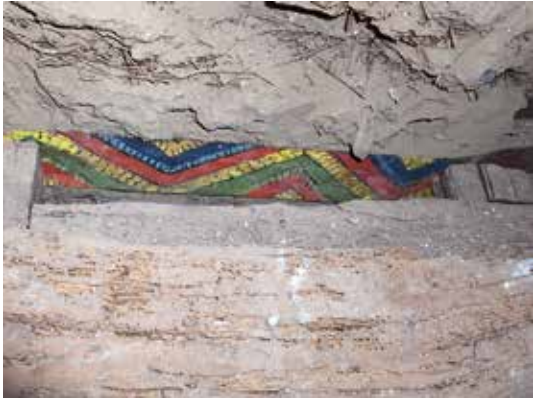
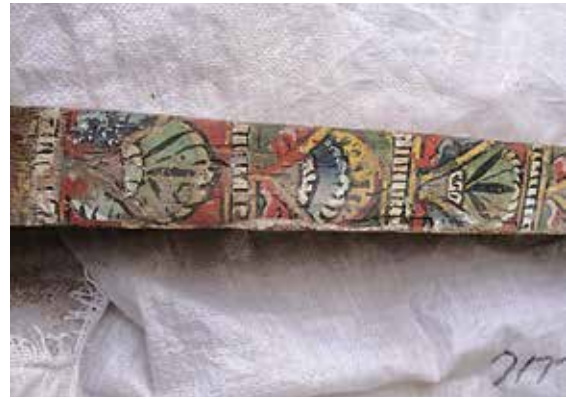
Figs 4a and 4b. Complete example of the first decorative scheme and its detail.

Although rebuilt and raised with respect to the contiguous aisles, the first aisle of the southern *riwāq* presents the first decorative scheme completely exposed and without

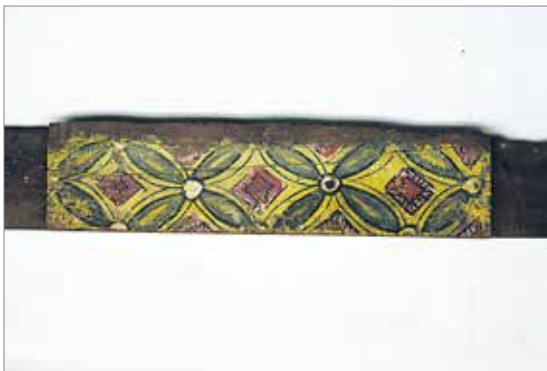
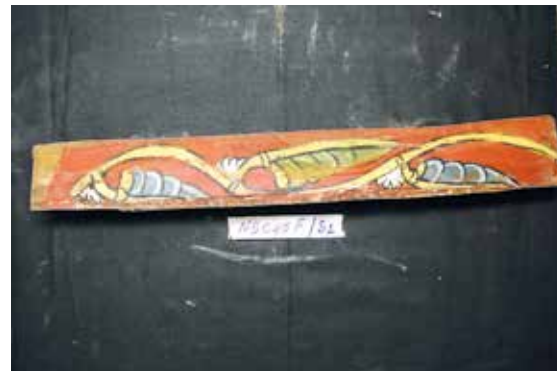
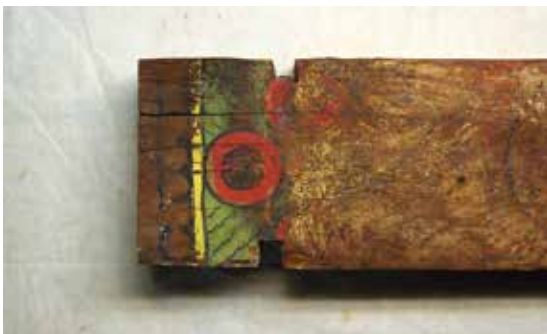
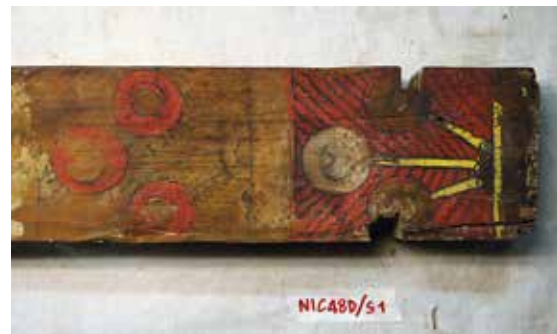
Figs 5, 6, 7 and 8. Examples of the first decorative scheme.

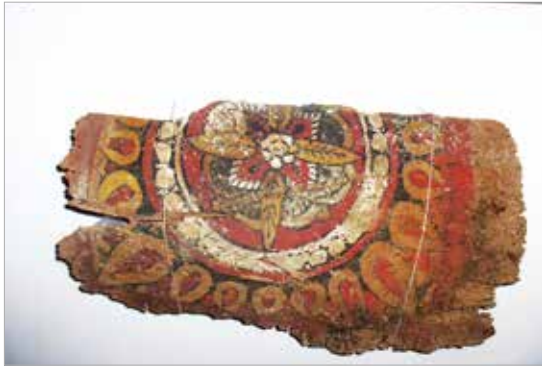
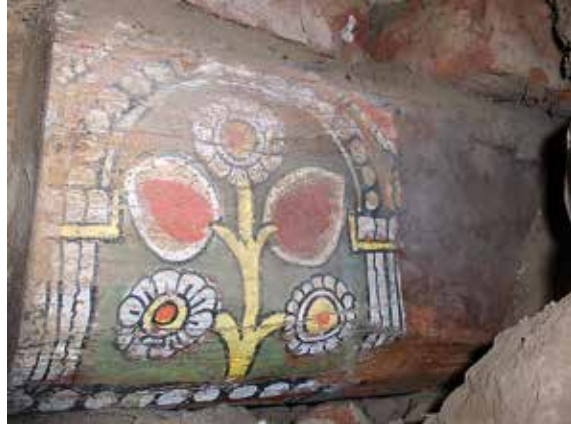
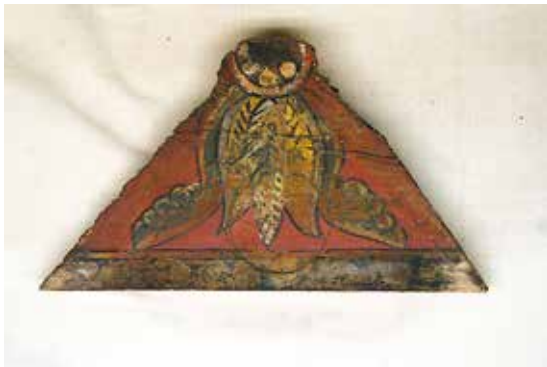
Figs 9, 10 and 11. Examples of the first decorative scheme.

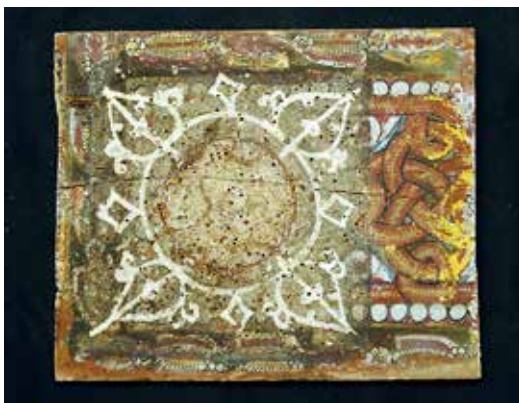
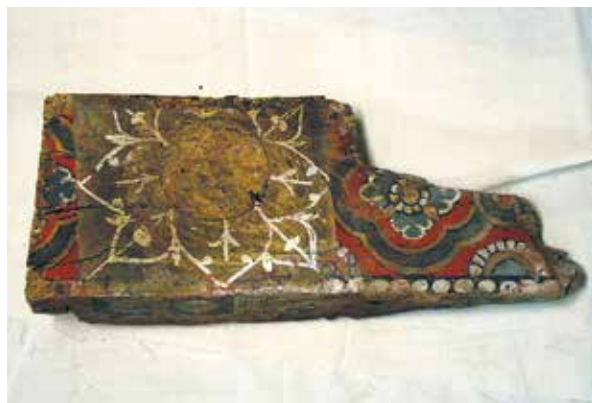
Figs 12 and 13. Examples of the first decorative scheme with second scheme overlapping.

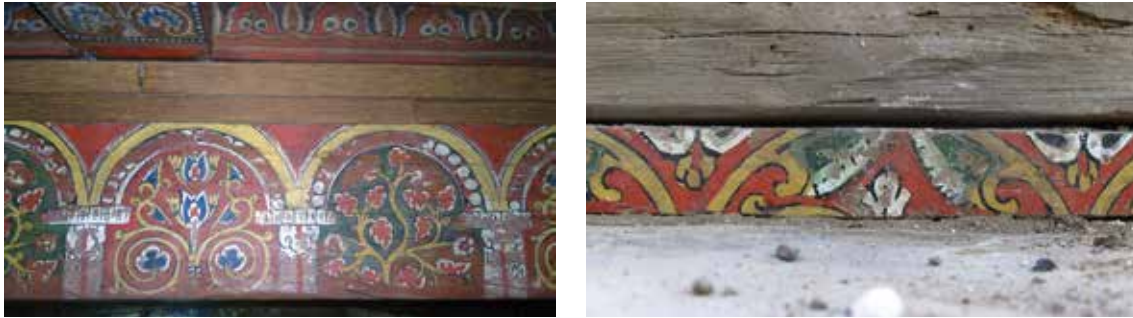
Figs 14a and 14b. Example of the first decorative scheme, TYPE B and its detail.

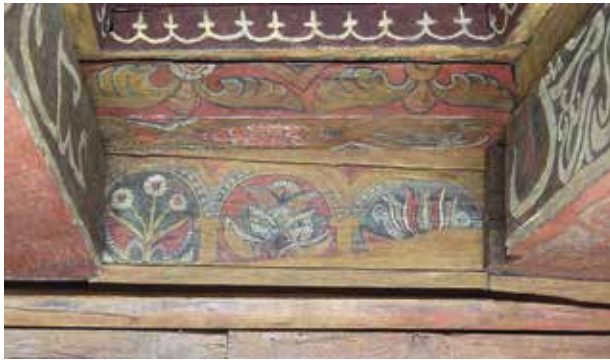
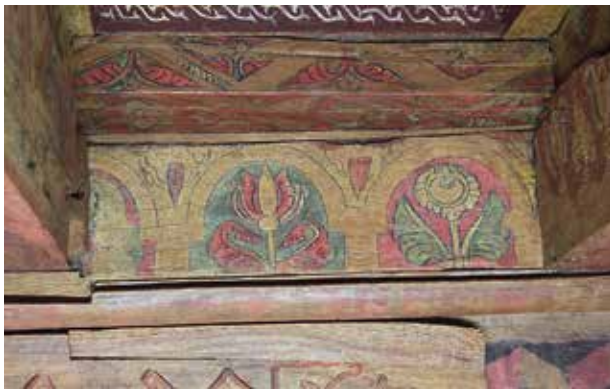
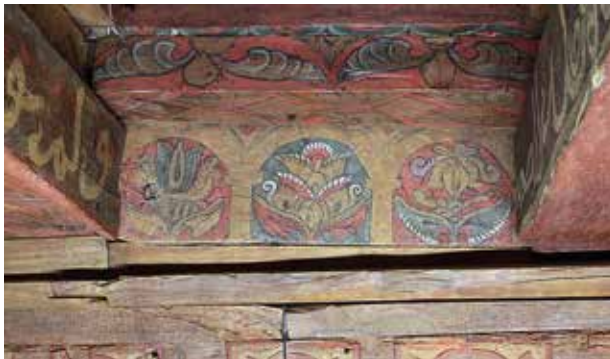
Figs 15, 16 and 17.
Examples of the first decorative scheme,
TYPE B.

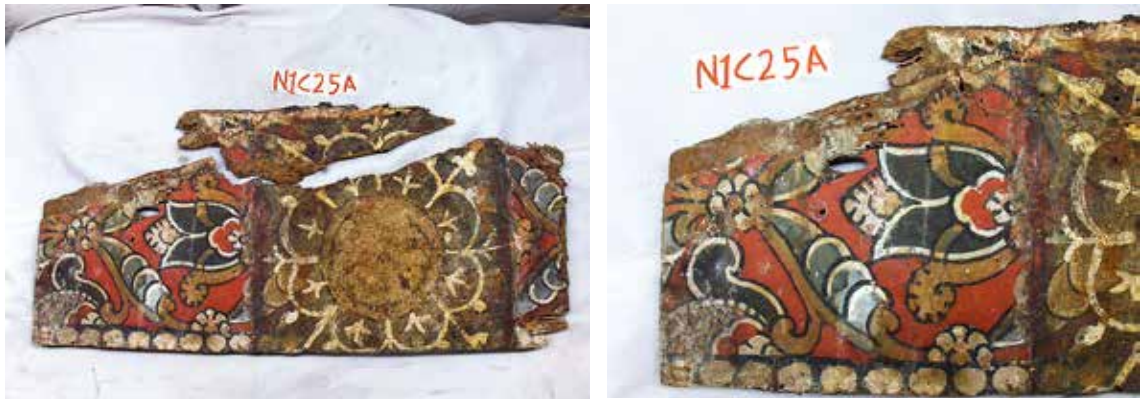
Figs 18a and 18b. Example of a board with the first decorative scheme, TYPE B, reused as closing panel for a coffer.

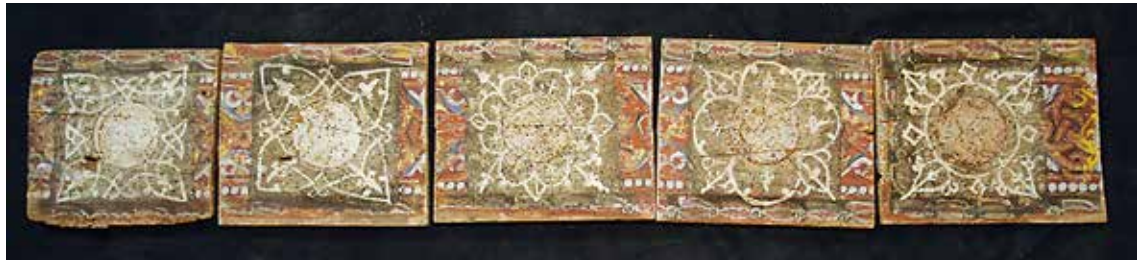
Fig. 18c. Example of reuse of a wooden board painted with the first decorative scheme, divided for the installation of the new coffer, and painted with the new motif.

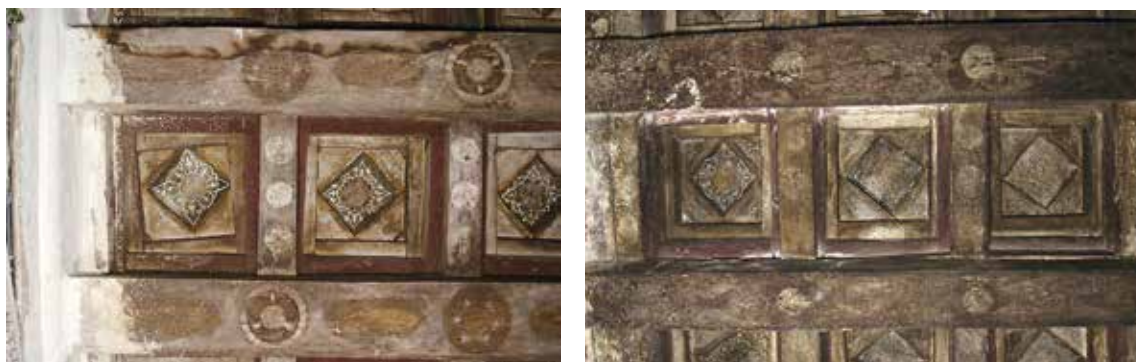
Figs 19 and 20. On the left a detail of the ceiling in the northern sector; on the right a detail of the southern sector.

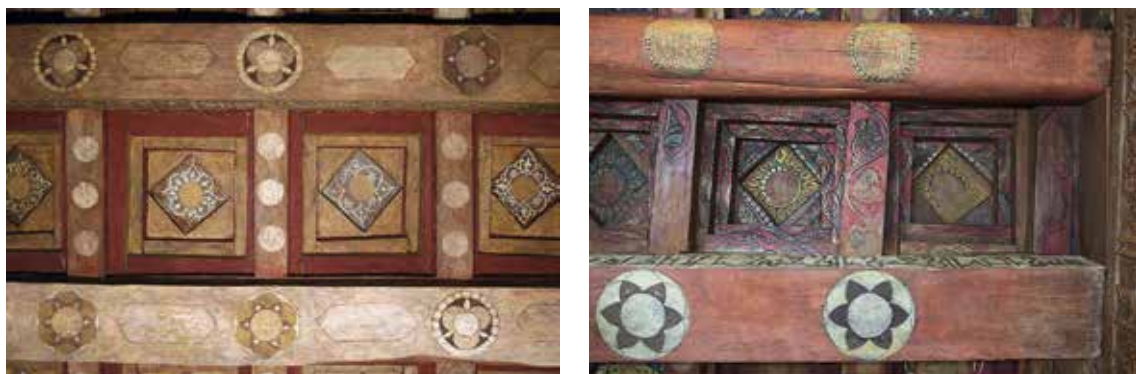
Figs 21 and 22. On the left a detail of the ceiling in the northern sector; on the right a detail of the southern sector.

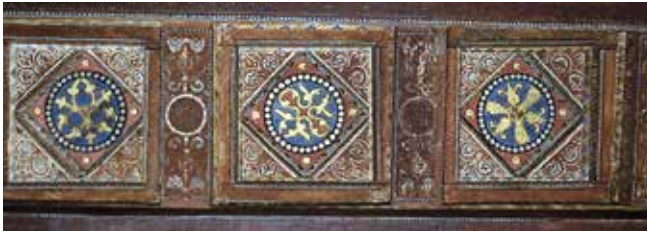
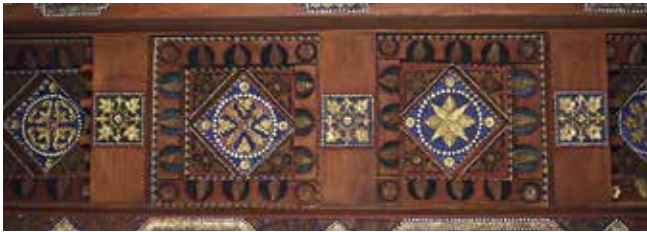
Figs 23 and 24. Above an example of decoration in the western sector; below an example of decoration present in the eastern sector.

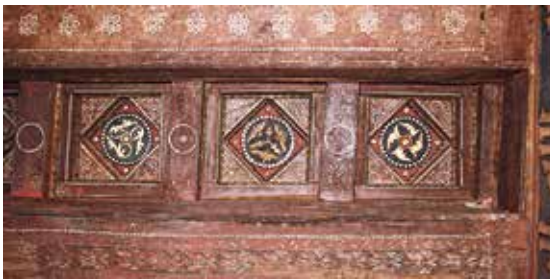
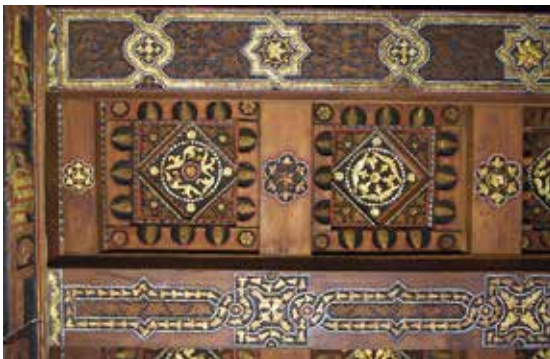
Figs 25 and 26. Above an example of decoration in the western sector; below an example of the present decoration in the eastern sector.

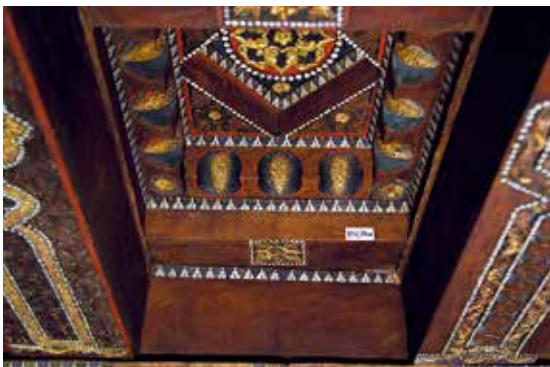
Fig. 27. Detail of a coffer in the eastern sector with carved golden pinecones on the first frame.

The eastern sector also dates back to this period but built with completely new material as the remaining timber from the demolition was insufficient. Precisely because new material was available, a new decorative scheme was created. The current decoration, albeit inspired by the one in the western sector, is characterised by the presence of the numerous gilded carvings on the underside faces of the beams.

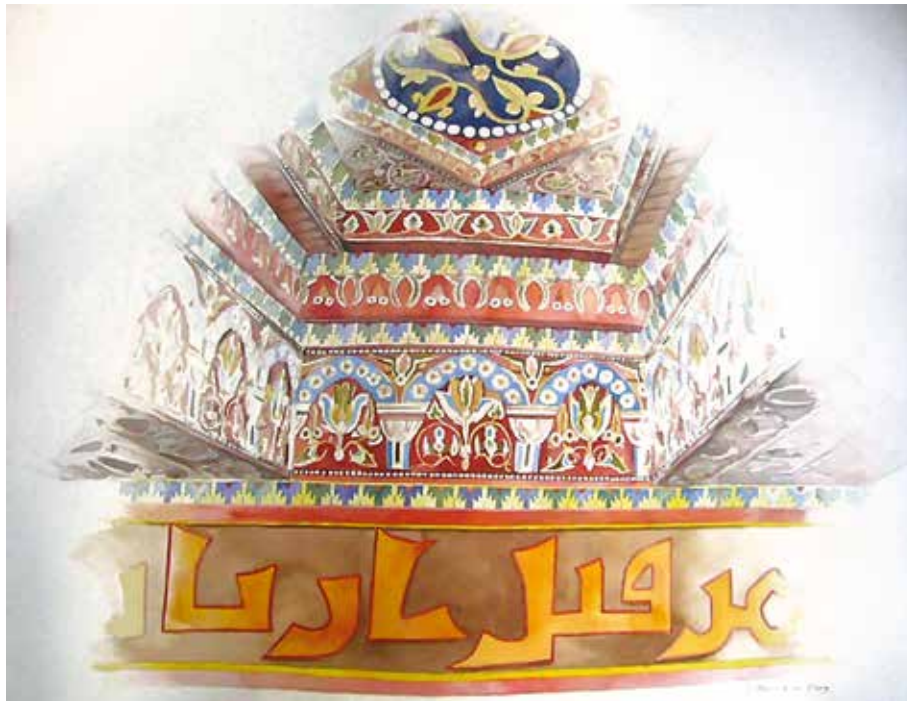
Fig. 28. Reconstruction of the decorative scheme present in the western sector (watercolor on paper, D. Ballarin, 2009).

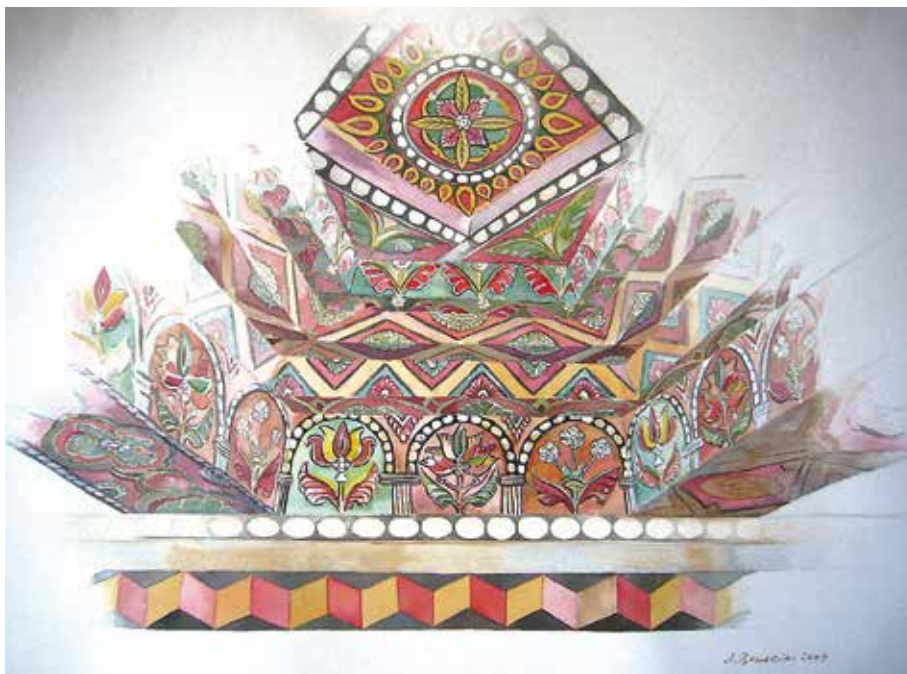
Fig. 29. Reconstruction of the first decorative scheme present in the northern and southern sectors (watercolor on paper, D. Ballarin, 2009).

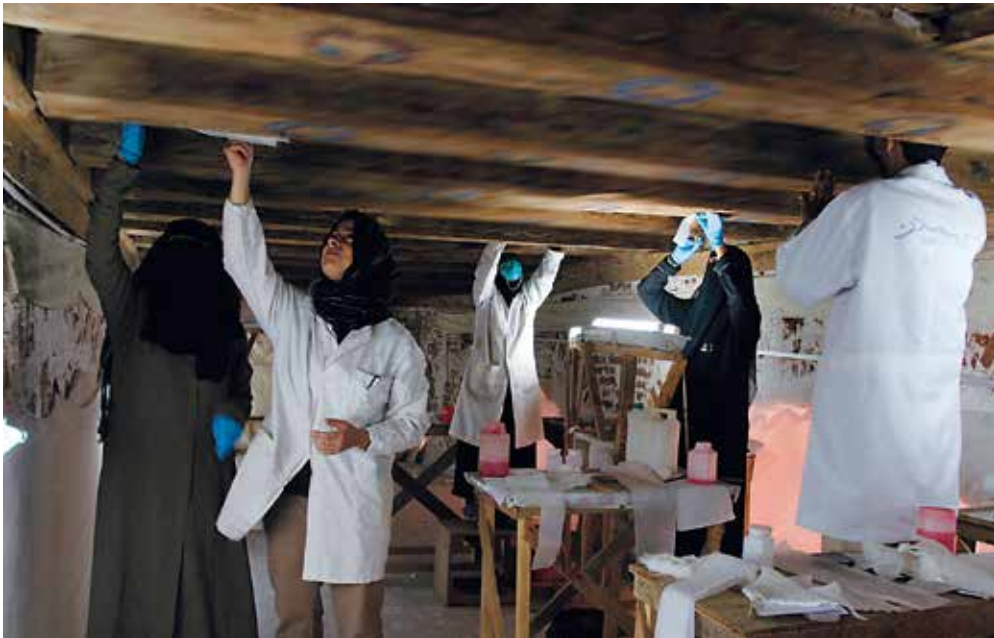
Fig. 6. The conservators team while working on the consolidation of the painted wooden ceiling.

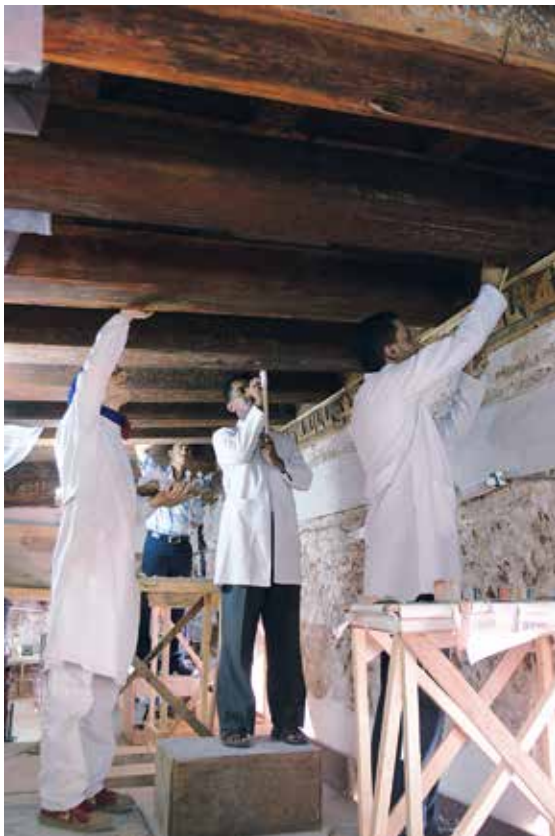
Fig. 9. Yemeni boys on scaffolding, engaged in the final stages of pictorial retouching of the wooden decorated surfaces.

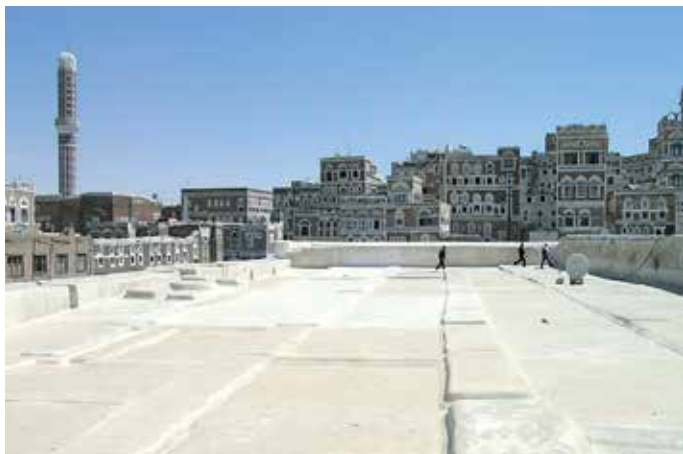
Fig. 4. View of the exterior surface of the mosque ceiling.

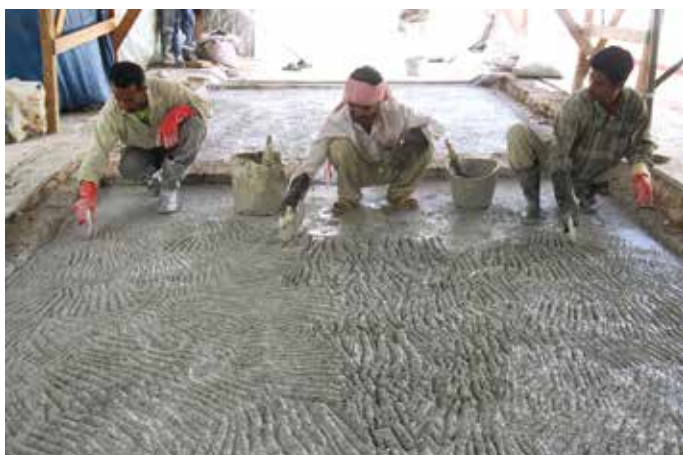
Fig. 5. Yemeni master intent on executing one of the drafts of the *qaḍād*.

Subsequently, the plaster is further finished by rubbing it with a flat stone until the surface is very smooth and shiny. Finally, the application of the final veil of animal fat gives the surface water-repellent characteristics.

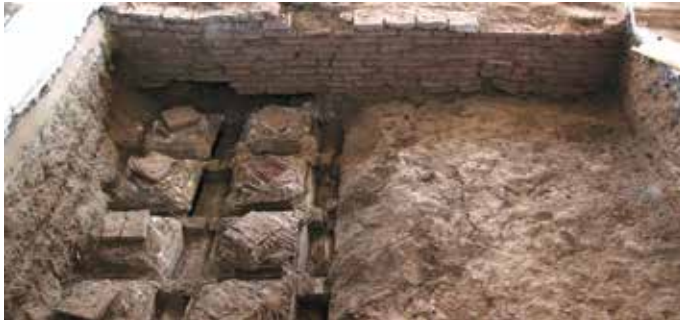
Fig. 6. Part of the open ceiling with the coffered panel exposed.

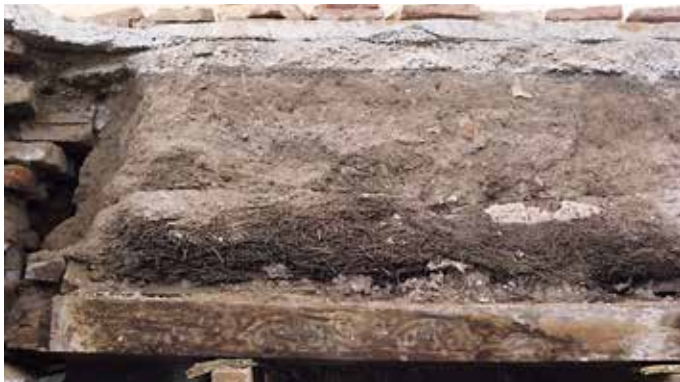
- The next layer consists of a thin bed of compact plant material, composed of branches, fagots and straw, which serves to prevent direct contact of the overlying earth with the wood of the coffering, and acts as a protective cushion to lighten the weight of the cover and probably also insulate the materials and spaces below from thermal excursions.

- With the surveys made at various points it was possible to calculate the weight on the entire thickness of ceiling which, although differing in various points of the roof, was proportional to the thickness of the layers, and amounted on average to 400-500 Kg/sq.mt. An incidental load such as one or two people per square meter in charge of

Fig. 7. Stratigraphic view of the ceiling cover.

maintenance walking on the roof, i.e., 150 Kg / sq.mt. was also considered. However, these values could significantly increase in the event of water seepage, due to wetting of the layers of soil.

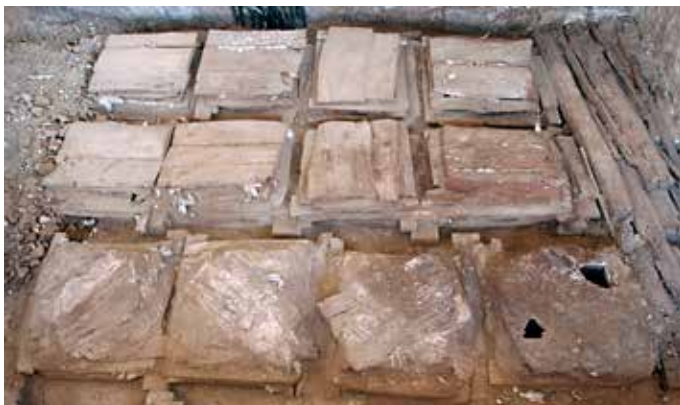
At the base of the ceiling, supporting the entire coffered system, there are large, sturdy supporting beams positioned transversely to the direction of the *riwāq*. The roof consists of more than 1200 such beams, measuring 14 x 22 cm, the length varying between 3.5 meters and 4.00 meters. The beams are spaced about 70 cm apart. The two ends of the

Fig. 8. Detail of the rear of the coffered ceiling, visible following the opening from the outside.

beams rest on the walls of the colonnades remaining embedded in the masonry for about 20/40 cm per side.

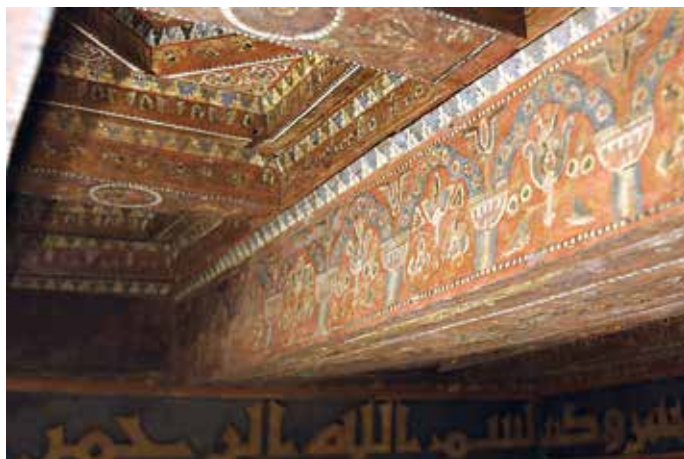
Fig. 9. Interior detail of the ceiling and coffer in the west sector.

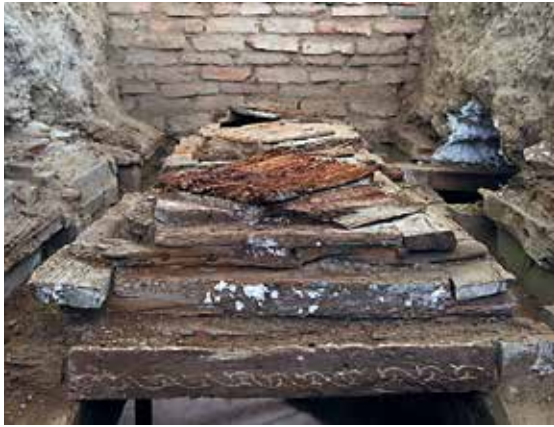
Fig. 10. Exterior detail of the “pyramid” formed by the elements of the coffering.

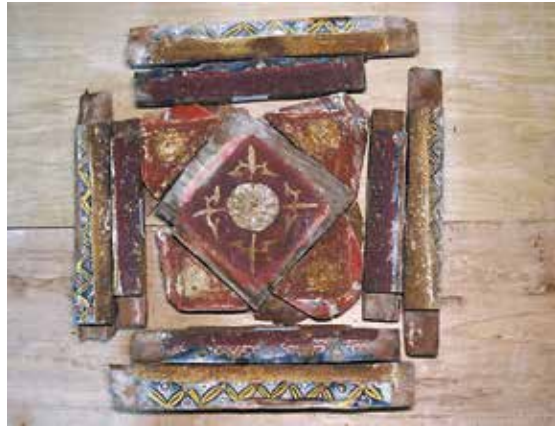
Fig. 11. A coffer in the north sector broken down into a counter.

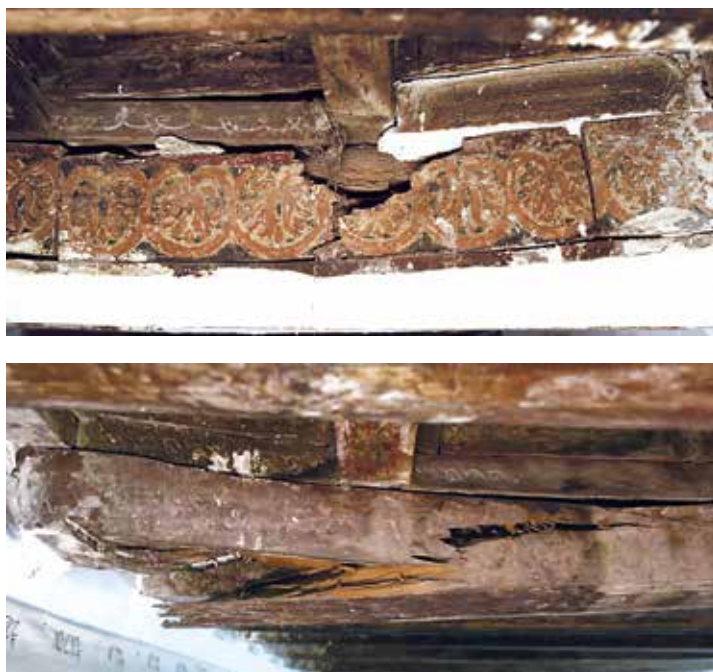
Figs 14 and 15. Examples of severe transverse beam fractures.

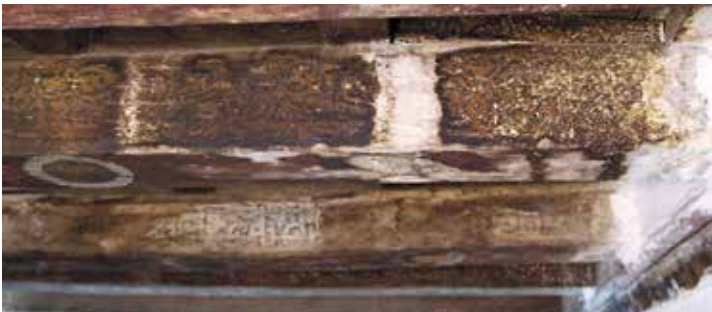
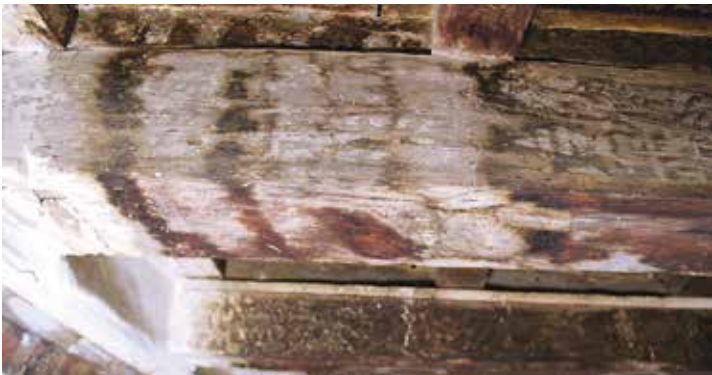
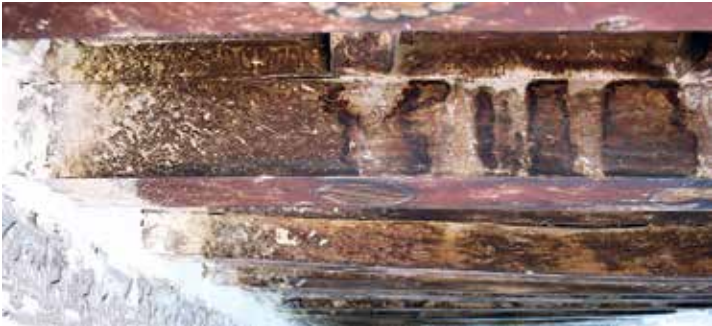
Figs 16, 17 and 18.
The images show one of the most common degradation factors of the wooden structure: water dripping with meteoric effect from the outside resulting in the washout of the pictorial matter and formation of white rot.

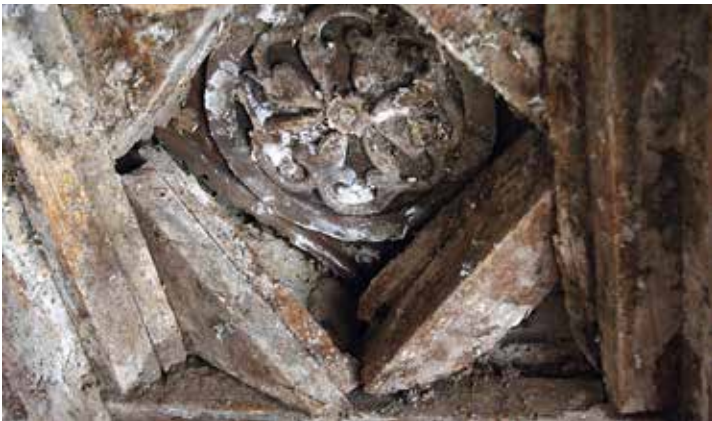
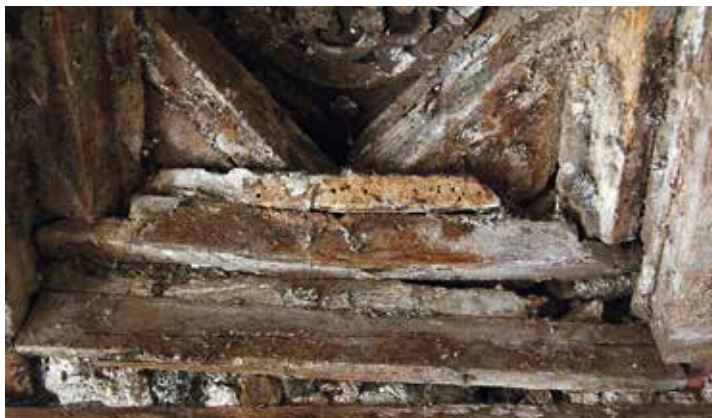
Figs 19 and 20.

Example of collapsed caissons due to infiltration of rainwater which weighed down the coverage material by weighing down the load.

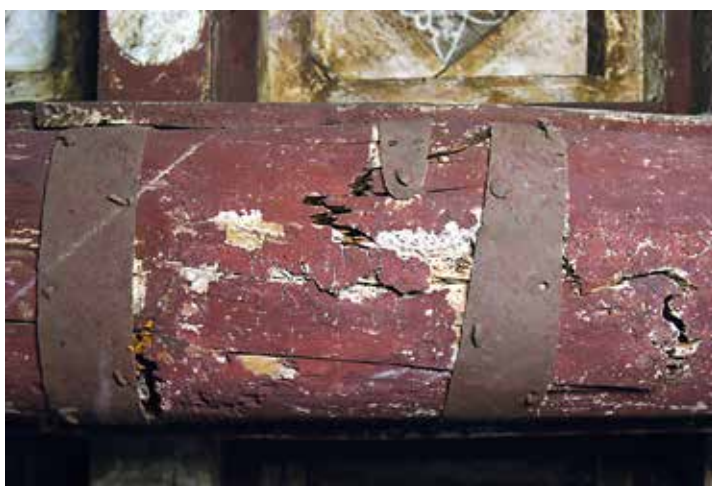
Fig. 21. Example of an old maintenance intervention that attempted to repair or avoid a complete fracture of the beam.

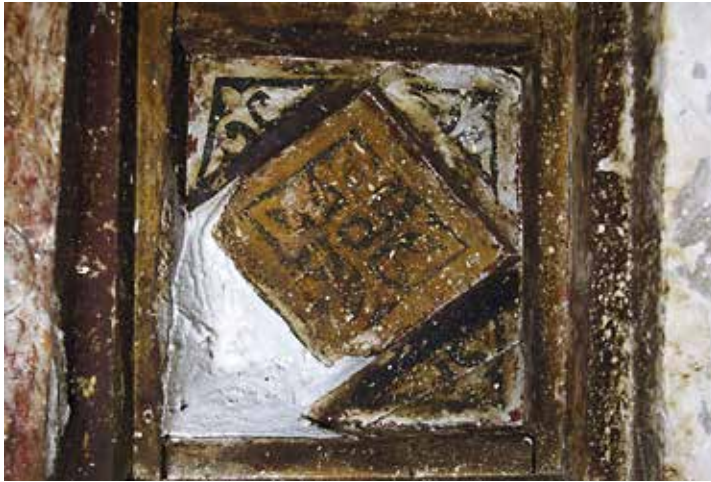
Fig. 22.
Example of an old maintenance intervention that fills the lack of one of the four triangles with one plaster grouting.

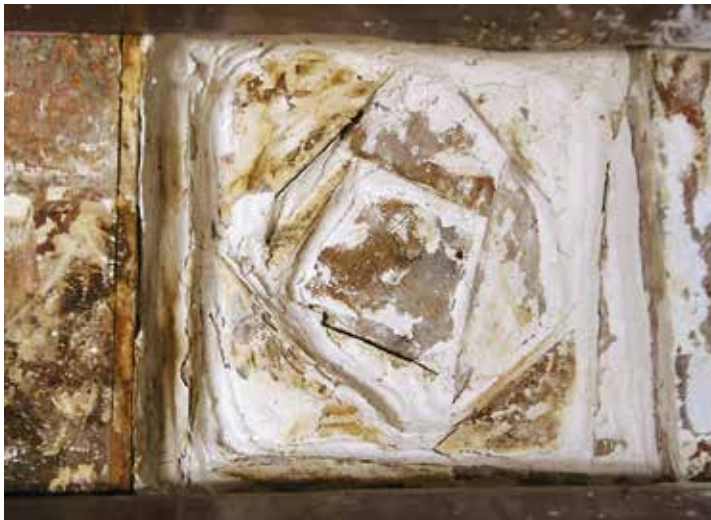
Fig. 23.
Example of an old maintenance operation where the coffer probably covered with plaster to fix and stabilize its unsafe elements.

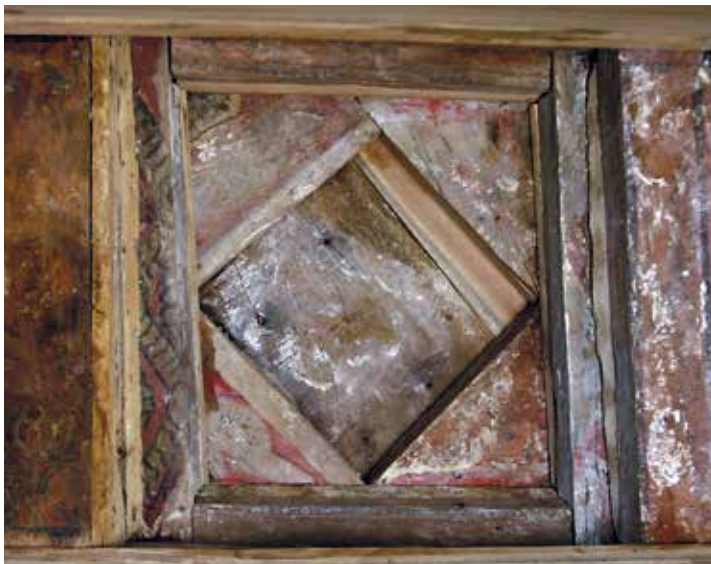
Fig. 24.
The same coffer in fig. 23, following cleaning and structural restoration.

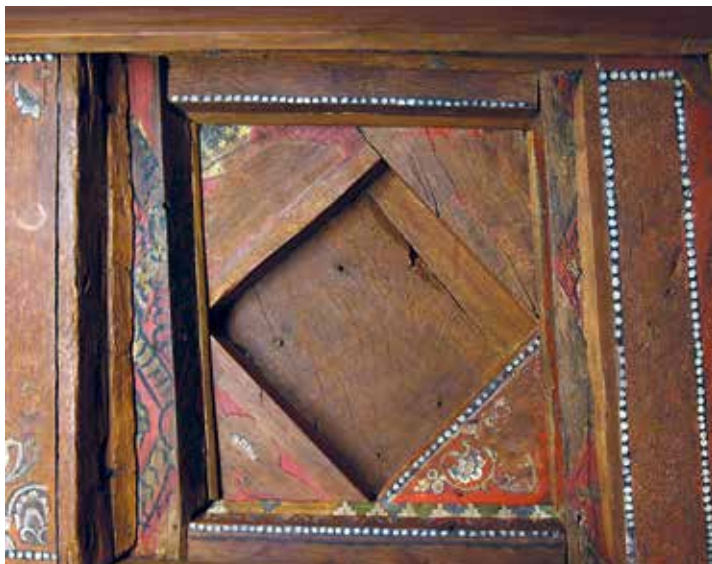
Fig. 25. The same coffer seen in fig. 23 and 24 after the restoration is completed.

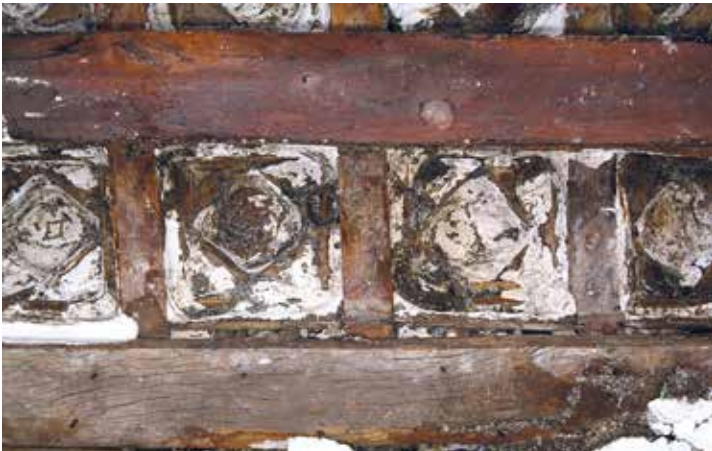
Fig. 27.
Detail of the west ceiling affected by an intense bird nesting action.
