THE GREAT MOSQUE OF ŞAN'Ā'

Conservation intervention

(2005-2015)

FOUNDATIONS OF THE GREAT MOSQUE IN ŞAN‘Ā’

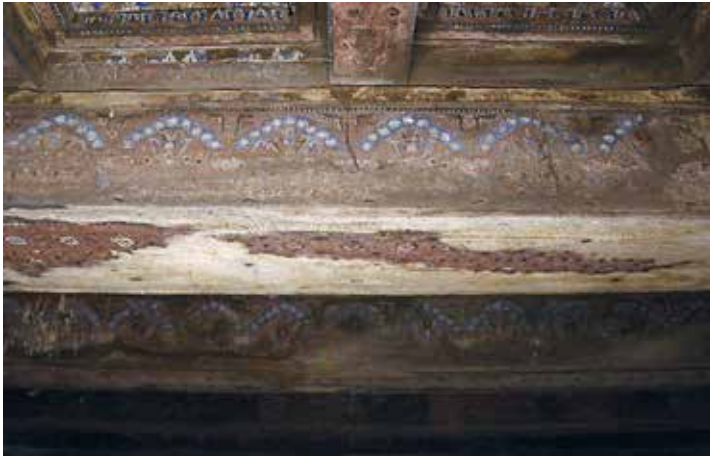
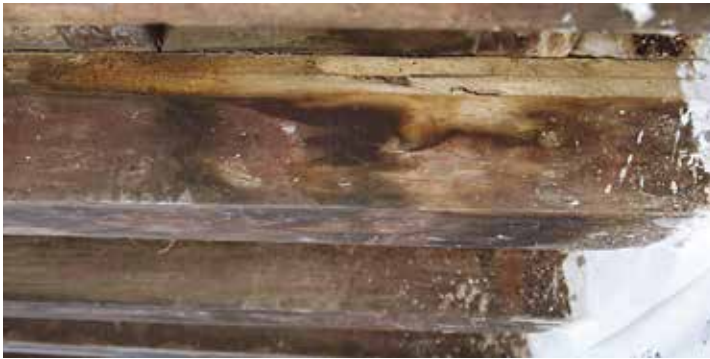
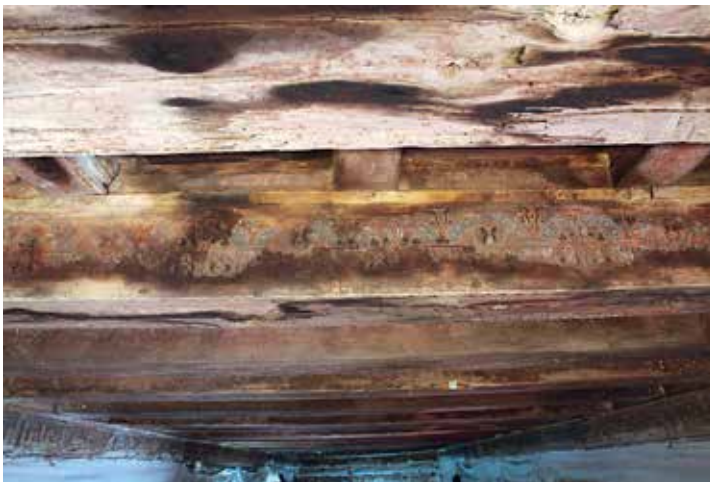
Figs 28, 29 and 30.

Examples of beams affected by the particularly destructive action of brown rot.

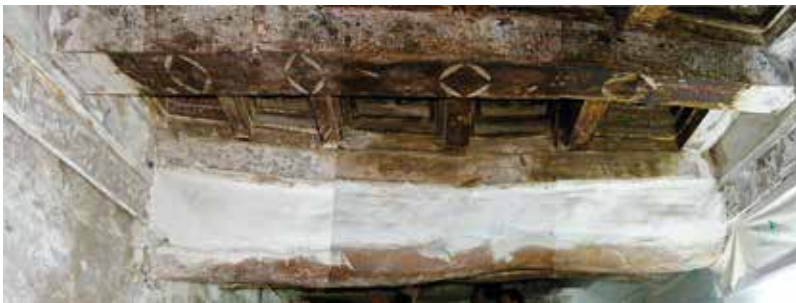
Fig. 2. Example of one of the most common types of maintenance work performed in the past to solve the problem of a fractured beam at risk of collapse.

The method chosen to reinforce the beams which, in keeping with the principle of conservation, appeared initially to be a rather complex process, was studied at length. Finally, it was decided to intervene from above, inserting steel girders (IPE 180 or HEA140 type profiles), previously painted and resting on the walls of the underlying arches, capable of absorbing the load of the roof above and relieving the damaged wooden beams of the weight, so that they no longer had to be replaced as they no longer performed a structural role. In fact, a framework of rafters will be placed transversely above the beams on which the roofing assembly will be reconstituted.

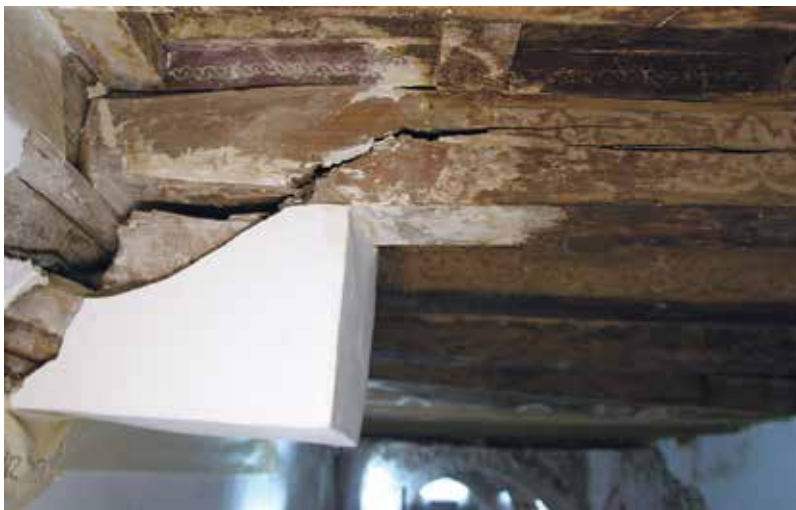
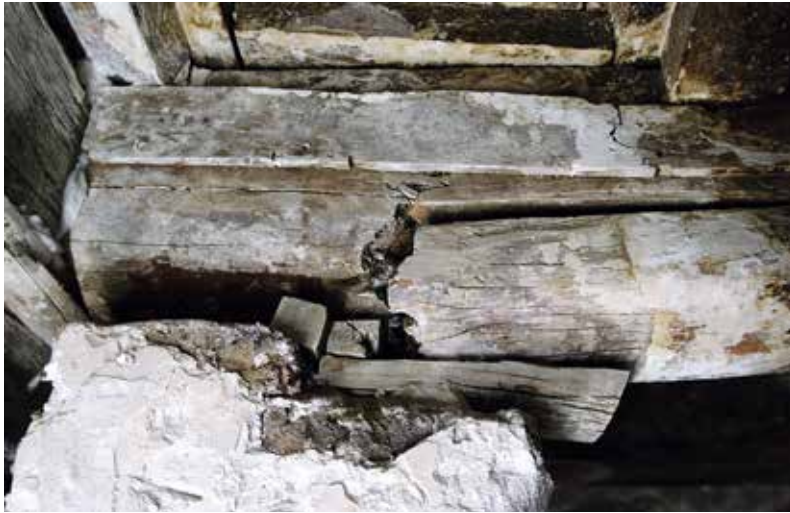
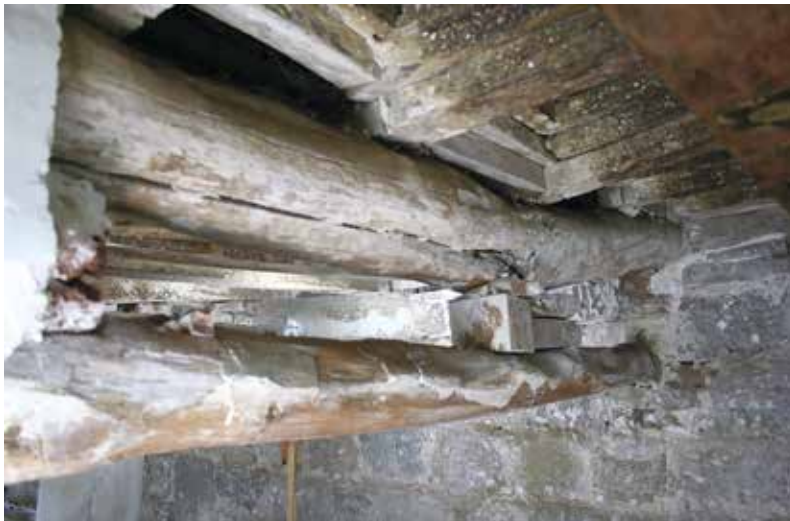
Figs 3, 4 and 5. Some examples of borderline situations of transversely fractured beams and the related past repair attempts.

A proposed intervention, alternative to the one just outlined and which would have been much simpler to implement, provided for the insertion of steel plates on the two side faces of the broken beams. In addition to the questionable esthetic effect, this type of reinforcement would not have fully guaranteed restoration of the load-bearing capacity due to the impossibility of extending the support of the profiles inside the walls, which would then be fastened only with lateral screws to the same broken beam.

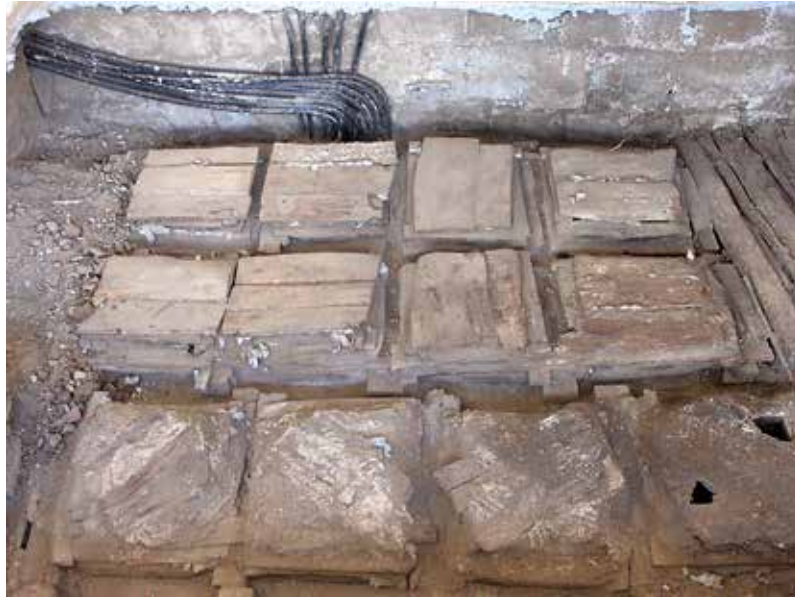
Fig. 6. The coffer free from covering material.

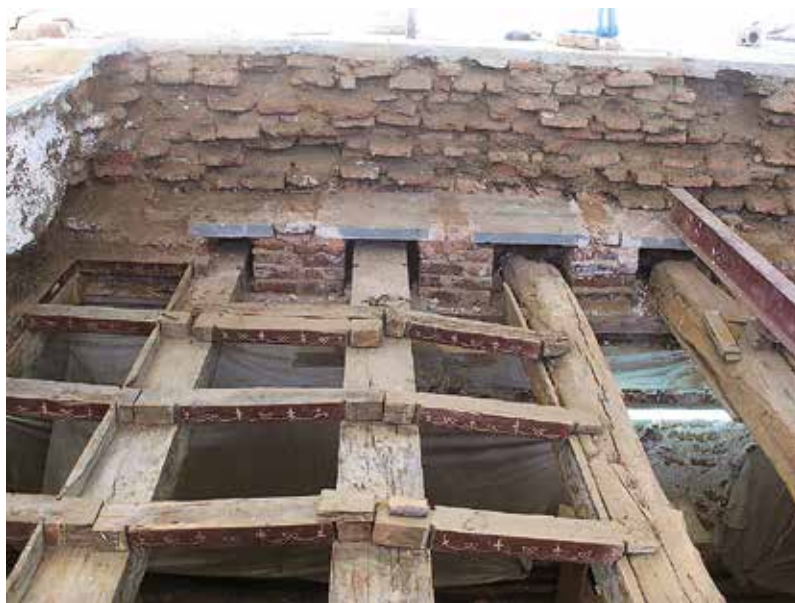
Fig. 7. The dismantled coffered beam and joist system is visible in the image.

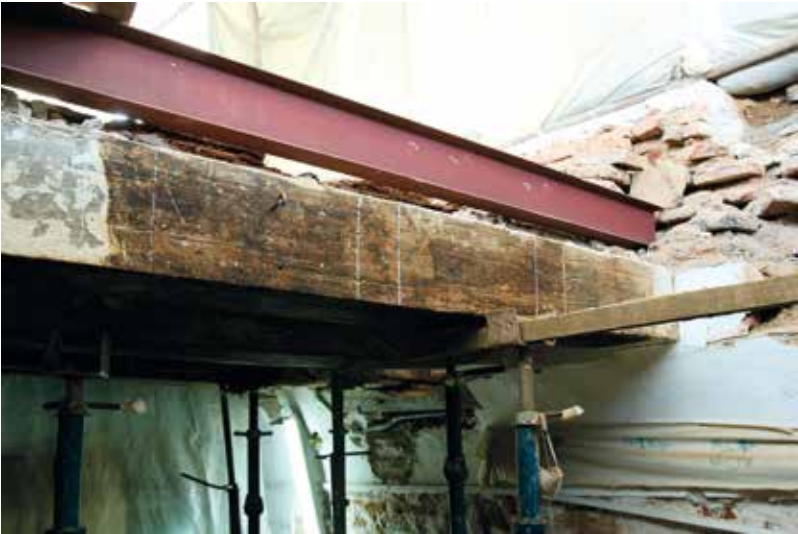
Fig. 8. Side view of a beam to which a support beam has been attached.

the coffer structure, the beam was fastened and an attempt was made, if feasible, to reduce the warping caused by the fracture, using steel rods threaded into a pair of steel beams, also supported and anchored to the load-bearing walls.

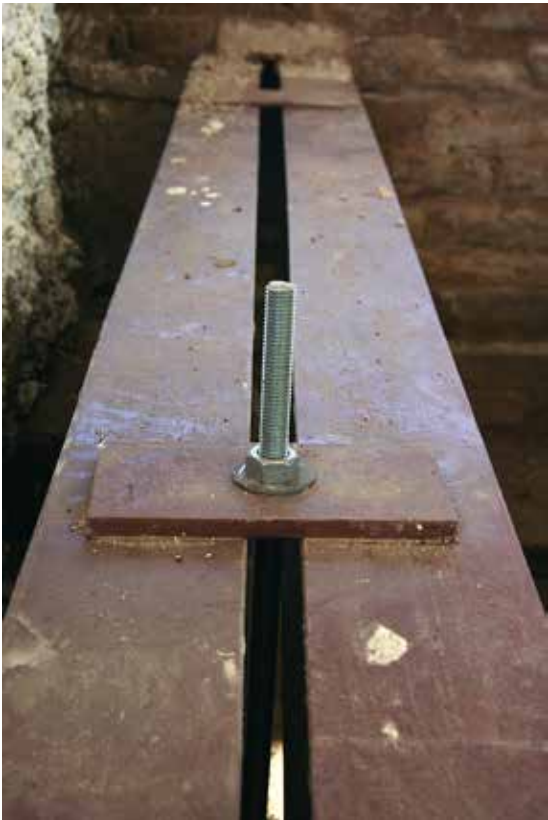
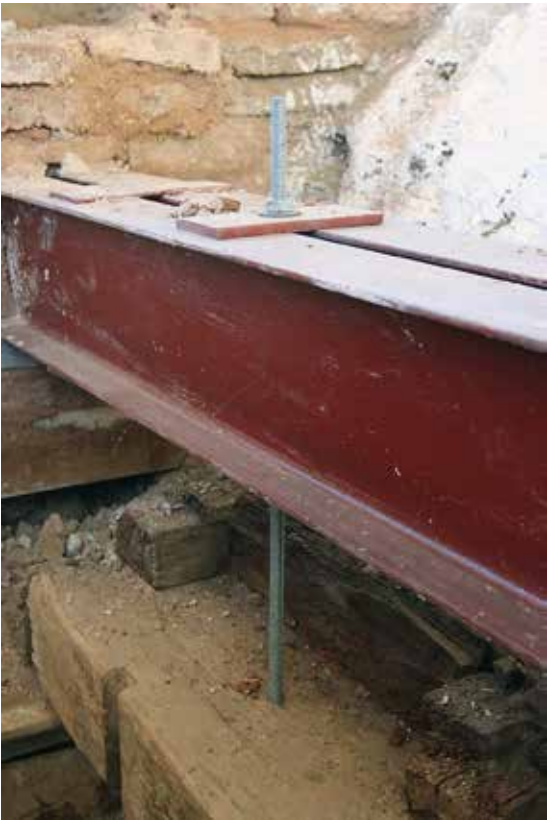
Figs 9 and 10. Detail of the threaded rod for coupling between the wooden beam and metal beams.

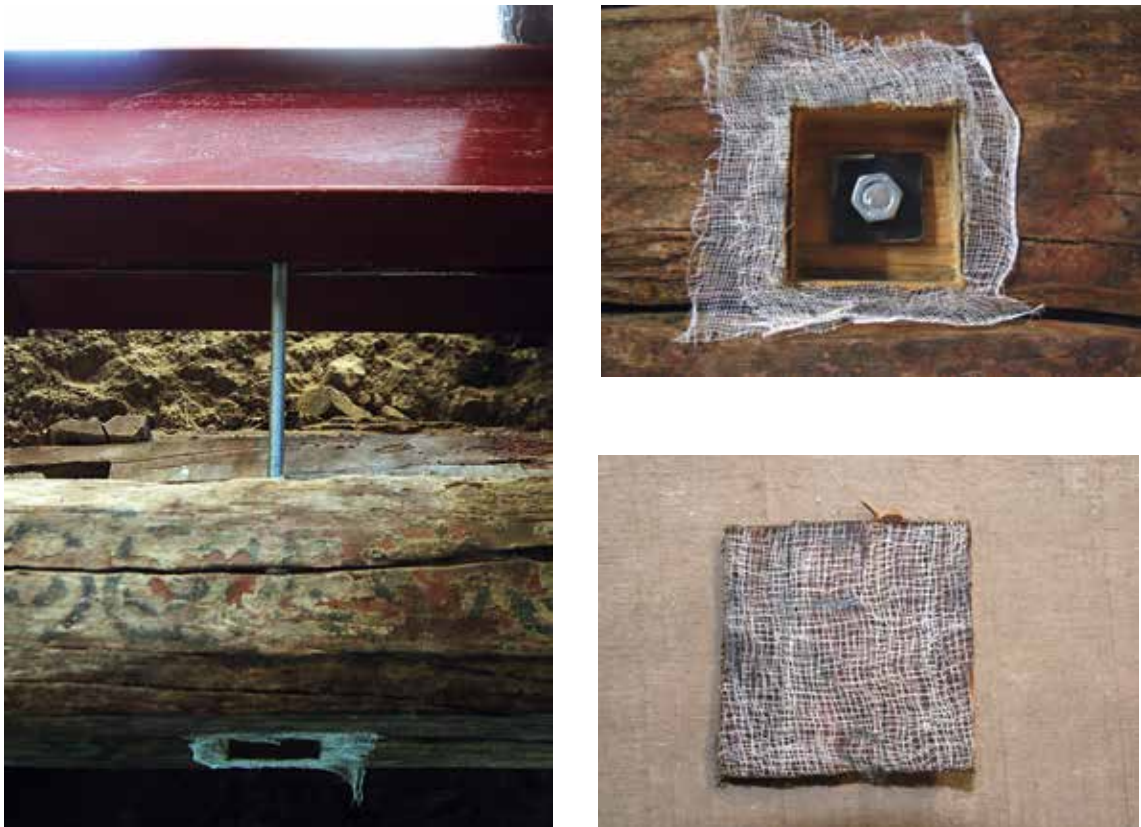
Figs 11, 12 and 13. Detail of the system used for inserting the hook bolt to the threaded tie rod.

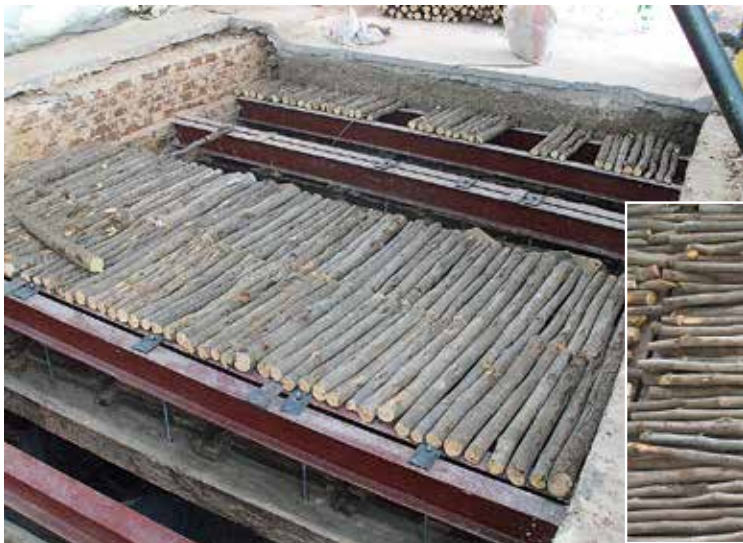
Fig. 14. First phase of closing the ceiling.

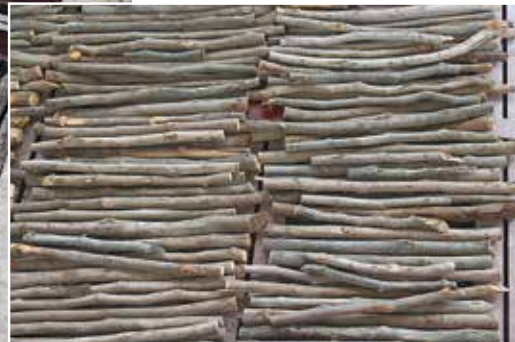
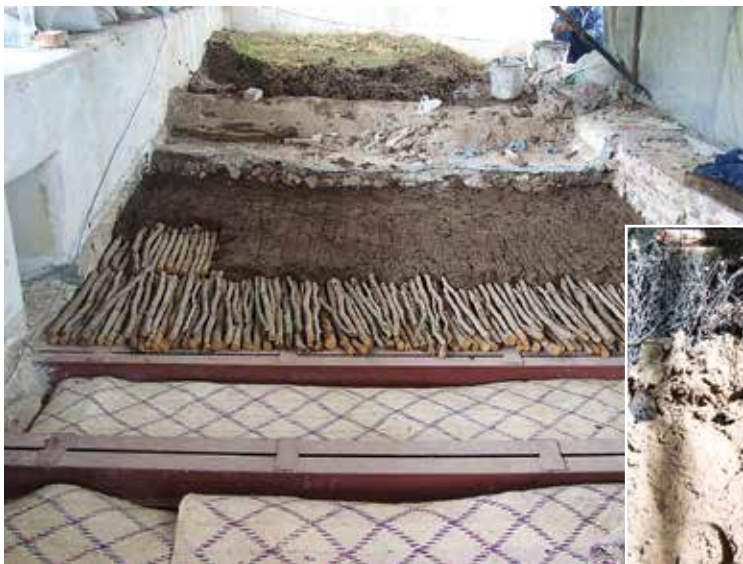
Fig. 15. Intermediate phase of closing the ceiling.

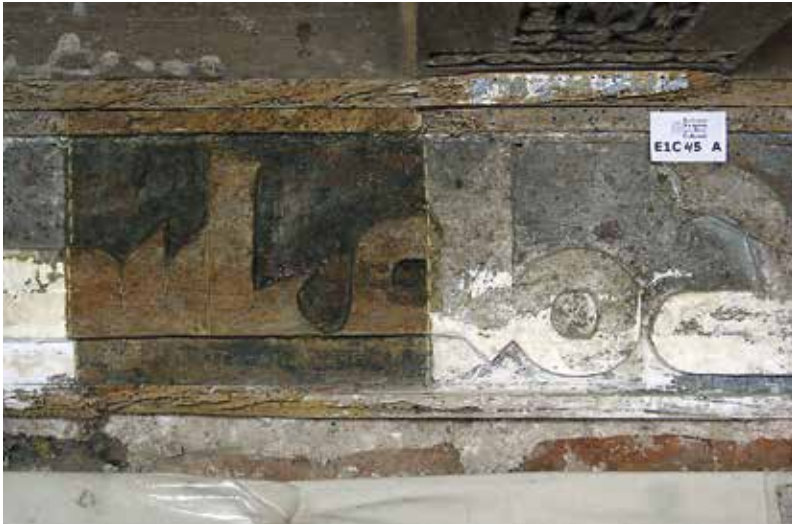
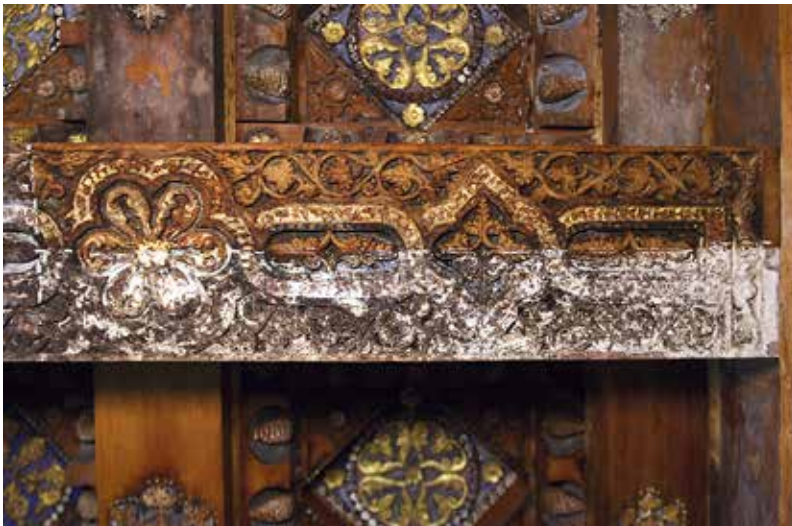
Figs 17 and 18. Some blocks and cleaning tests carried out in the eastern sector.

The adhesive used most is Klucel G, as it has the necessary adhesive power and, as a cellulose, is also the most respectful of the fundamental principles of restoration such as compatibility and reversibility. A second binder used was Aquazol 200, as it has good resistance to aging and high reversibility. Both materials were used in low concentrations.

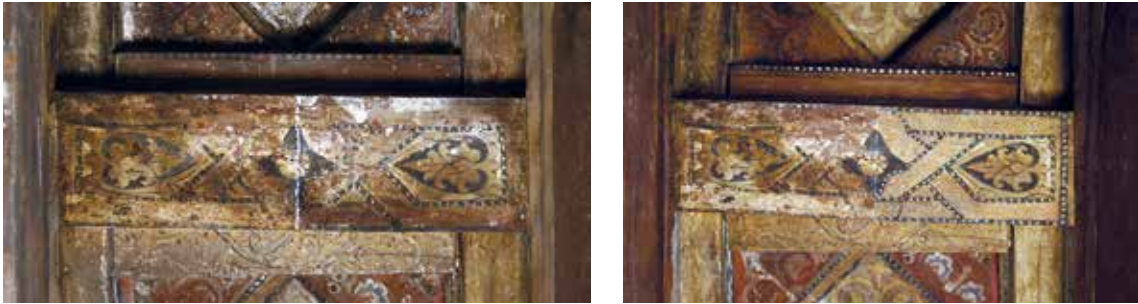
Figs 19 and 20. In sequence on the left, cleaning a tile, and on the right a pictorial integration test carried out on the same beam in the west sector.

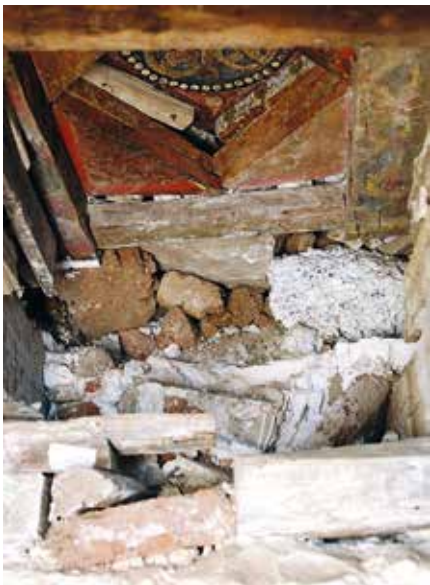
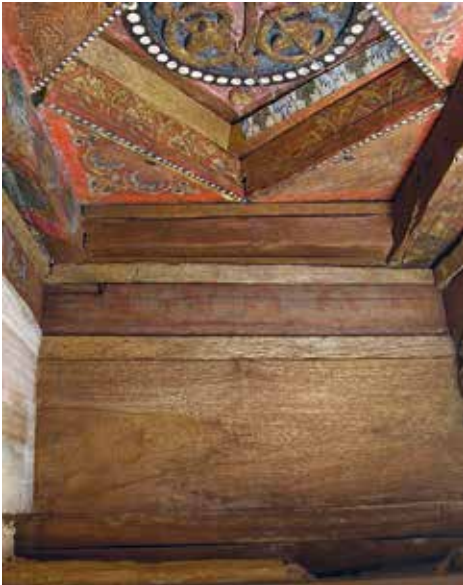
Figs 21 and 22. Before and after the renovation and restoration of the coffered ceiling in the western sector.

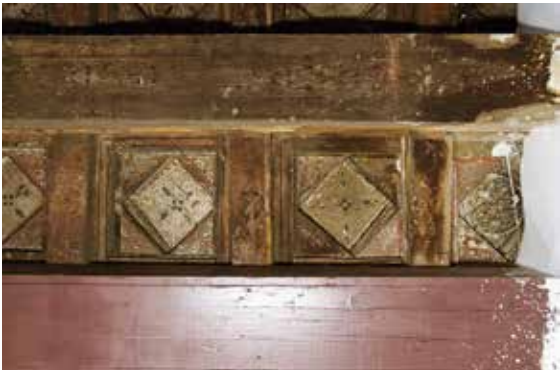
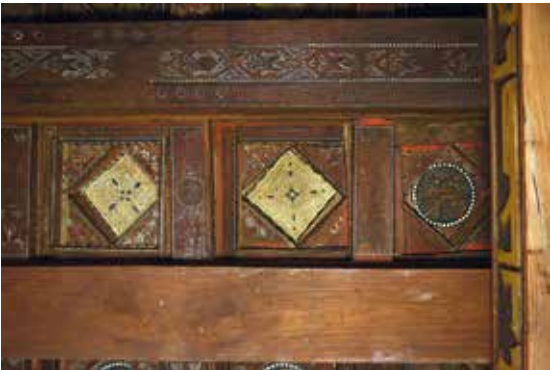
Figs 23 and 24. Detail of a portion of coffered ceiling, before and after the restoration. West sector.

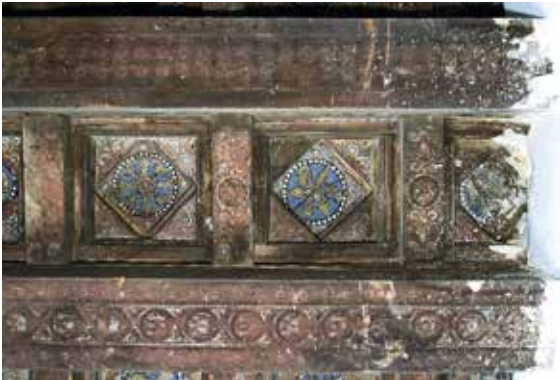
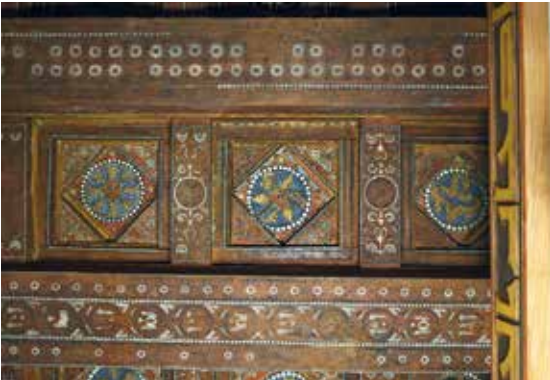
Figs 25 and 26. Detail of a portion of coffered ceiling, before and after the restoration. West sector.

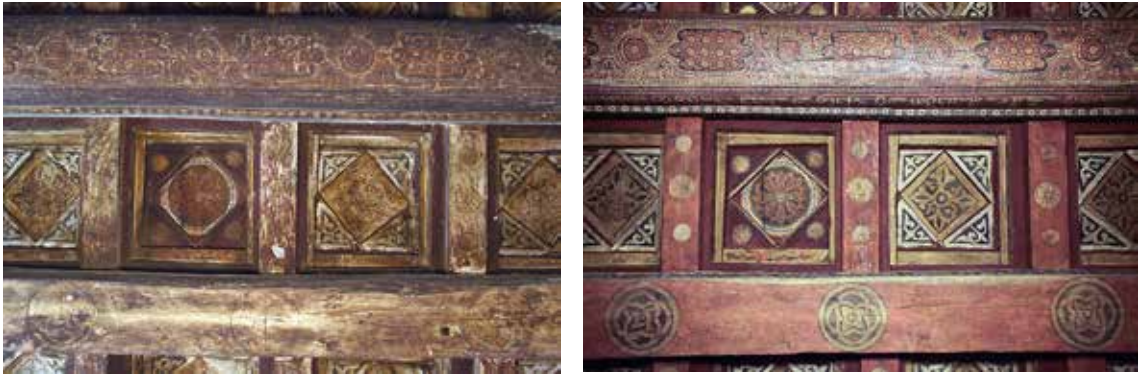
Figs 27 and 28. Detail of a portion of coffered ceiling, before and after the restoration. North sector.

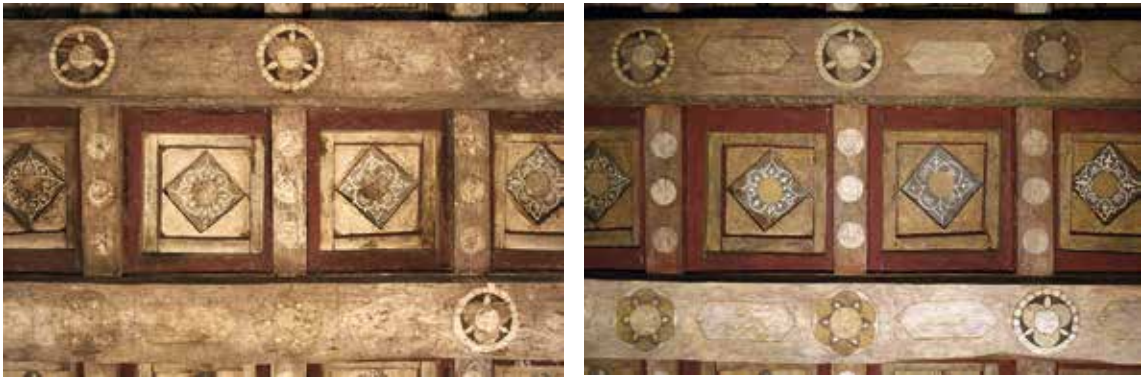
Figs 29 and 30. Detail of a portion of coffered ceiling, before and after the restoration. North sector.

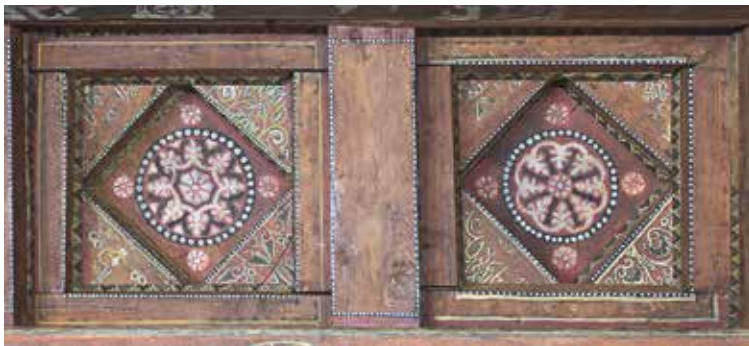
Fig. 1. This decorative typology is present in all the first six rows of coffers of the five northern sectors, those adjacent to the east sector. The structure has a top, four triangles and a single framing level. It can be assumed that some catastrophic events damaged this area which structurally represents a weak point of connection between the two north and east sectors. For the reconstruction of this portion, surviving wooden elements were used, and for this reason is closely resembles western sector 1.

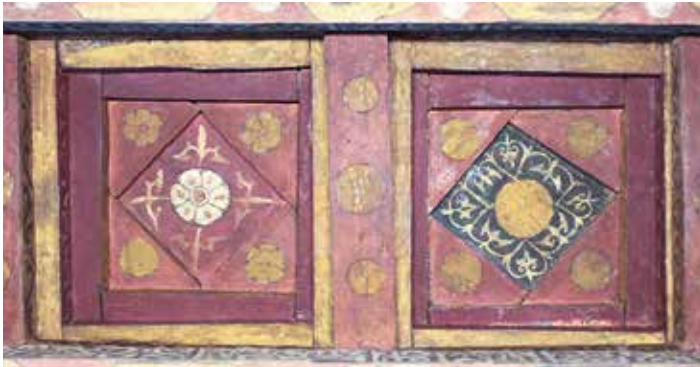
Fig. 2. This typology is present in a few rows of the northern sector one, from N1 c37 to c41. The structure is the typical one, top, triangles and double framing. The motif of the top echoes that of others in the same sector, as well as the motif of the triangles.

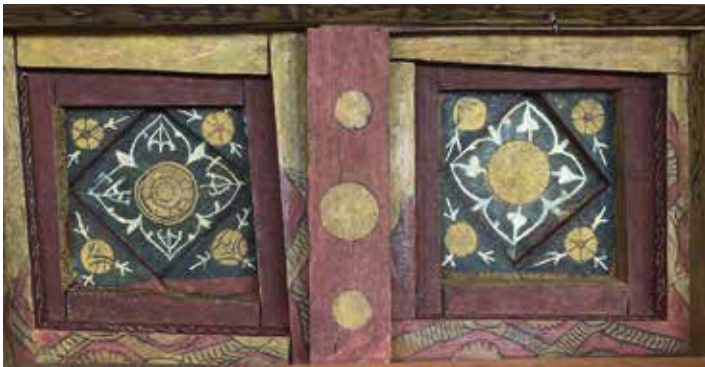
Fig. 3. This decorative typology is unevenly present in the northern sector (N1 c7; N1 from c12 to c25; N1 from c46 to c50; N1 from c52 to c62). The structure of the coffers is typical of the northern sectors, i.e. top, triangles and double framing. The motif of the top is what is found in sectors N4 and N5.

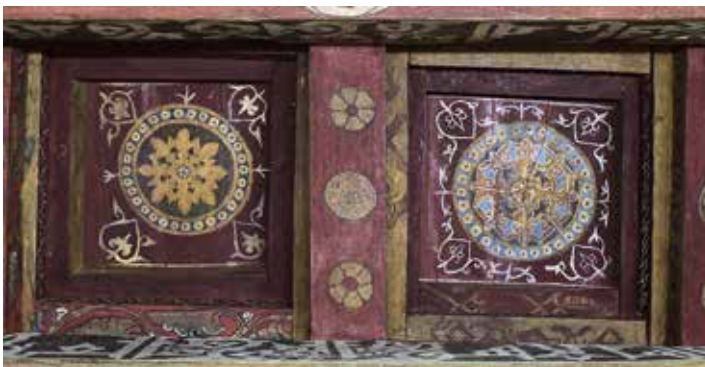
Fig. 4. This decorative typology is present in only two rows of the northern sector one, from N1 c10 to c11. There the structure differs from the typical due to the lack of triangles under the top.

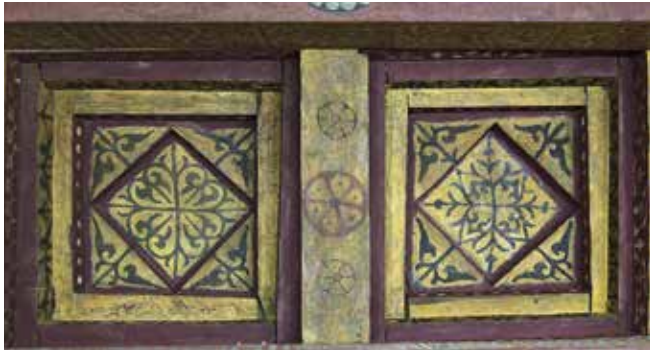
Fig. 5. This typology is present in a few rows of the northern sector one, from N1 c26 to c30. The structure is the typical one, top, triangles and double framing.

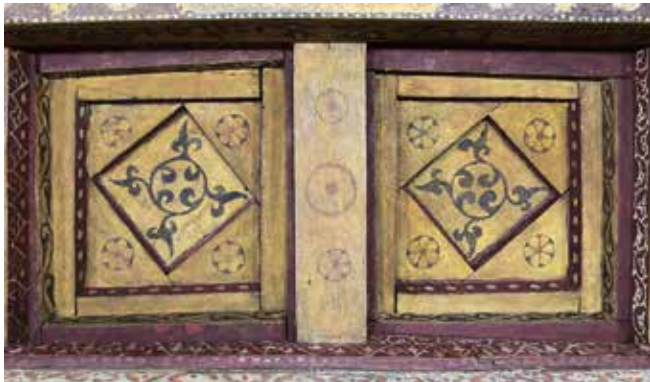
Fig. 6. This typology is present in a few rows of the northern sector one, from N1 c31 to c34. The structure is the typical one, top, triangles and double framing. The decoration resembles the one described previously.

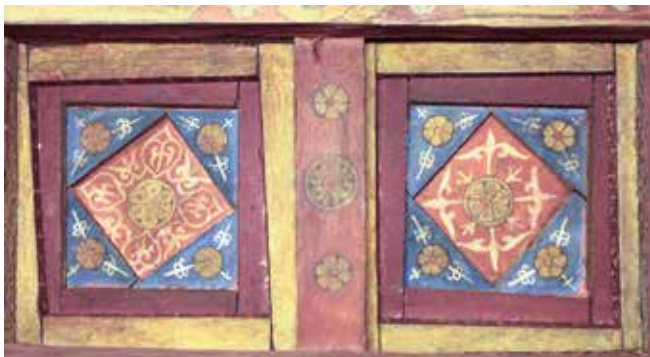
Fig. 7. This typology is present in a few rows of the northern sector, from N1 c37 to c41. The structure is the typical one, top, triangles and double framing. The motif of the top echoes that of others of the same sector, as well as the motif of the triangles.

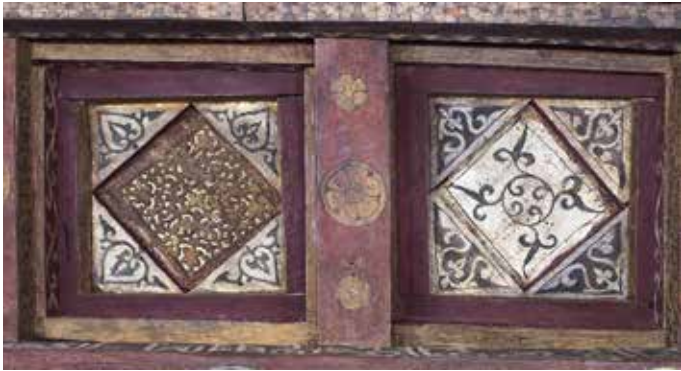
Fig. 8. This decorative motif is present in only two rows of coffers in north sector, N1 c42 and 43.

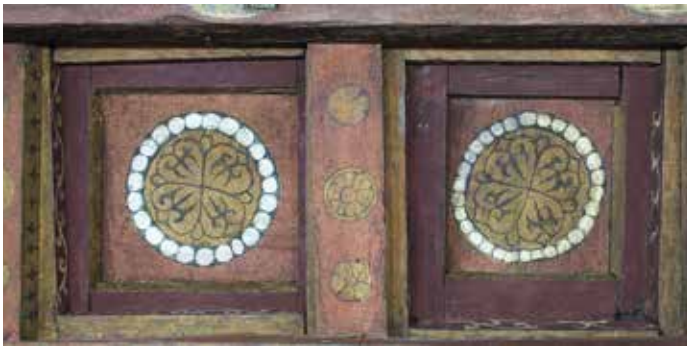
Fig. 9. This decorative typology is present in a single row of coffers in the north sector, N1 c44. The coffer structure lacks the triangles. The decoration is reminiscent of the style of the two previous rows described above.

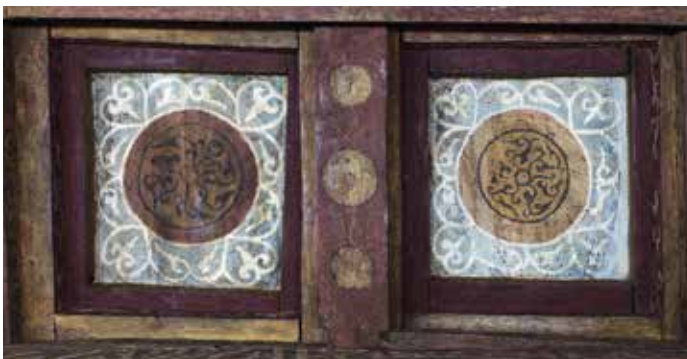
Fig. 10. This decorative typology is present in a single row of the coffered ceiling in north sector one, N1c45. The coffer structure lacks the triangles. The motif present in the tops is reminiscent of that found present at the top of northern sectors 4 and 5.

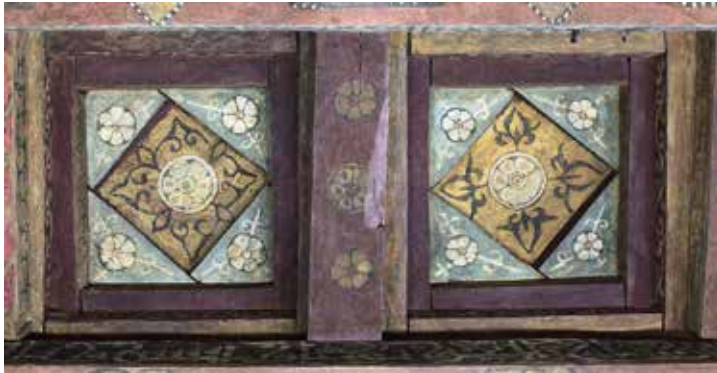
Fig. 11. This decorative typology is present in a single row of coffered in north sector one, N1 c51. The motif of tops and triangles may resemble that of others in the north sector with variations of colors.

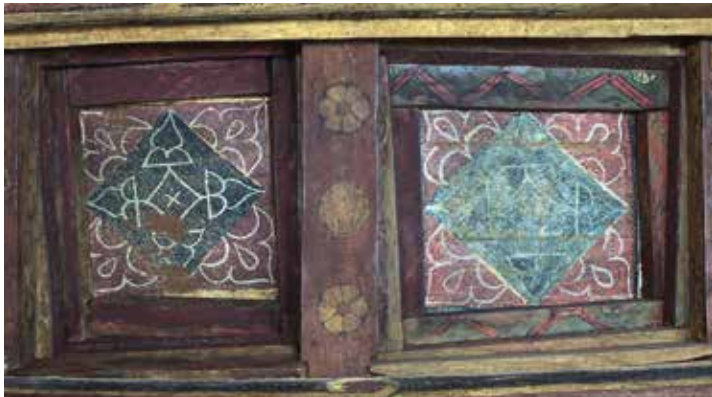
Fig. 12. This decorative typology is present in two rows of coffers in north sector one, N1 c63 and c64. The structure of the coffers lacks the triangles that are reproduced here pictorially at the top.

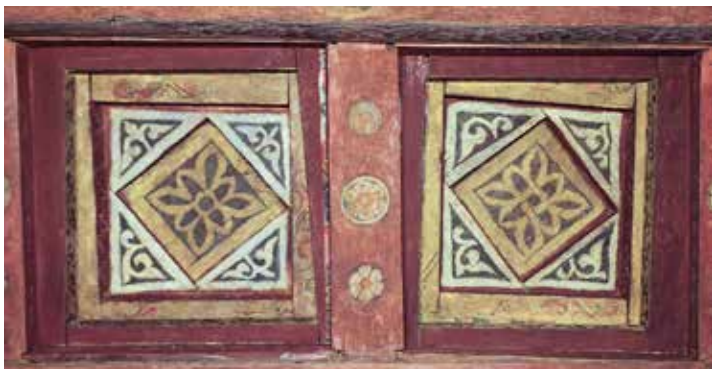
Fig. 13. North sector two is fairly homogeneous for its entire length, from N2 c9 to c63. The variation of the decorative motif is mainly present in the variation of the geometries and polychromies of the top.

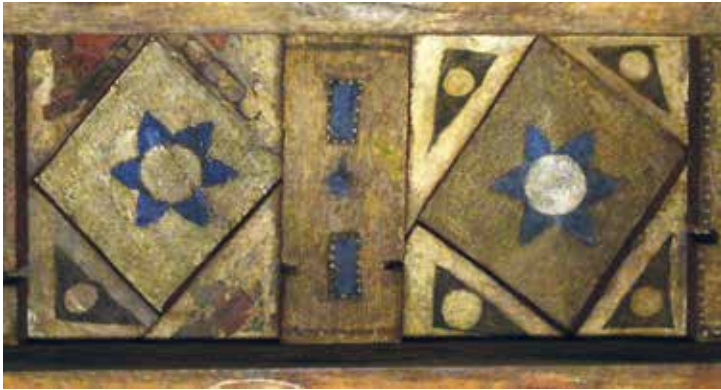
Fig. 14. This decorative typology is seen here in a single row of coffers in north sector three, N3 c7. The structure of the coffer lacks frames and the decorative typology and is very simple and primitive.

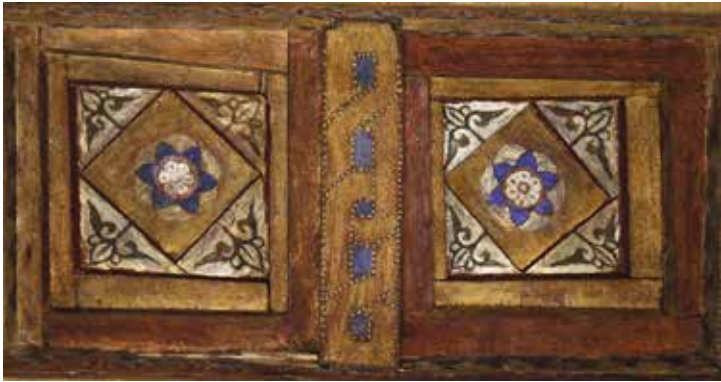
Fig. 15. This decorative typology is the main one of north sector three, present from N3 c8 to c57. The only variation is that of the floral motif painted in the triangles.

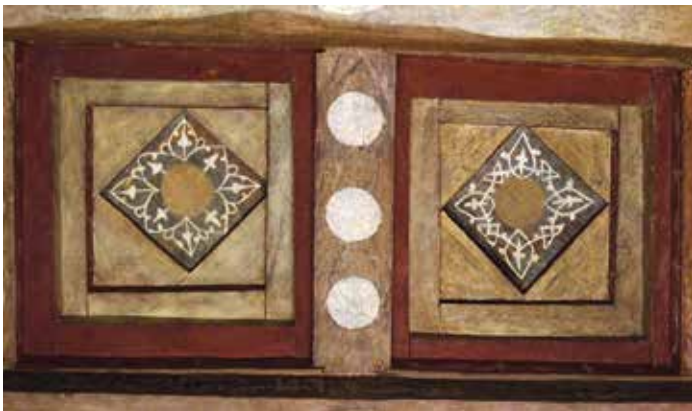
Fig. 16. This is the most common decorative module and is present in both the north and south sectors, in N4 from c7 to c66, in N5 from c7 to c66, in S2 from c47 to c74 and in S3 from c47 to c74.

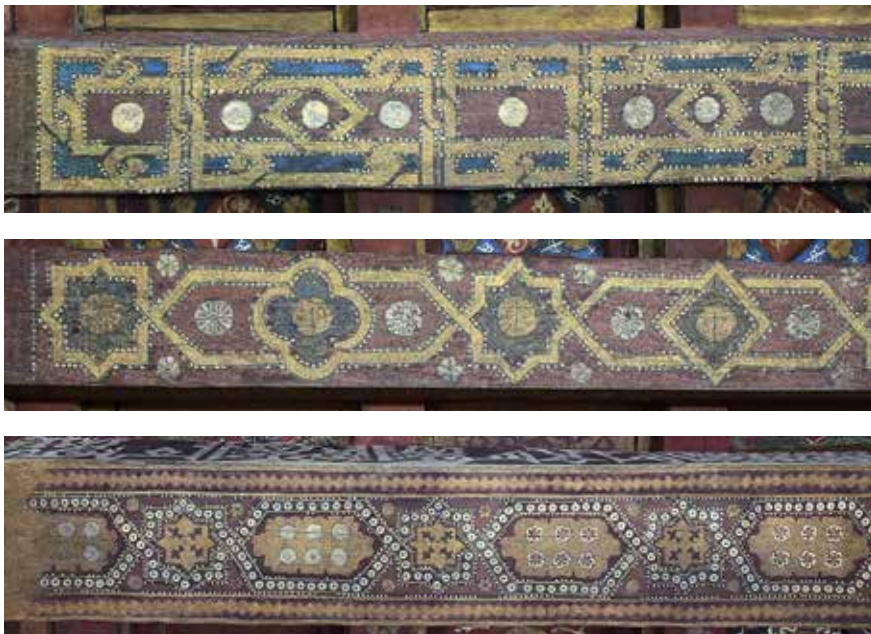
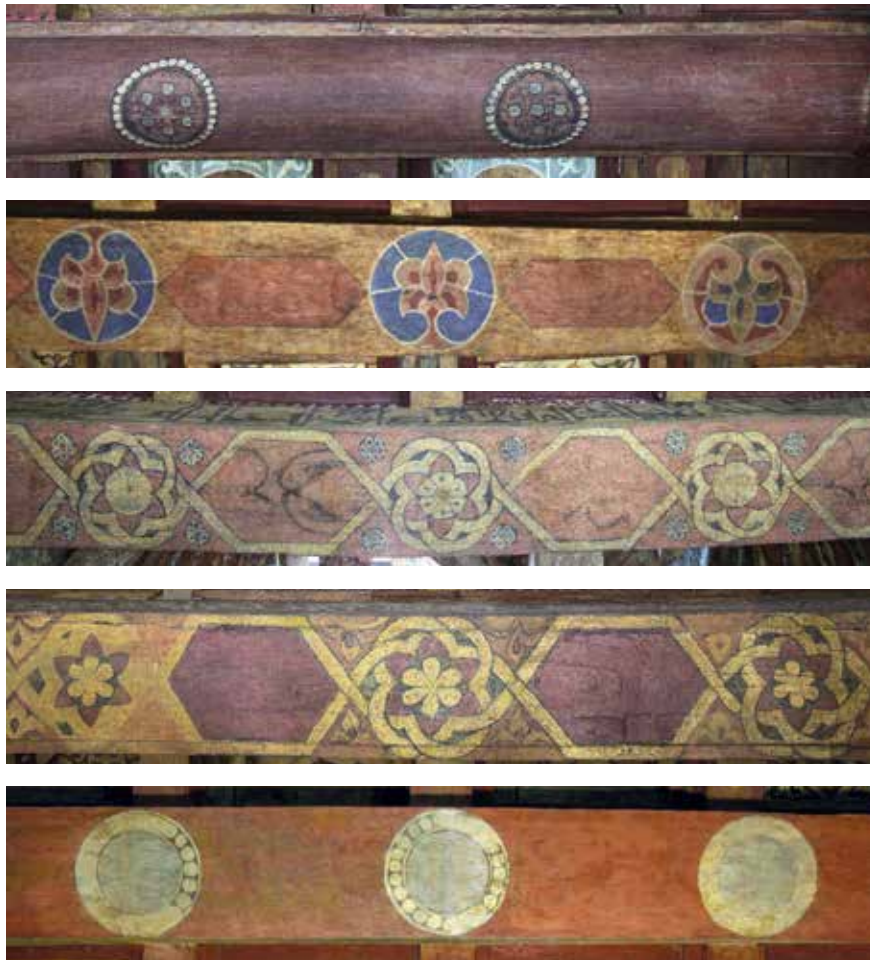
Figs 17-24. Some examples of the decorative patterns found on the lower surface of the beams. This small selection clearly demonstrates how articulated the decorations in the northern sector are.

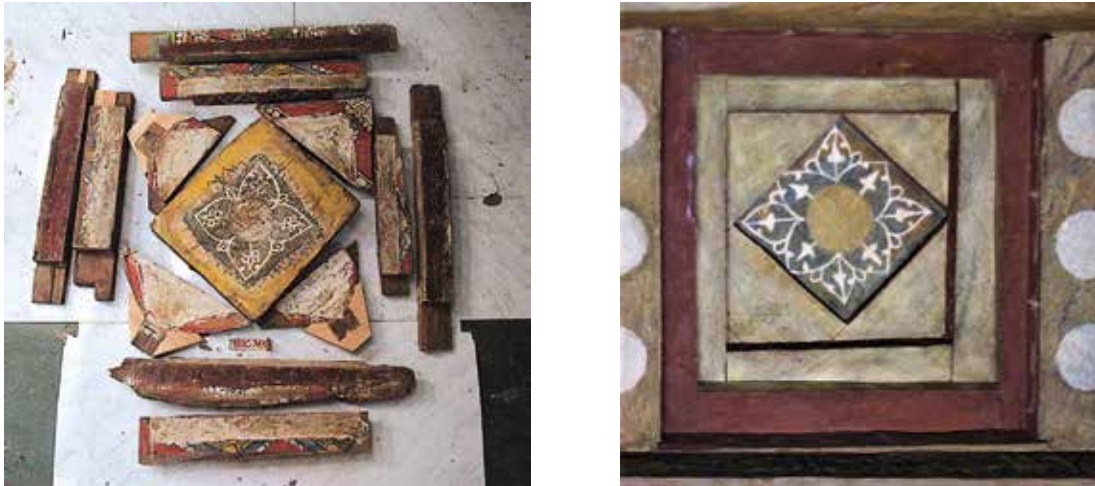
Figs 25, 26. On the left, a sample of all the components of a coffer. On the right, the same coffer after being assembled.

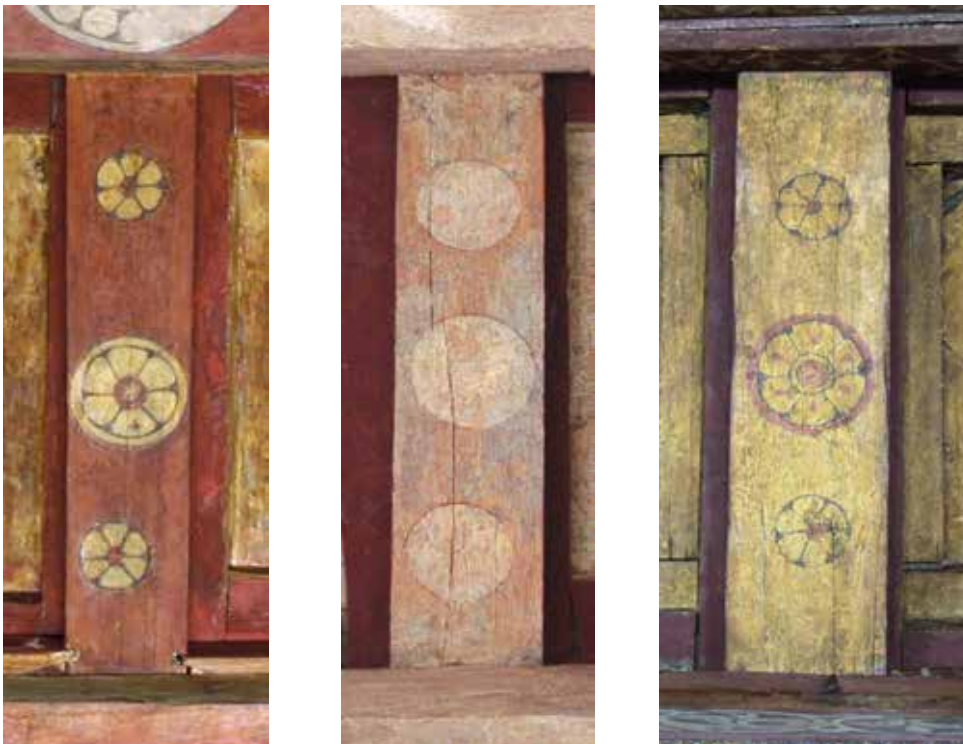
- Under joists: have a red / burgundy background color with three yellow or white medallions with a black decoration, often a flower. In some cases, the bottom of the underlayers does not show any trace of color but only the white preparation is observed. What could be a residue of color is definitely toned in gray / black and would almost certainly have been red originally. On the other hand, the three circles have a floral design.

Figs 27, 28 and 29. Examples of decoration on the underjoists.

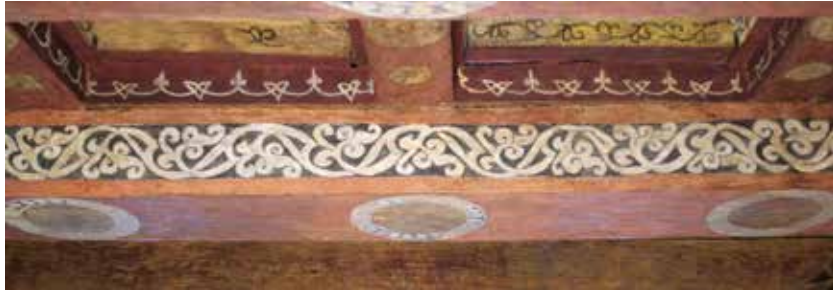
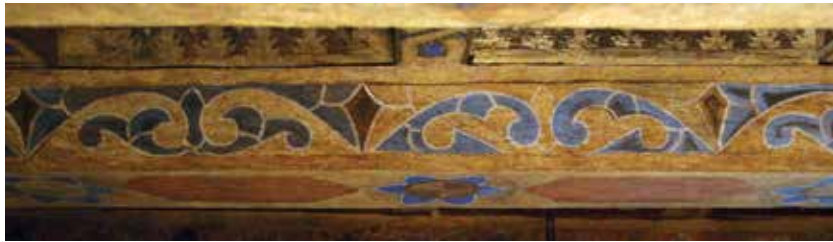
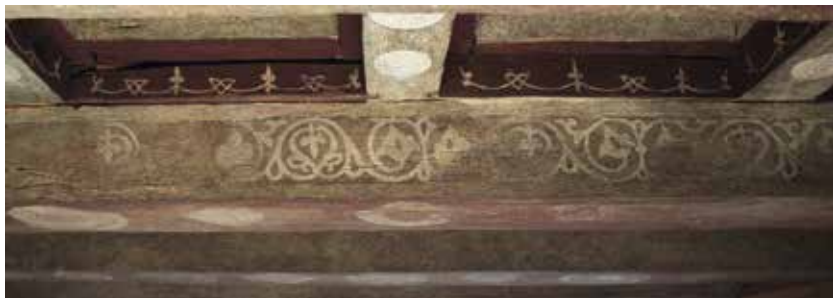
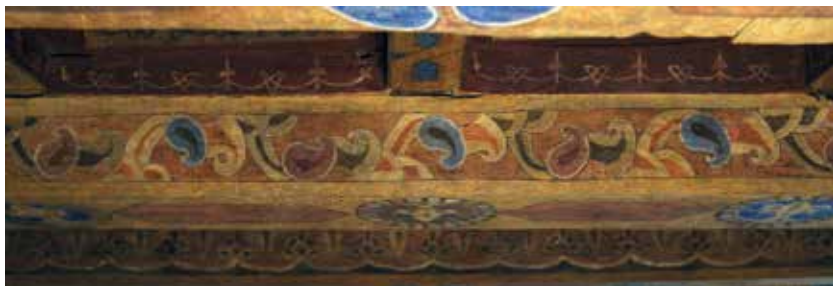
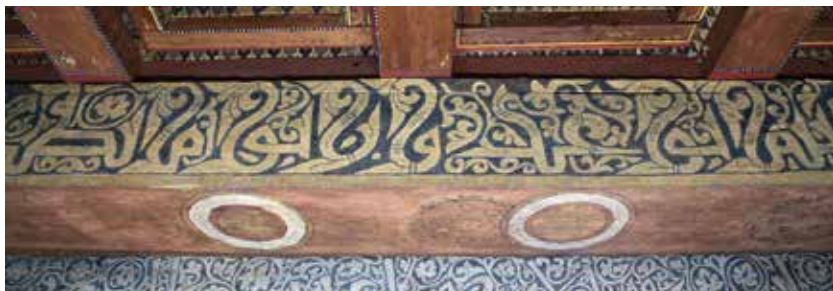
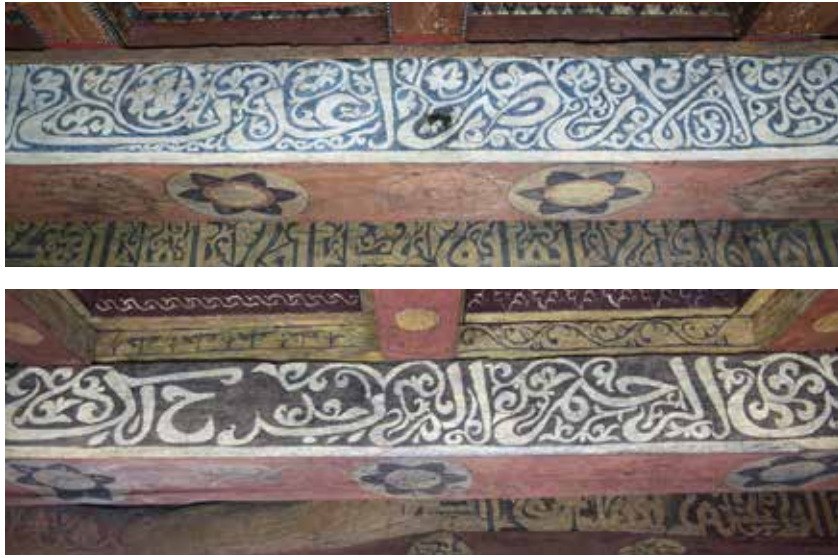
- Beam sides: they are characterized by Koranic inscriptions or by decorations with colored floral motifs in yellow, black, white and red, on a chalky preparation.

Figs 30-36. Some examples of decoration of the lateral faces of the beams.

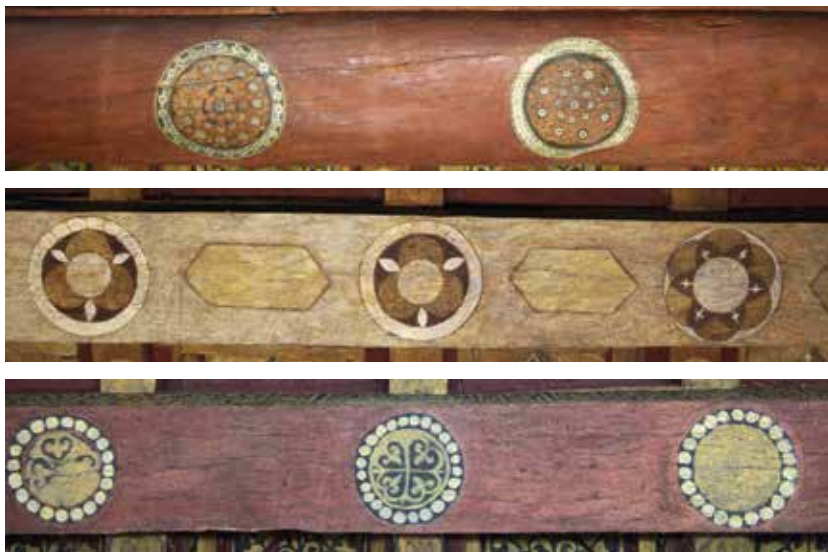
- Underbeams: The decorative typology of the underbeams is very varied even in restricted areas of the same aisle and it is difficult to establish basic recurring patterns. However, a predominant decoration has a red / burgundy base on which three circular medallions are designed, based on the motif of many under-beams, with black border and white dots that surround a central decoration with a black background and yellow designs. Others have a decoration whose background color has been lost, probably also red or ocher yellow. This is made up of four circles, with a black border and white dots that surround a central decoration with a black background and yellow designs, though for the bottom there is only the preparation.

Figs 37, 38 and 39. Most common decorative motif on the underbeams of the northern sector.

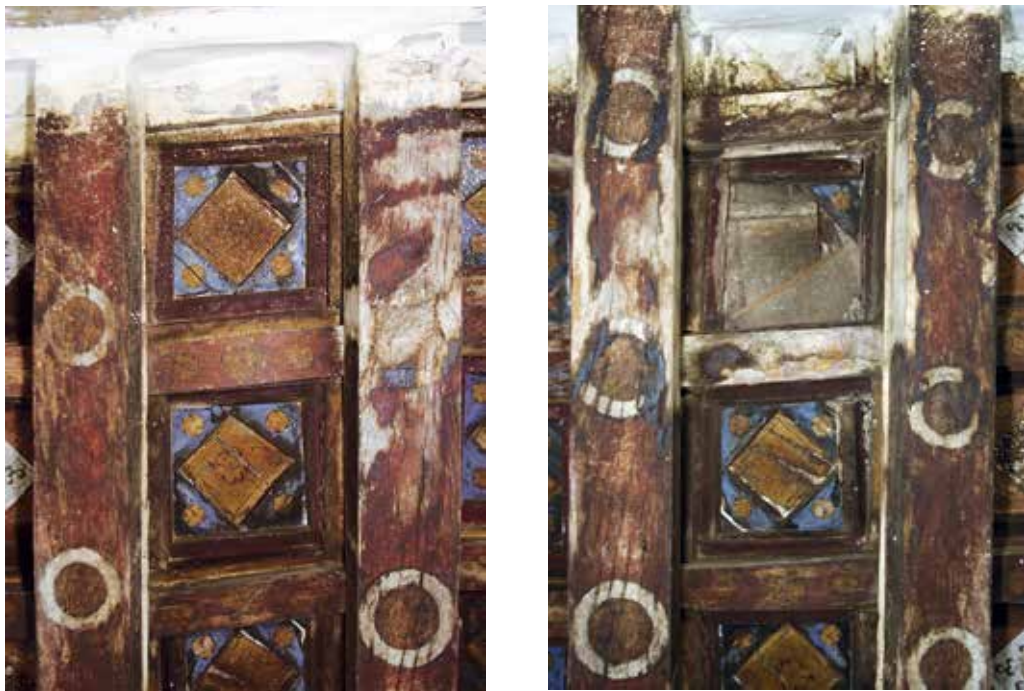
What at first glance appeared most worrisome was the presence of particular areas of the ceiling with fractured beams and part of the surrounding coffered ceiling that had completely collapsed. The damage present in these areas was so severe that it led to the choice of a seemingly rather drastic intervention but one which proved to be the only way to remedy that type of structurally unstable situation in a targeted, precise and definitive way. The operation, which will be described more fully later, provided for the removal of the roof covering layers from the outside so as to be able to act from above to proceed with the complete disassembly of the coffers. The opening of the ceiling and disassembly of the coffers also revealed the extent of the biological deterioration on the back of all the wooden elements.

Figs 40 and 41. In the pictures some of the typical situations encountered in the northern sector at the beginning of the works are visible.

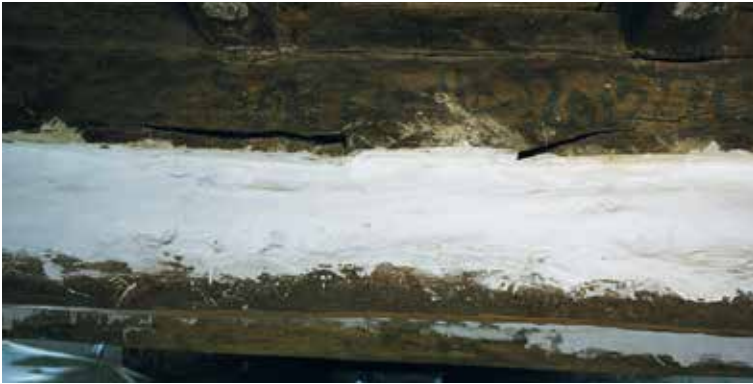
Fig. 42. Crosswise fractured beams supported by an additional support beam, generally an unworked and rather rough wooden beam, with a circular section added in the lower part and the heads set in the masonry. The large empty space between the two beams was filled with plaster and brick infill.
