THE GREAT MOSQUE OF ŞAN'Ā'

Conservation intervention

(2005-2015)

FOUNDATIONS OF THE GREAT MOSQUE IN ŞAN‘Ā’

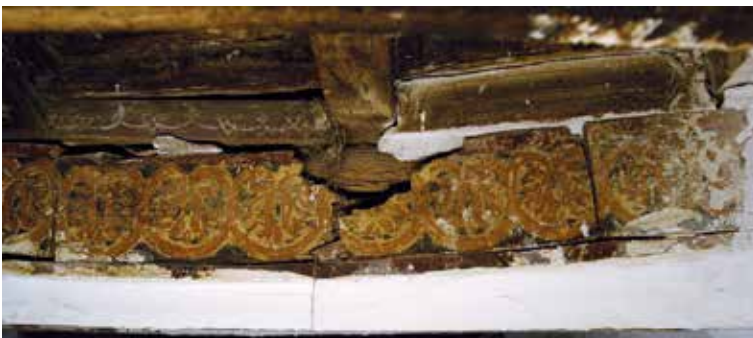
Fig. 43. Embossed beams without evident fractures, and cracked or fractured beams in the longitudinal direction, covered on the three exposed sides with decorated boards. These boards, often composed of several elements nailed to the internal beam, are also broken, fractured and incomplete, being forced in their movements to follow those of the internal beam.

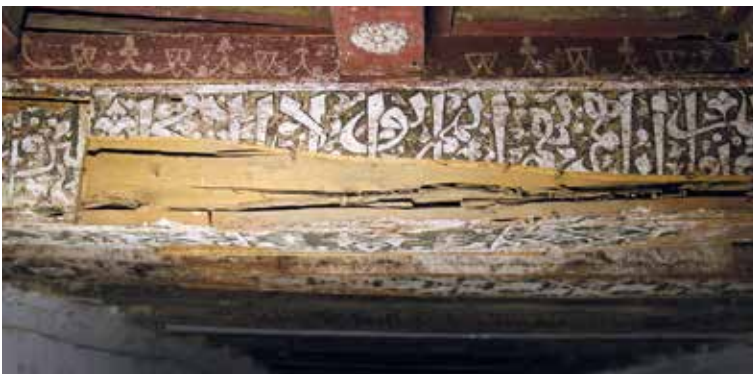
Fig. 44. Longitudinally slotted beams entirely or extensively covered and buffered with a white plaster-based mixture.

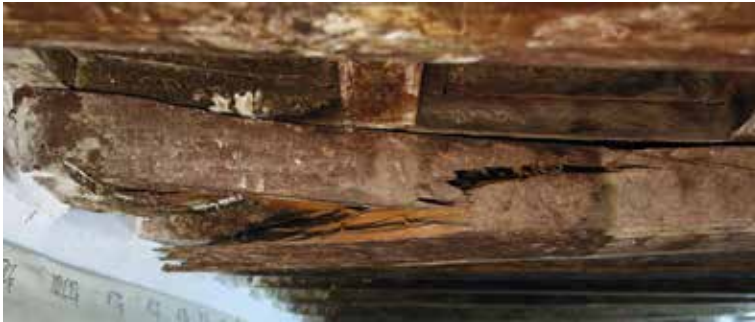
Fig. 45. Beams with large cracks and transverse fractures with relative static and structural weakening.

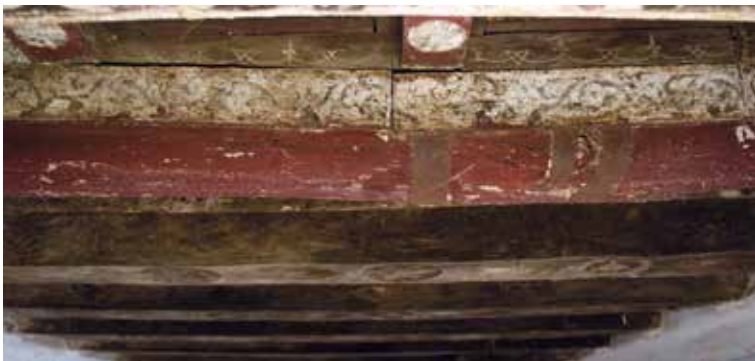
Fig. 46. Beams with large cracks and transverse fractures and related old restoration intervention consisting of metal elements of the most varied type (hooks, nails, chains, pulleys, etc.)

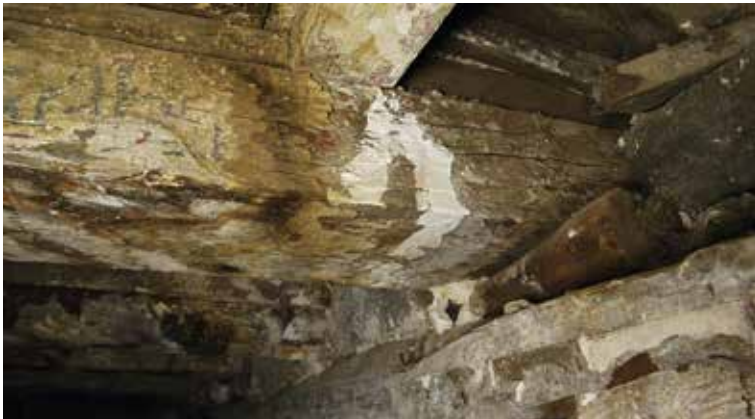
Fig 47. Cracked and/or remodeled beams, incorrectly and unsafe inserted in the masonry, and supported on the side only by wooden and / or brick shelves.

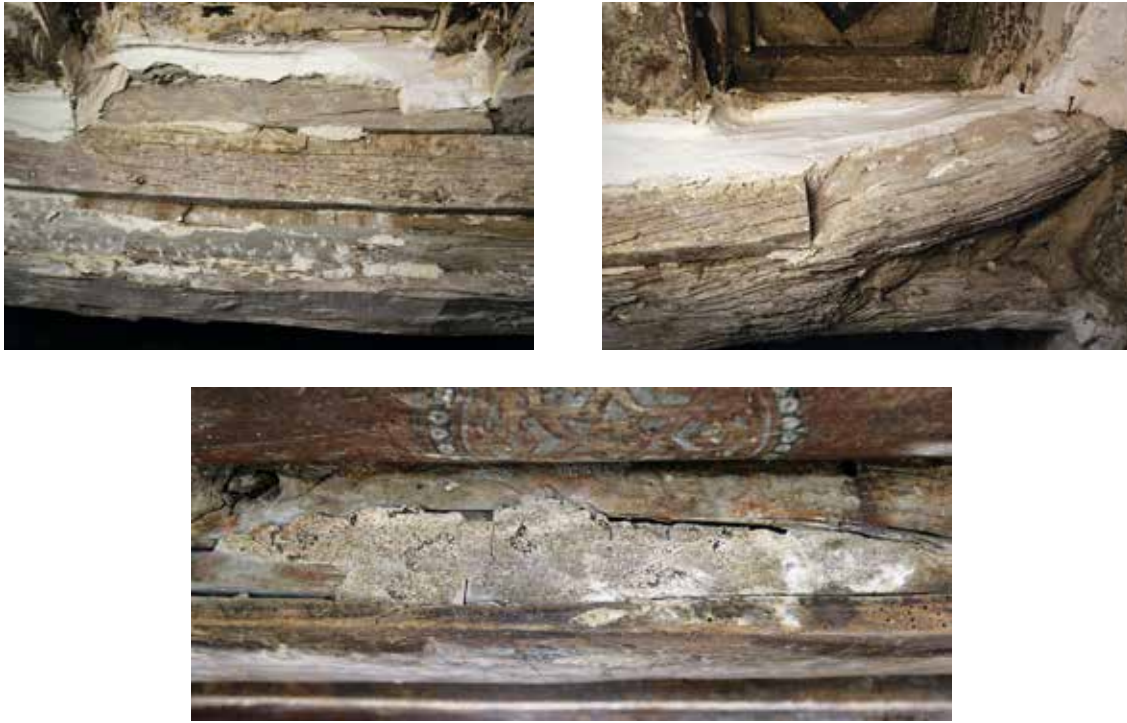
Figs 48, 49 and 50. Beams and coffers with wooden or brick and plaster infill to fill in the gaps or the loss of original wooden elements.

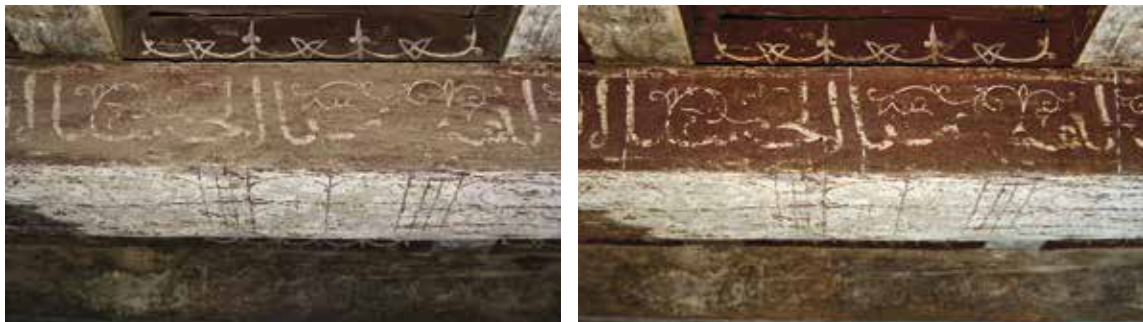
Figs 51, 52. Cleaning phase, before and after.

- Brush application of the citric acid solvent gel at pH 7.5 on Japanese tissue paper. Spreading times with a brush of the citric acid solvent gel at pH 7.5 on Japanese tissue paper. Short contact times and removal of the tissue from the paint film.
- Removal of excess with the application of a clean tissue.
- Rinsing of the treated part with the application of ligroin in acetone 1:1 over the tissue (also performing the operation twice, changing the physical support).
- Finishing with the application of ox gall over the tissue.

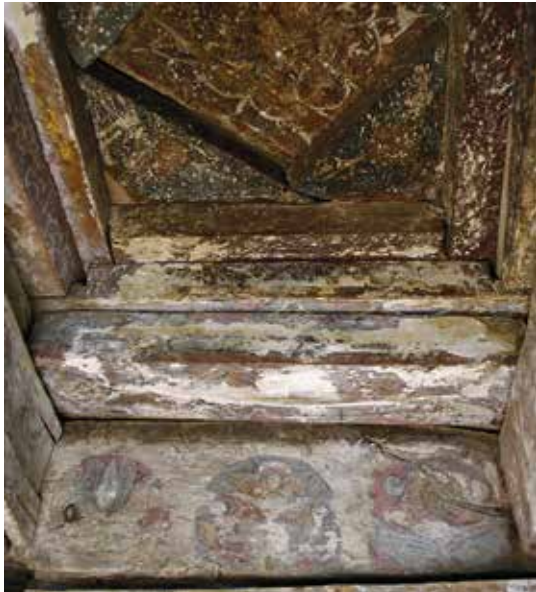
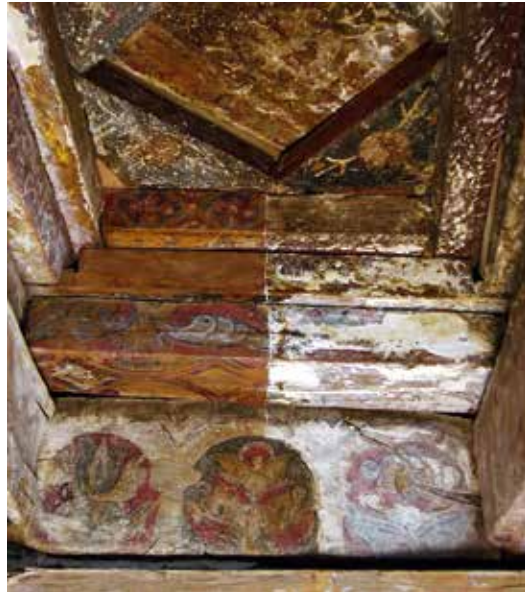
Figs 53, 54. Cleaning phase, before and after.

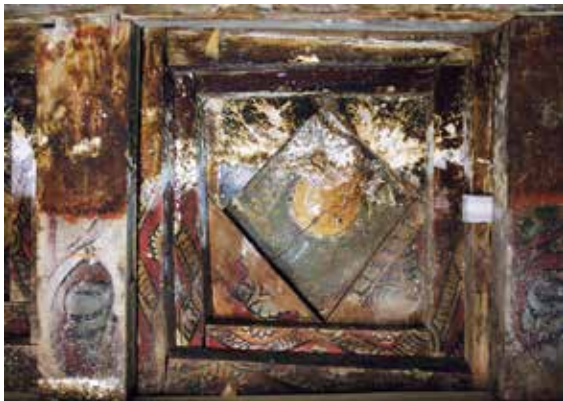
Fig. 55. Cleaning pad on a coffers.

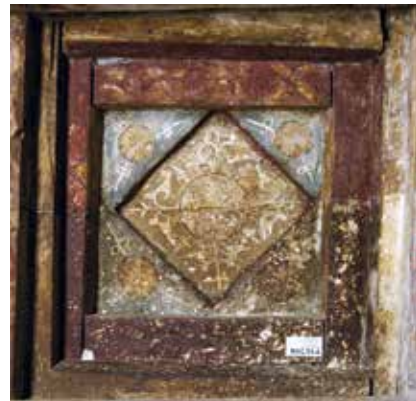
Fig. 56. Cleaning pad on a coffers.

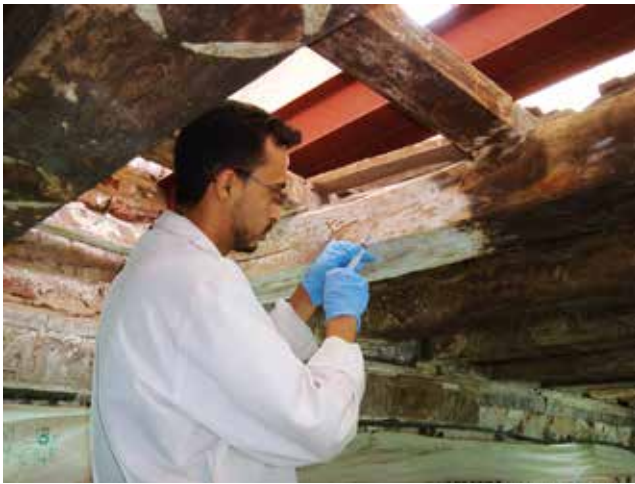
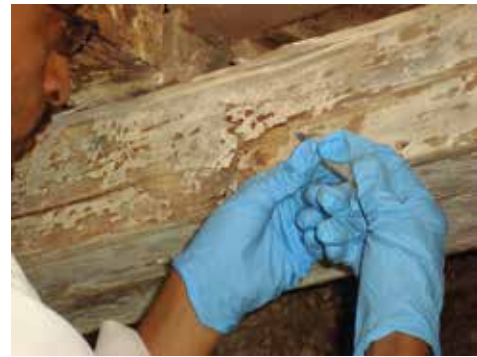
Fig. 57. Yemeni restorer during the film consolidation phase. *Fig. 58.* Detail of the phase of consolidation.

The badly deteriorated and fragile wooden elements, found above all in the joists and frames of the sleepers, were if possible, carefully removed and consolidated with Paraloid B7 2 acrylic resin, diluted 5% in acetone and subsequently reinforced with bi-component epoxy resin (Araldite). Sometimes, given the state of fragility of the wood and its extreme degradation due to the continued action of xylophageous insects, the consolidating action of the Paraloid resin being not sufficient and not wanting to exceed the use of this resin, we opted for injections of Araldite, diluted with alcohol, into the tunnels formed over the years. In this way the wooden structure was recreated, strengthened and partly restored.

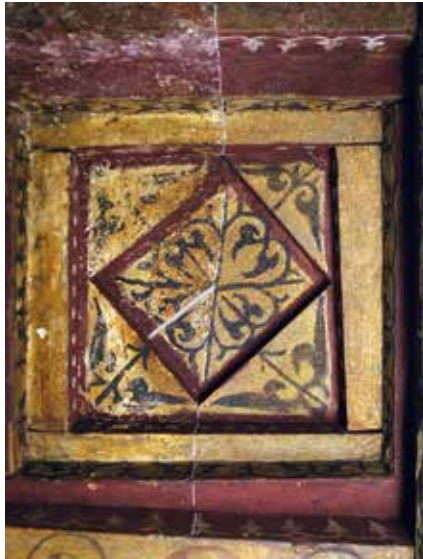
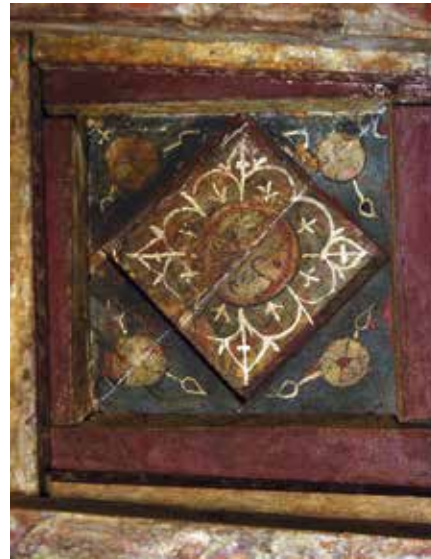
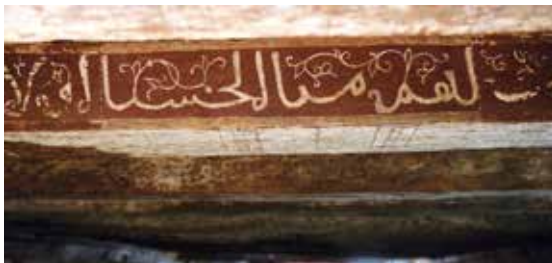
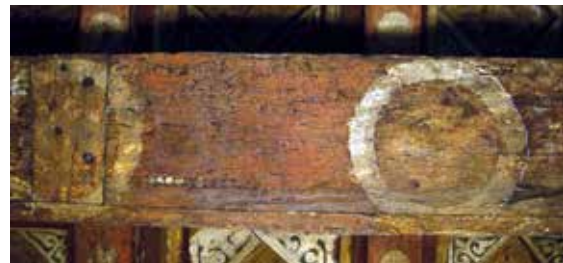
Figs 59, 60, 61 and 62. Some examples of pictorial retouching.

All wooden surfaces were treated with a brush coat of Regal Varnish matte paint diluted 40% in white spirit.

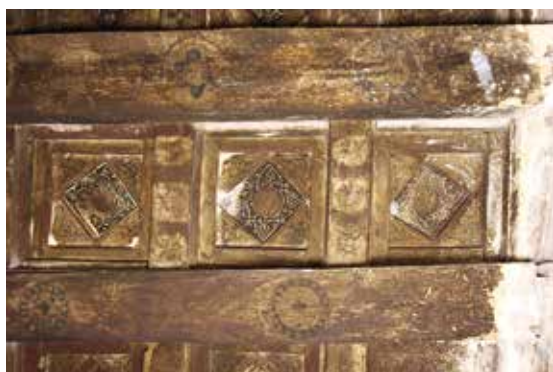
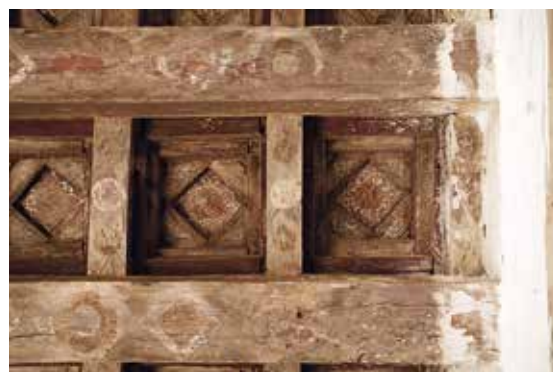
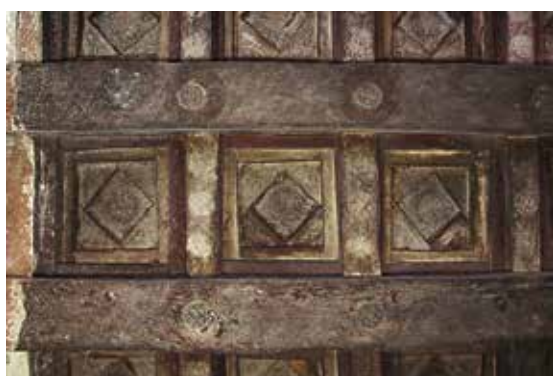
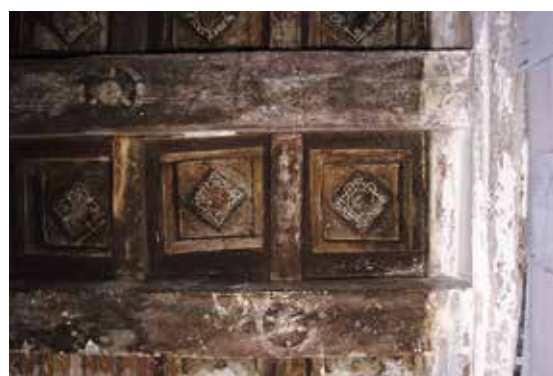
Figs 1, 2, 3 and 4. On the left, two examples of the coffered panel of the south *riwāq*. On the right, examples of the north *riwāq*.

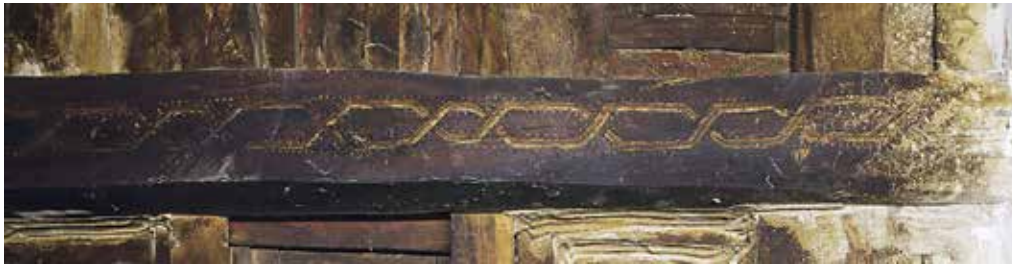
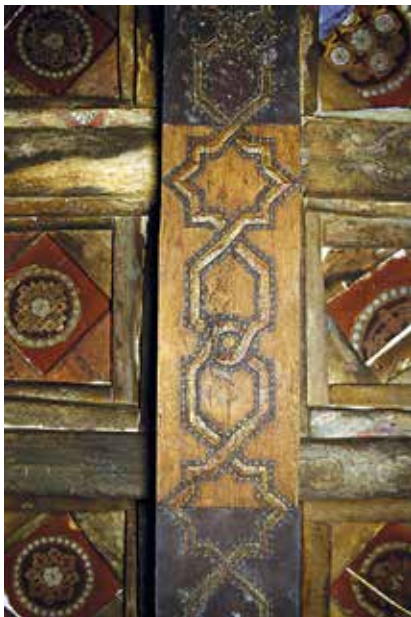
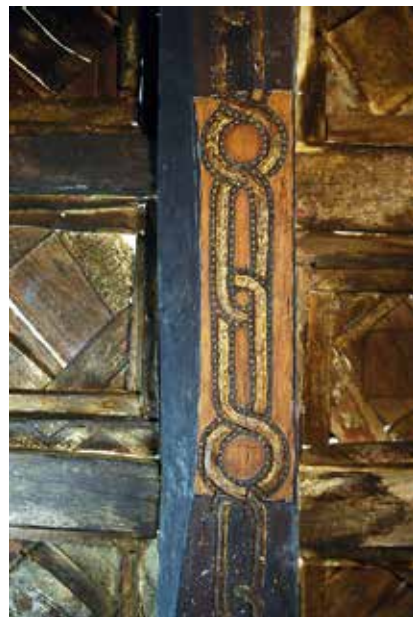
Figs 5, 6 and 7. Some examples of the particular carving and gilded decoration present in the southern *riwāq*.

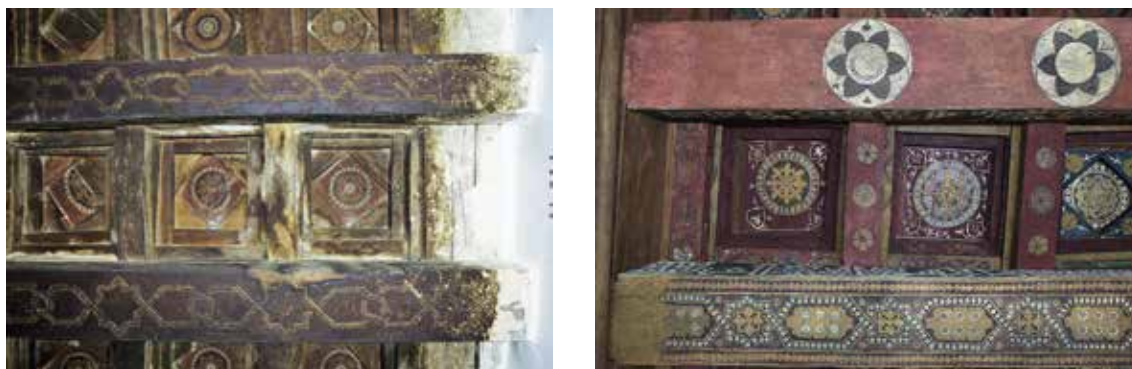
Figs 7a and 7b. Above an example of the decorative motifs of the first southern *riwāq*, below an example of the first spans of the north *riwāq*.

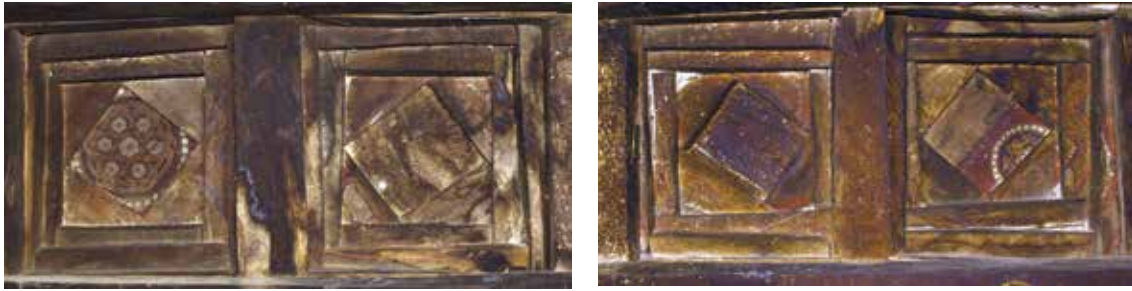
Figs 8 and 9. Some coffers in the southern sector.

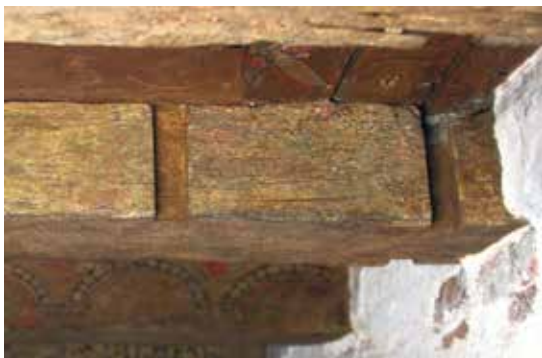
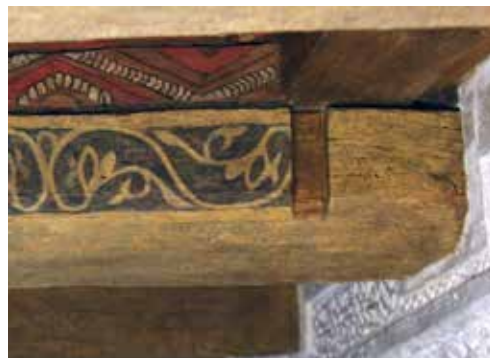
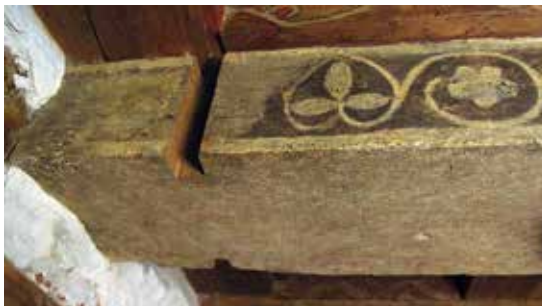
Figs 10, 11 and 12. Some examples of old exposed joints that are no longer used, reflecting a reuse of the beams.

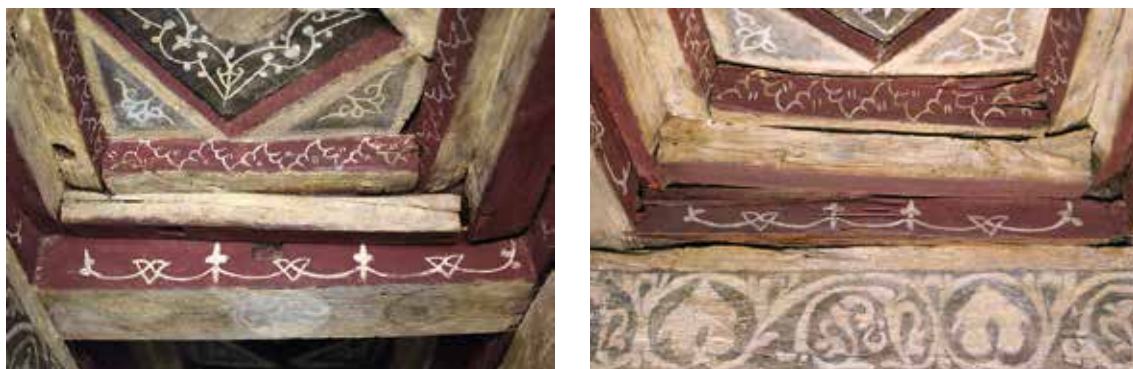
Figs 13 and 14. Some more common examples of the decorative system present in the coffers of the southern sector.

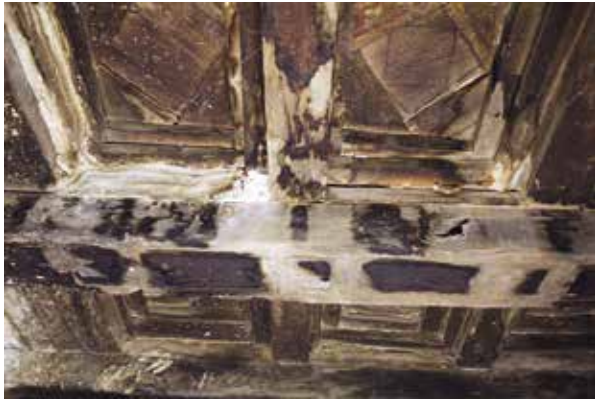
In this sector too, the seepage of rainwater from the ceiling, dissolving the plaster and transporting inert material of various kinds present in the false ceiling, caused numerous stains with relative plaster halos or dark spots, especially between the joints and the strips.

Fig. 18. One of the largest areas in which rainwater, seeping in from the ceiling, washed the decorated surfaces off the ceiling.

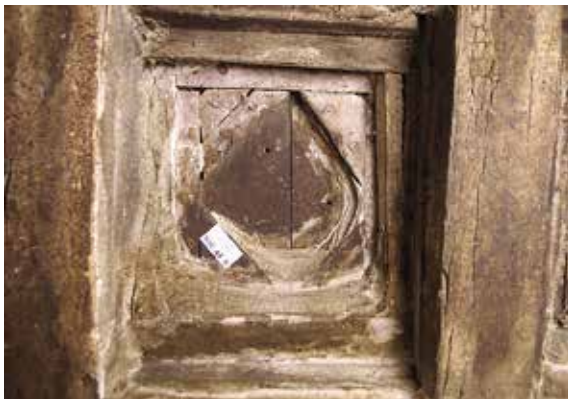
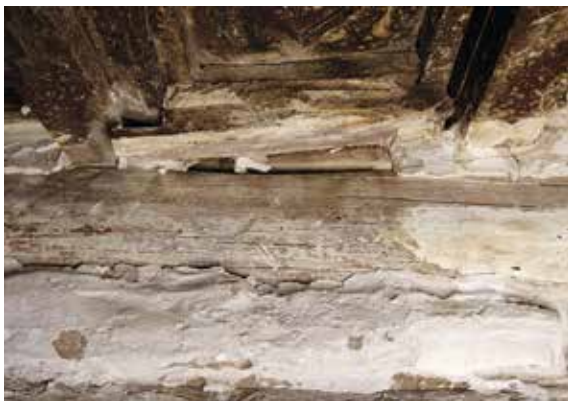
Figs 19, 20 and 21. Some examples of plaster cladding, carried out in past maintenance interventions to stop parts of the coffered ceiling from crumbling.

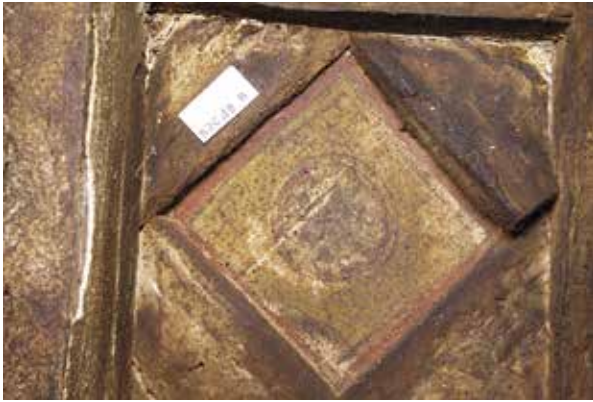
The under beams and joists of the first rows showed a particular blackening given

by the degradation of protein material spread perhaps as a consolidating agent, over the entire surface and by deposits of “greasy” matter since, in the past, in the south / east corner there had been kitchens.

Fig. 22. Detail of a coffer in the southern sector and of the type of deterioration consisting in a general blackening and browning of the decorated surfaces.

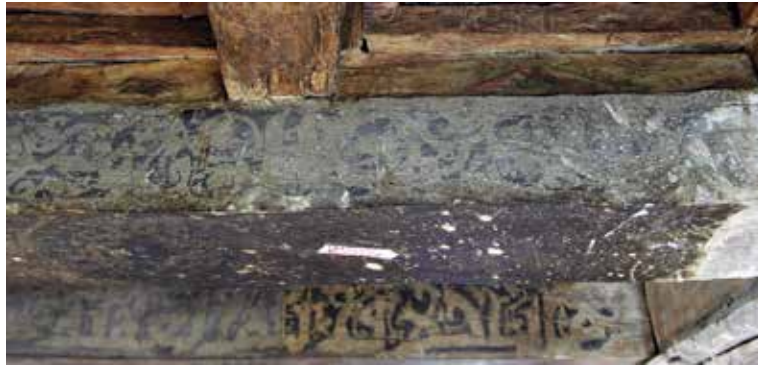
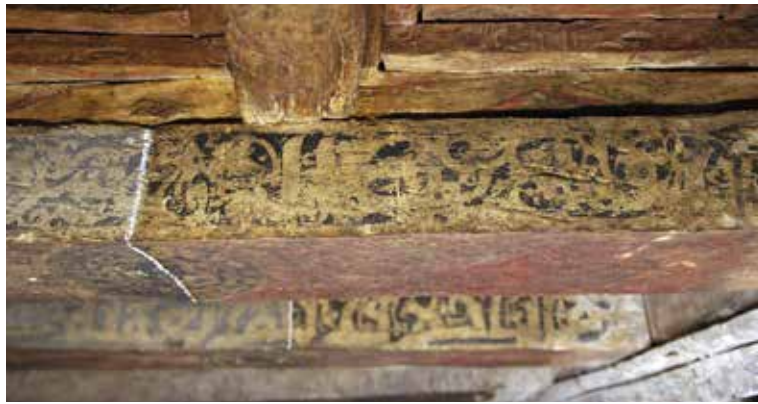
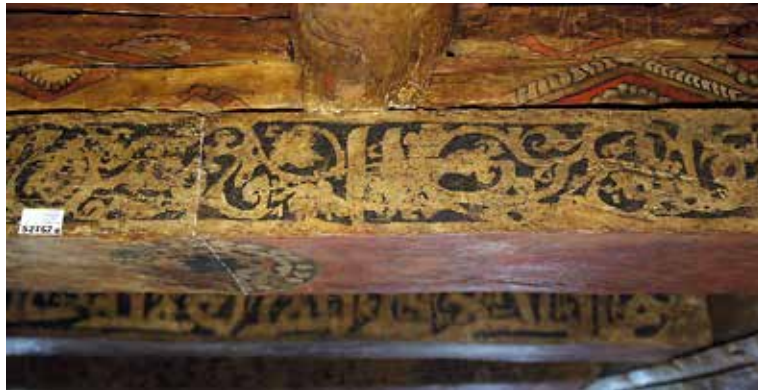
Figs 23, 24 and 25. Sequence of the restoration of a beam in some in its phases. From top: the state of affairs, cleaning and pictorial retouching.

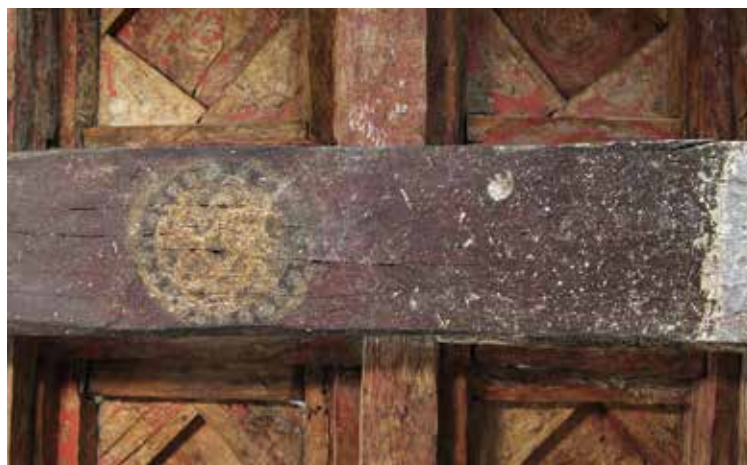
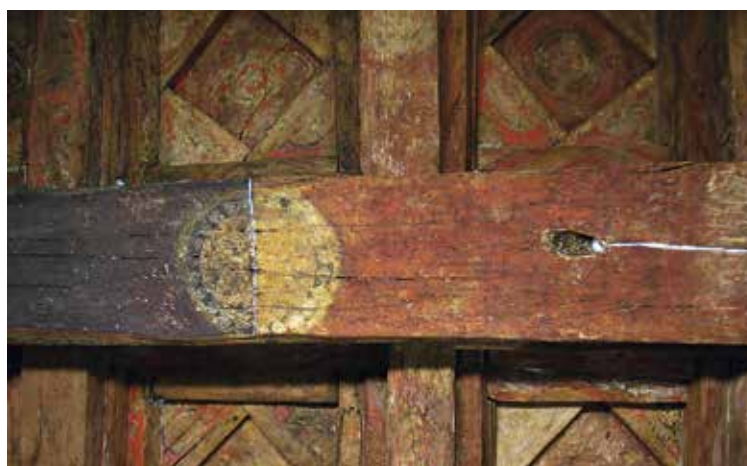
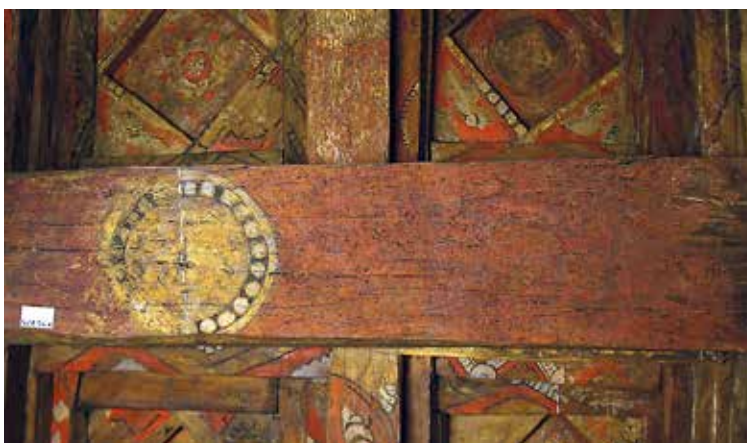
Figs 26, 27 and 28. Sequence of the restoration of a beam in some of its phases. From top: the state of affairs, cleaning and pictorial retouching.

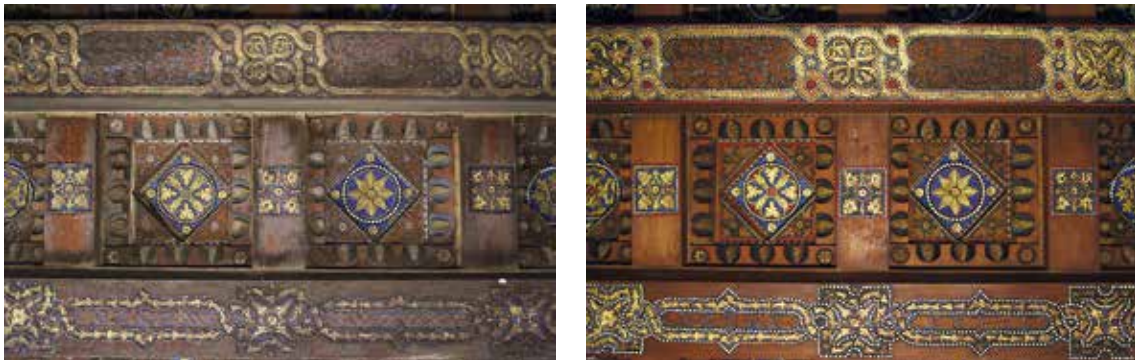
Figs 1 and 2. Typical detail of the ceiling in the east *riwāq*, before and after the intervention.

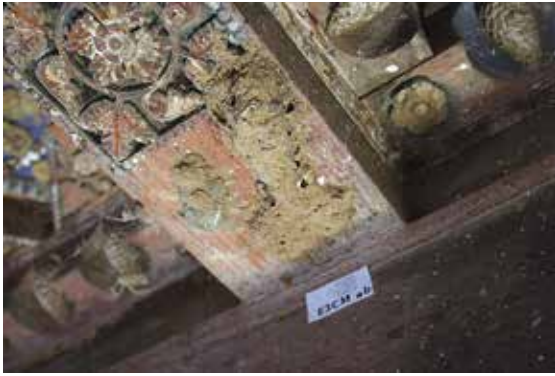
Fig. 3. An insect nesting area is visible in the photo.

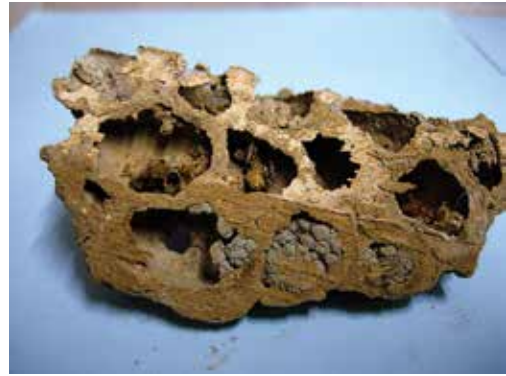
Fig. 4. Detail of the nest removed from the east *riwāq*.

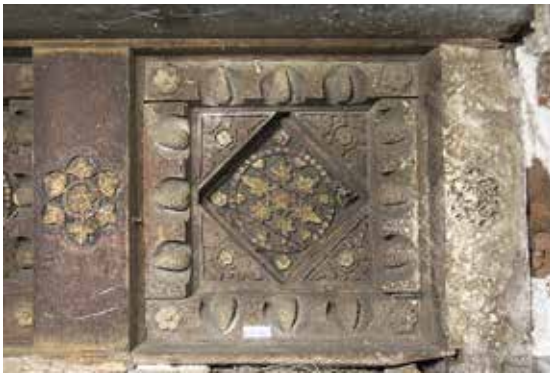
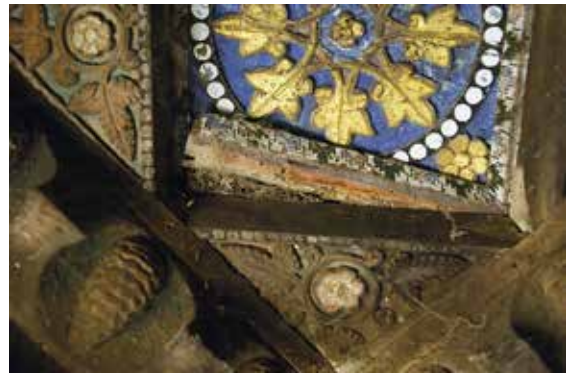
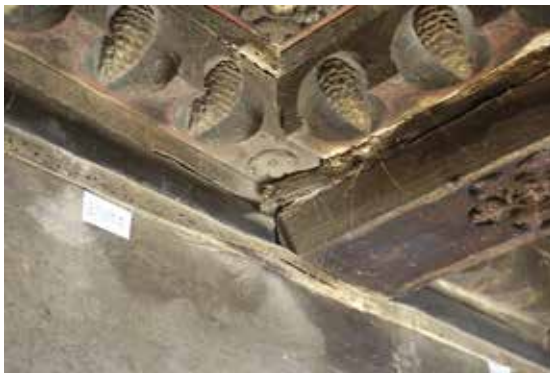
Figs 5, 6 and 7. The photos highlight typical situations of deterioration of the eastern *riwāq*, in particular the attack of xylophageous insects on the narrow frames that divide the elements of the coffers.

The border of the innermost frame that profiled the elements of the coffered ceiling seemed initially to have remained more intact since it still had an intact polychromy but, in fact, in many points immediately below the same color, the cavities formed by insect attacks made the wooden support spongy and structurally inconsistent, putting at risk the adhesion of the pictorial film, now close to disintegrating even on these elements.

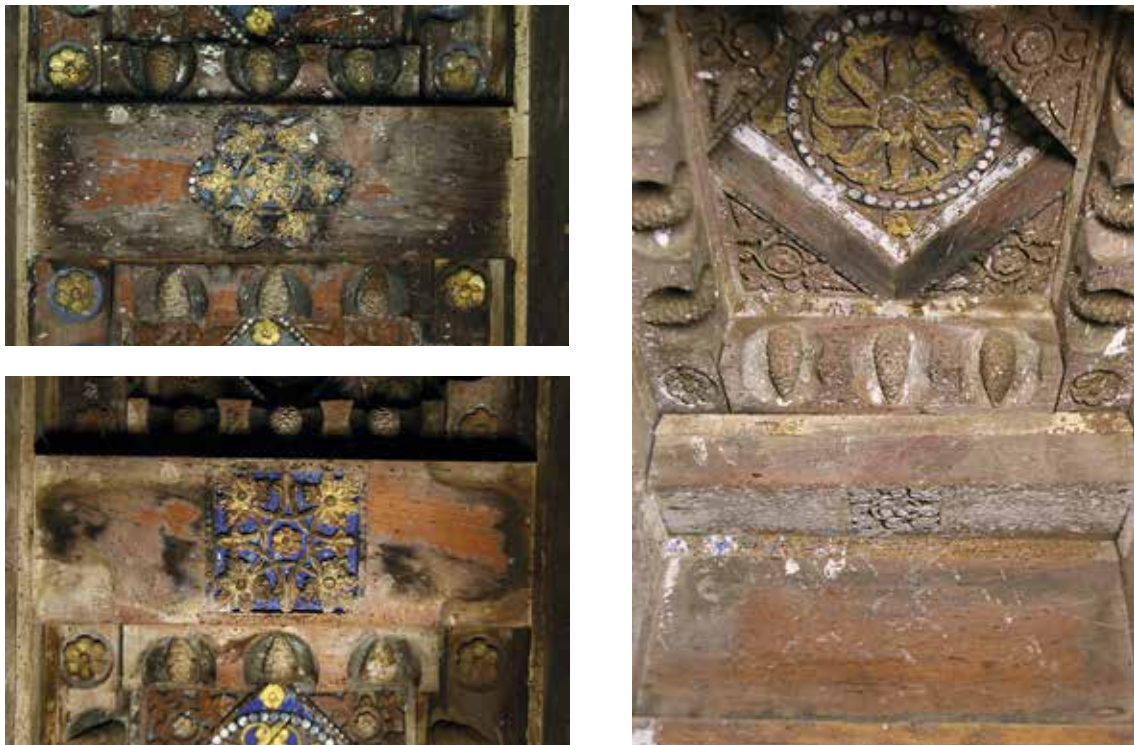
Figs 8, 9 and 10. Some examples of badly damaged coffered areas due to water seepage and percolation.

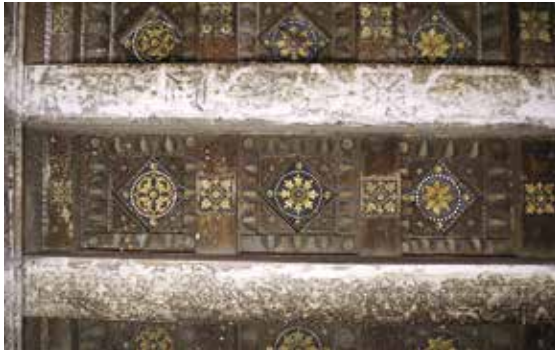
Also, in this sector the whole ceiling structure had white spots and stains, if not whole sectors covered by the gypsum-based material used during the maintenance interventions of the past, mainly located on the boards of the sleeper with its Koranic inscription and on some sub-beams. In particular, the sleeper's structure was largely hidden by plaster but, although covered, was still generally intact except for some missing profiles and small gaps on the Kufic letters.

Figs 11, 12, 13 and 14. Beams and details showing the covering of the original decorative motive with white plaster-based paint.

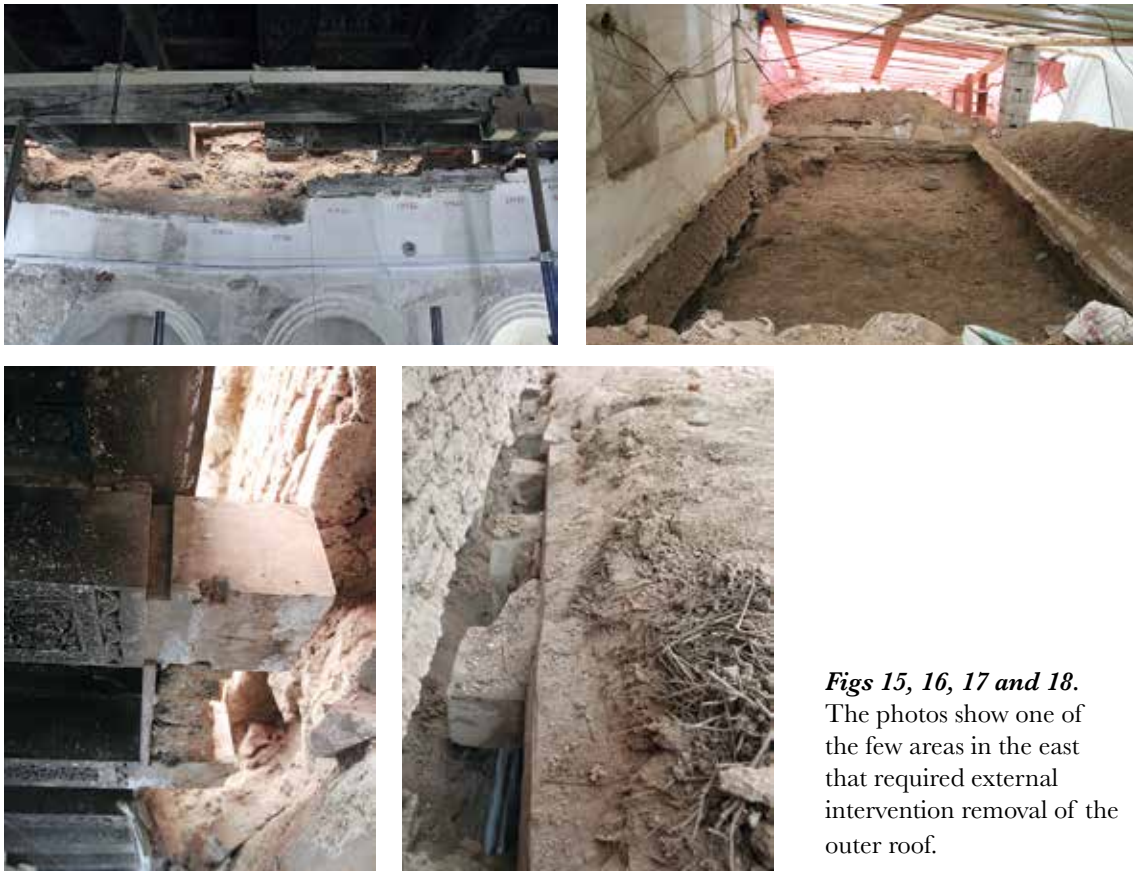
Figs 15, 16, 17 and 18.
The photos show one of the few areas in the east that required external intervention removal of the outer roof.

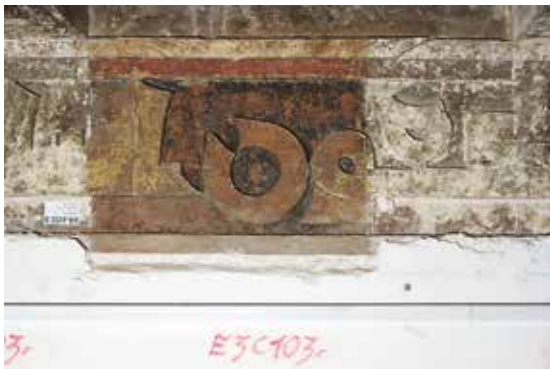
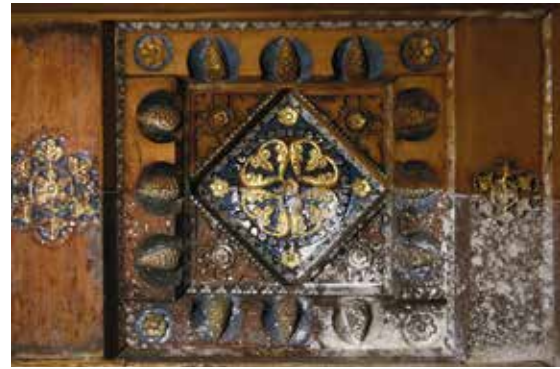
Figs 19 and 20. Some cleaning pieces with the removal of the white rot.

In this sector, a preconsolidation phase of the narrow polychrome frames that delineate the coffered elements was necessary, since they were particularly deteriorated due to fungus or white rot. This biological attack had determined a complete alteration in the solidity of the wooden structure giving rise to a spongy consistency. This caused particular problems in the chemical cleaning phase, since the wood surface was so badly damaged it tended to react to the solutions used, both liquid and thickened, creating halos and stains that are difficult to remove in subsequent phases. Consolidation, by limiting the absorbency

of liquids, prevented this drawback in the subsequent cleaning phase. This was done with Paraloid acrylic resin diluted 5% in acetone, applied with a brush or by injection for a deep treatment, depending on the degree of deterioration of the treated surface.

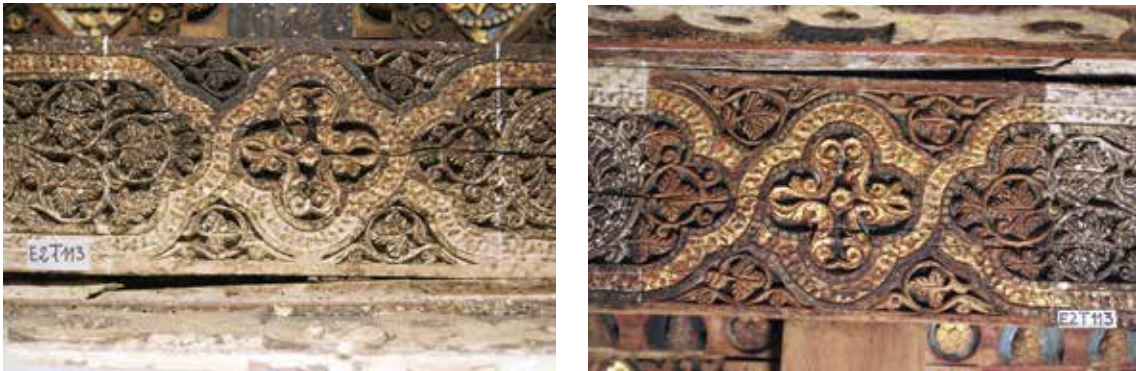
Figs 21 and 22. Under-beam cleaning blocks.

the coffers was generally done with ligroin since the dirt was not particularly stubborn and its removal was relatively simple. If, on the other hand, there was a strong adhesion of the coherent layer, the chelating solution at pH 7.5 and a cotton swab was used, without applying a particular mechanical action but only with small delicate touches to remove the surface deposit.

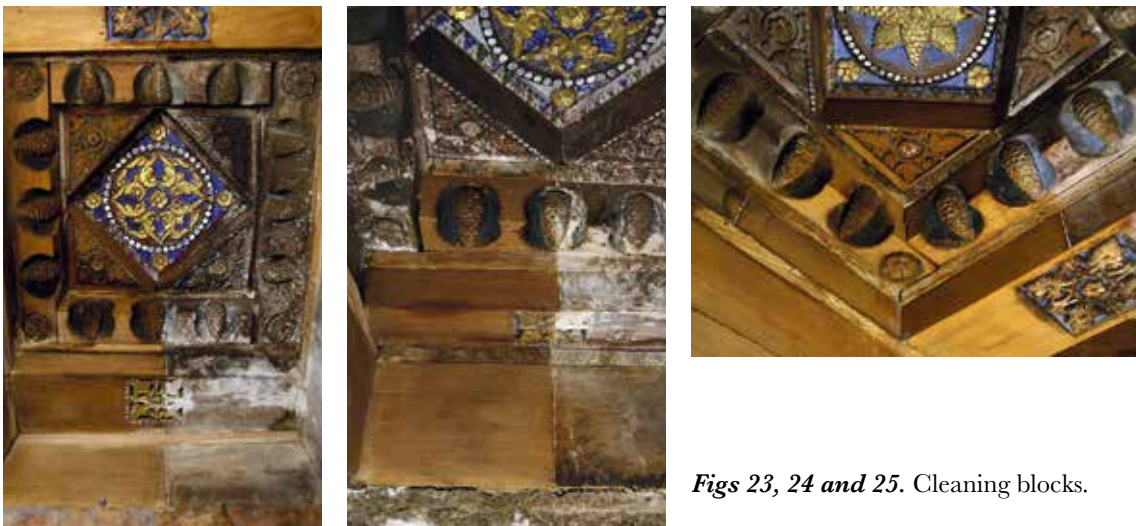
Figs 23, 24 and 25. Cleaning blocks.

First of all, we established that for the areas of unpainted exposed wood, a treatment with hot water and high absorbing synthetic PVA sponges of the “blitz fix” type was sufficient, as it allowed removal of that pigmented layer of organic origin uniformly present over the entire surface. The sides of the beams on the other hand, those affected and compromised by the seepage of rainwater infiltrated from the ceiling, which caused numerous and evident stains surrounded by grime of a rather dark color, required, following the drying of the first general intervention with hot water, a second and subsequent finishing phase, which therefore took place in a localized way, to ensure uniformity of the intervention itself, which then facilitated, with the accompaniment of tones, the subsequent intervention of chromatic restitution. In areas with strong blackening, 1% Coccocollagen in a gelled solution was generally used with the interposition of Japanese paper and subsequent rinsing with demineralized water.

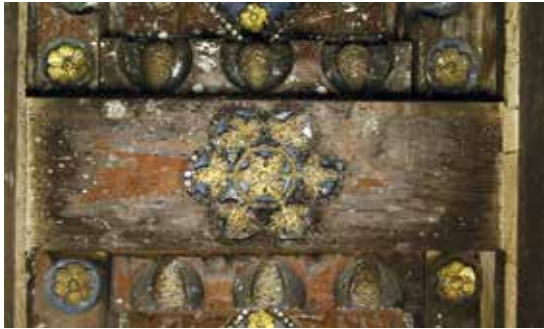
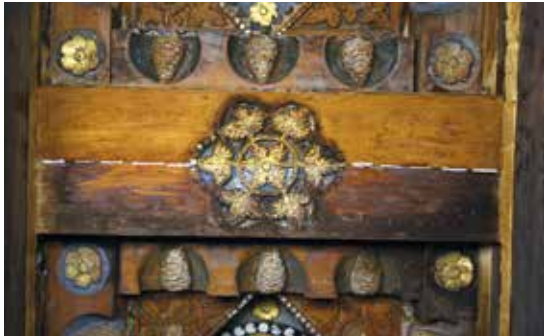
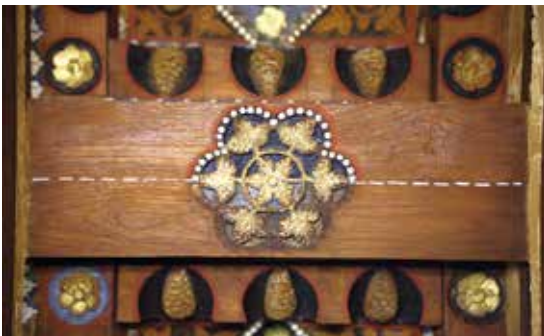
Figs 26, 27 and 28. In sequence the restoration intervention on an underbeam in some of its phases, from above the state of affairs, cleaning and pictorial retouching.

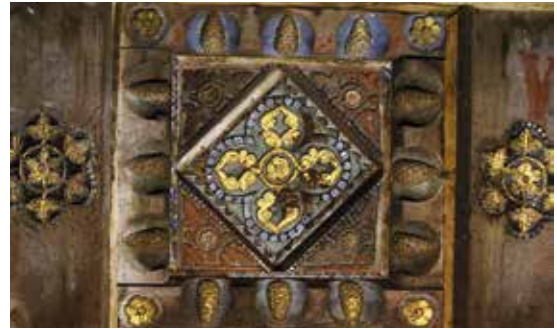
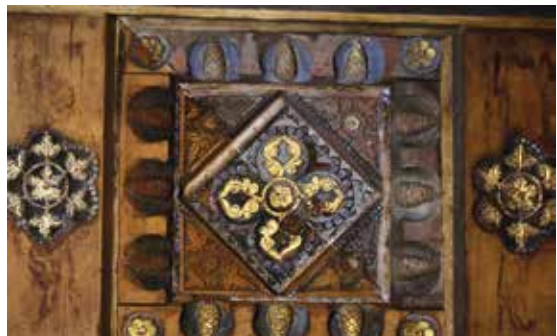
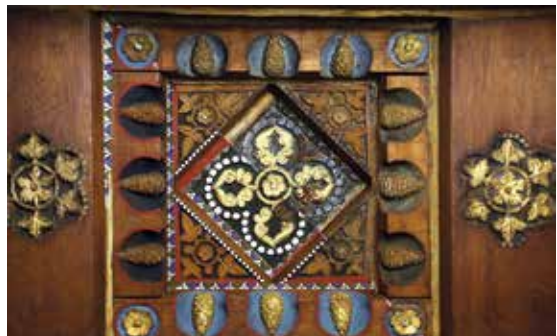
Figs 29, 30 and 31. In sequence the restoration intervention on a coffer in some of its phases, from above the state of affairs, cleaning and pictorial retouching.

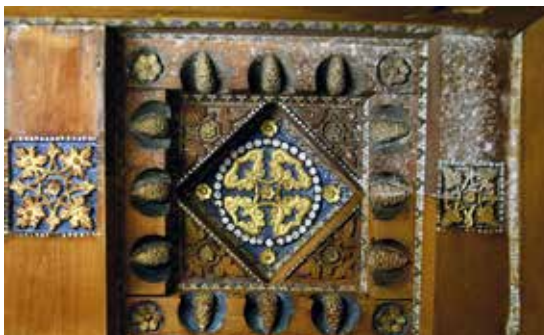
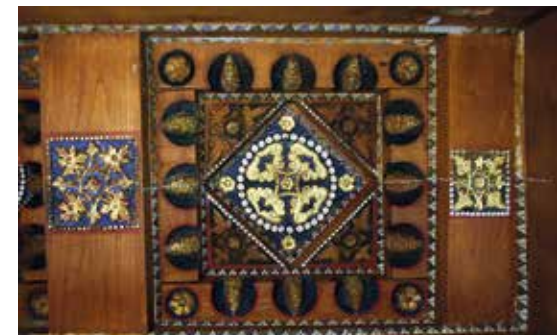
Figs 32 and 33. In sequence the restoration intervention on a coffer in two of its phases, cleaning and pictorial retouching.

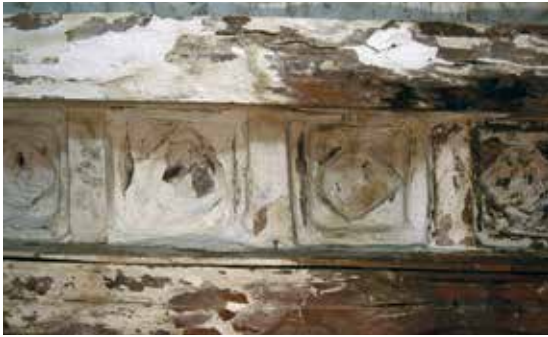
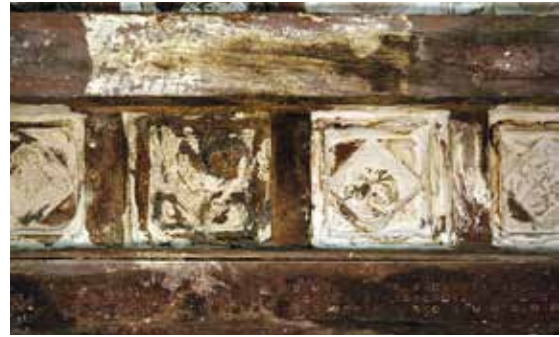
Infill and plastering had also been used abundantly on the beams. Probably, also in this case, the work had been done in the past, as for the coffers, with the aim of restoring

Figs 3 and 4. Some areas of the western sector that had been completely covered with acrylic paint and gypsum-based plaster.

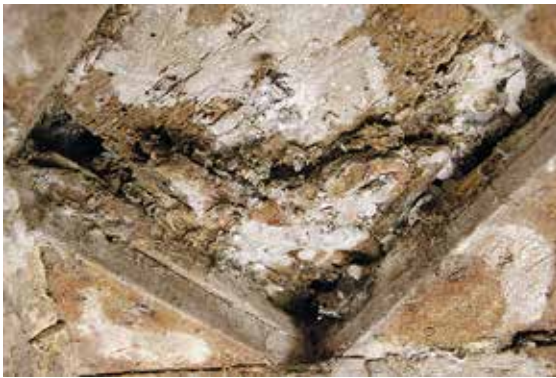
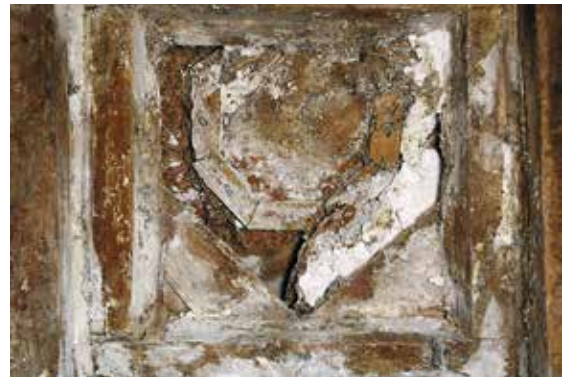
Figs 5 and 6. Some areas of coffers freed from the layer of white plaster reveal numerous unsafe elements.

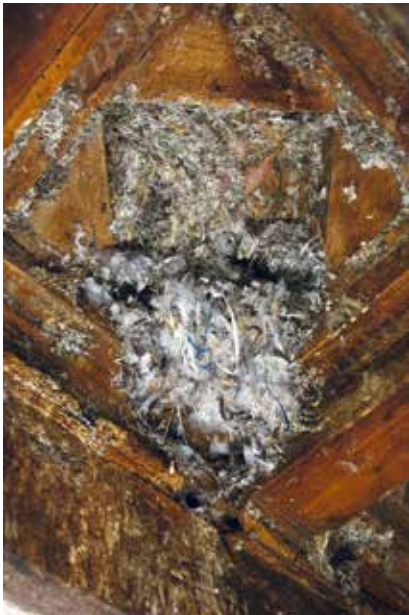
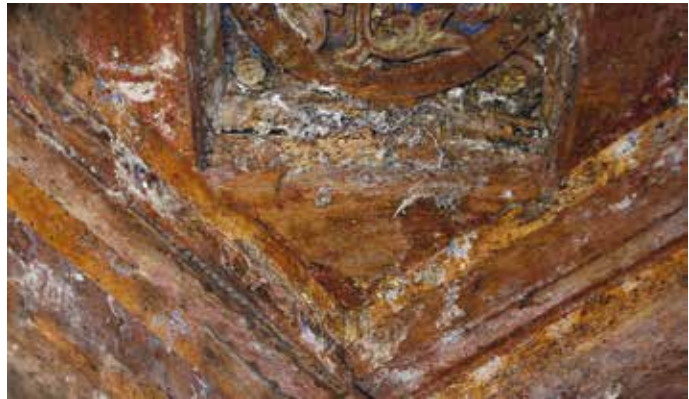
Fig. 7 and 8. Detail of one of the many coffers damaged by nesting birds.

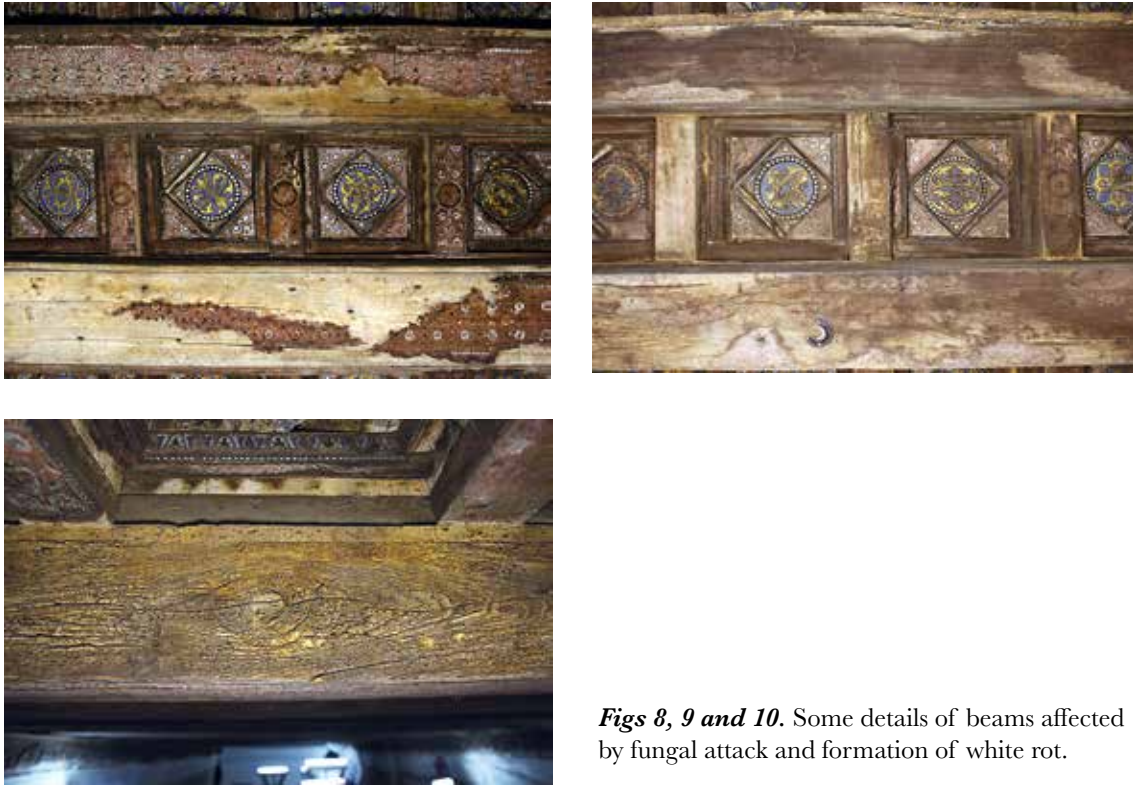
Figs 8, 9 and 10. Some details of beams affected by fungal attack and formation of white rot.

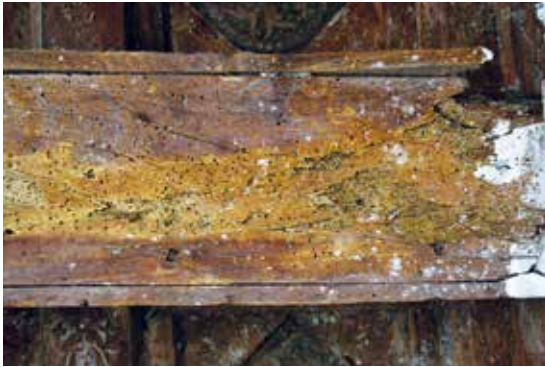
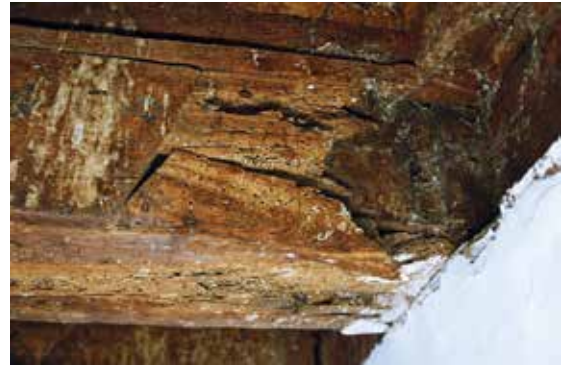
As for the beams, some cladding boards have been lost, possibly fallen or removed over the years as completely deteriorated, others were in an advanced state of decay with cavities affecting the board itself in all its dimensions.

Figs 11 and 12. Detail of some roofing of the beams damaged by attacks of xylophageous insects.

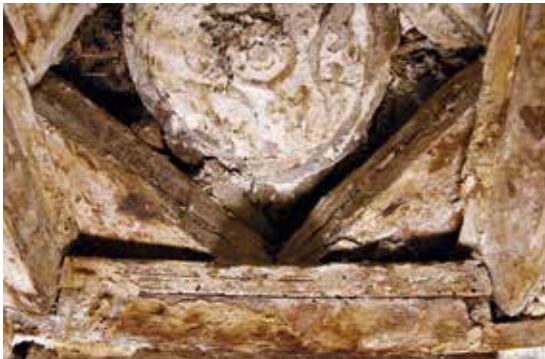
Fig. 13. Detail of a coffer in which the combination of various degradation factors caused the constituent elements to collapse.
