THE GREAT MOSQUE OF ŞAN'Ā'

Conservation intervention

(2005-2015)

FOUNDATIONS OF THE GREAT MOSQUE IN ŞAN‘Ā’

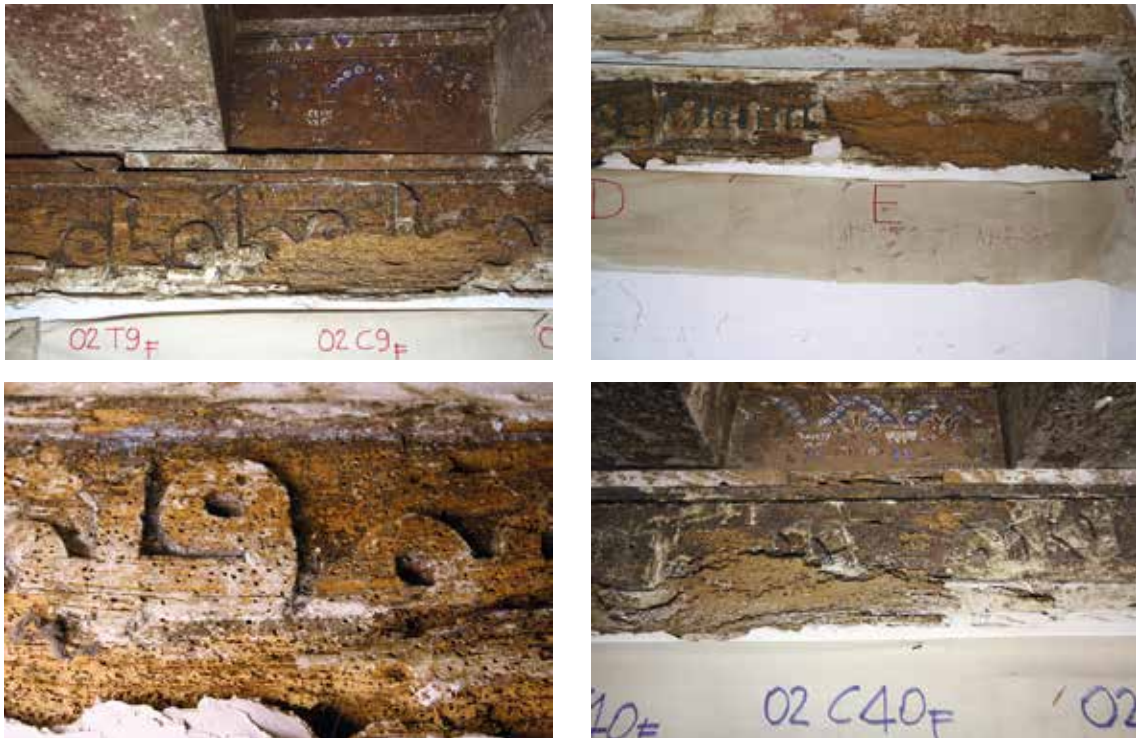
Figs 14, 15, 16 and 17. Details of the sleeper band obscured by the attack of xylophagous insects.

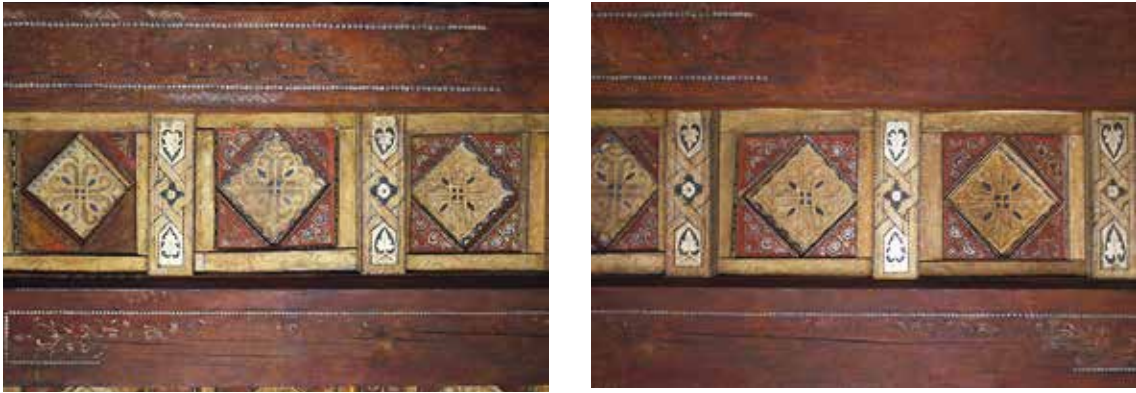
Figs 18 and 19. Example of the rows of coffers in the first spans of the west sector 1.

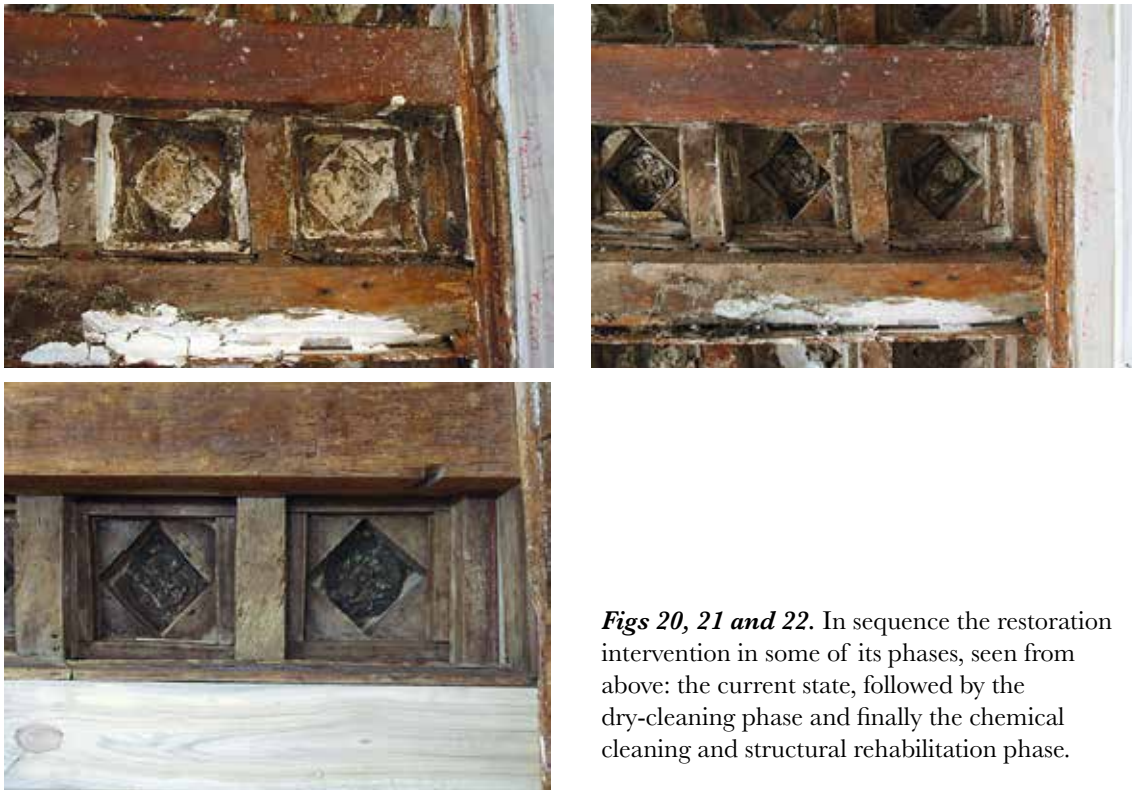
Figs 20, 21 and 22. In sequence the restoration intervention in some of its phases, seen from above: the current state, followed by the dry-cleaning phase and finally the chemical cleaning and structural rehabilitation phase.

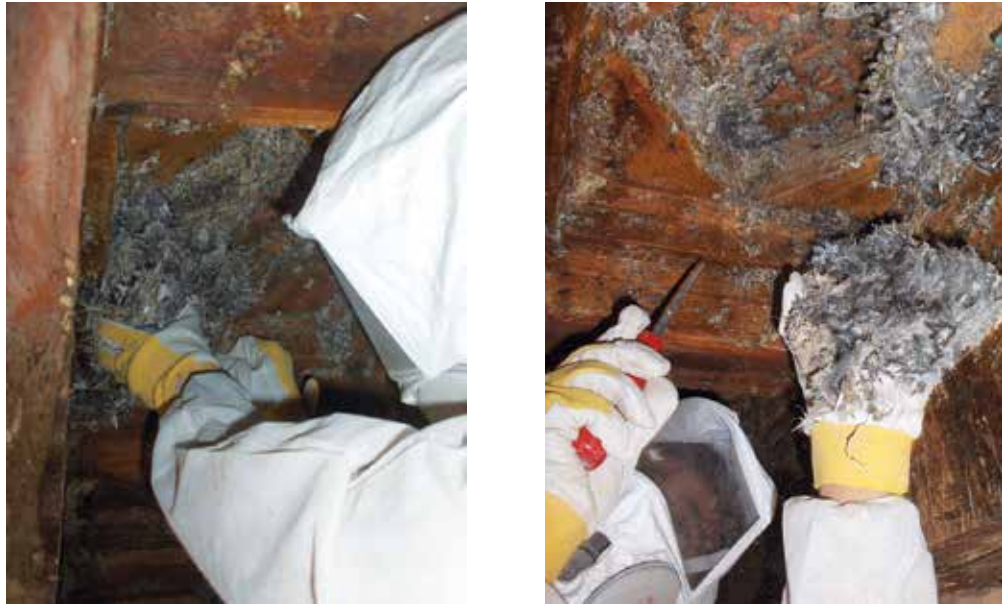
Figs 23 and 24. First cleaning phase which involved the removal of the numerous bird nests.

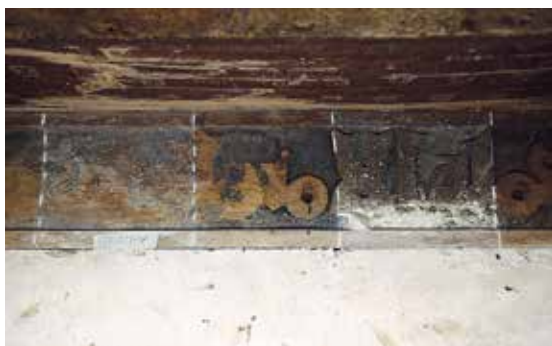
Fig. 25. Solvent-based cleaning on the band of the Koranic inscription.

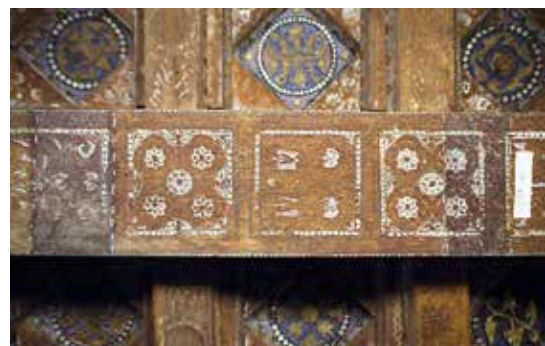
Fig. 26. Solvent-based cleaning on the dehumidification of an under-beam.

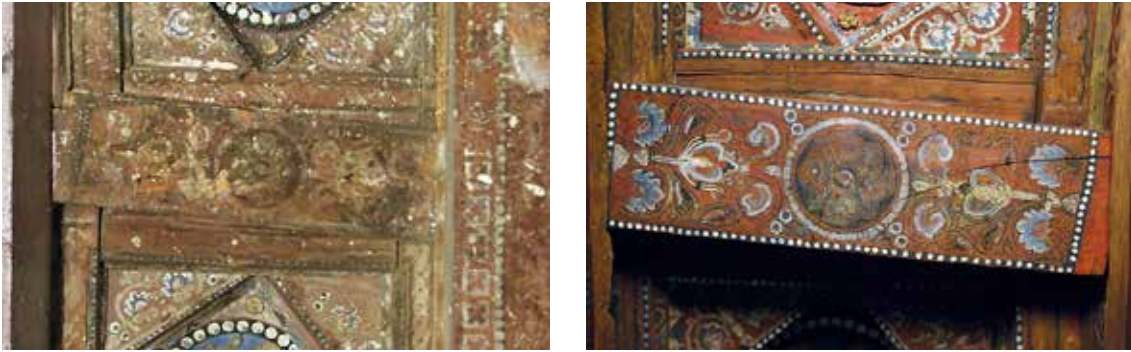
Figs 27 and 28. A photographic comparison between the first and final part of the restoration on a portion of the under beam.

the first spans of the sector. Subsequently, in a localized way, benzalkonium chloride was applied by brush, in all those areas affected by the growth of mold and fungi or white rot.

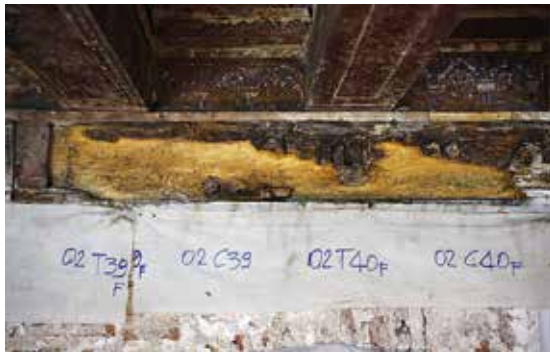
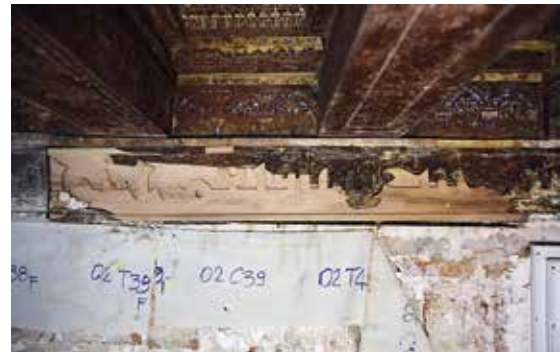
Figs 29 and 30. Example of integration of the Koranic inscription band with a shaped wooden piece.

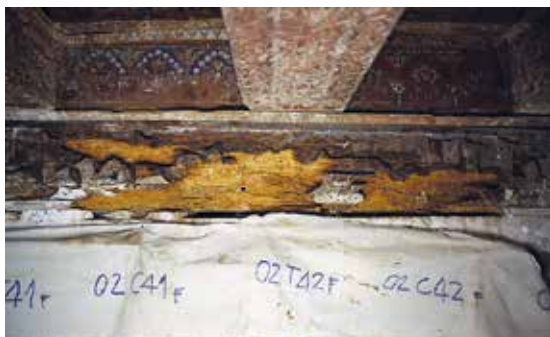
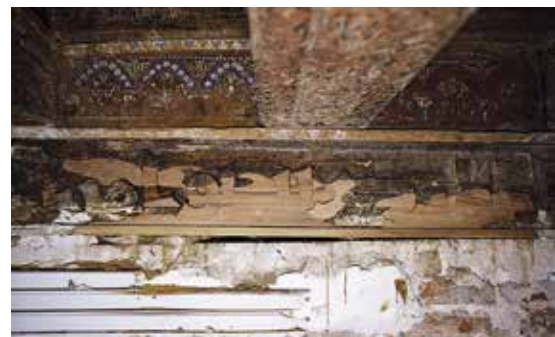
Figs 31 and 32. Example of integration of the Koranic inscription band with a shaped wooden piece.

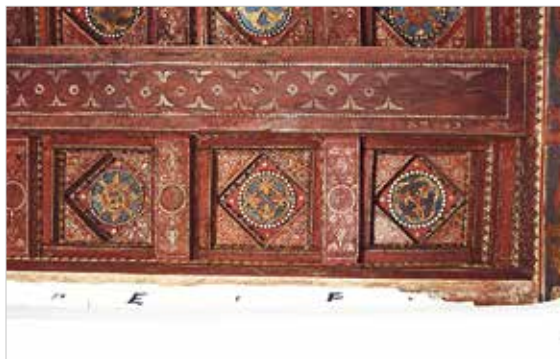
Fig. 33. Detail of the western sector at the end of the intervention.

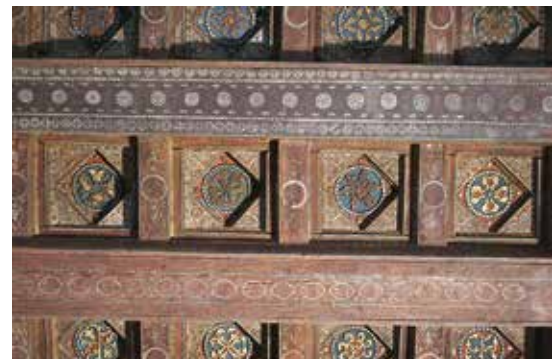
Fig. 34. Detail of the western sector at the end of the intervention.

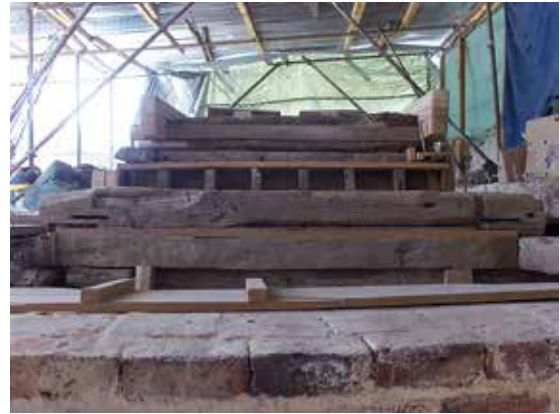
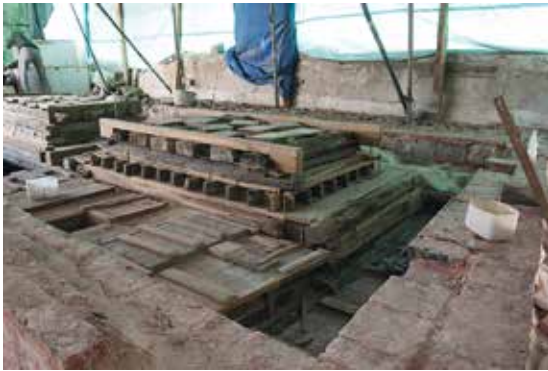
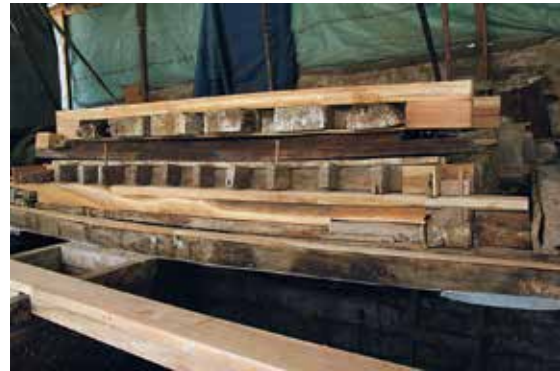
Figs 2, 3, 4 and 5. External structure of the upper “capping structure”.

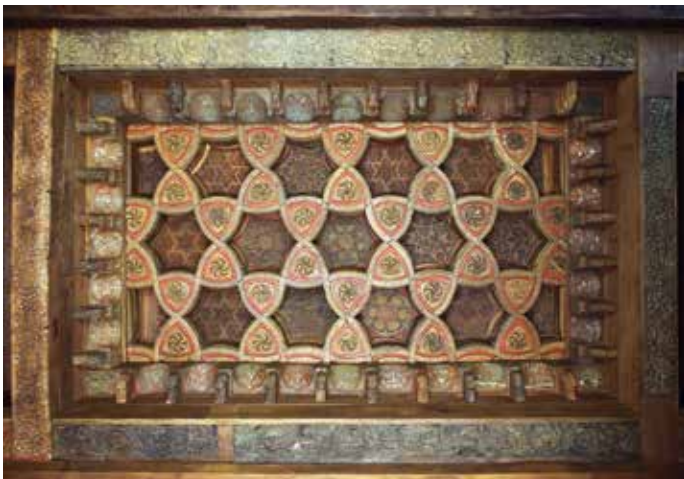
Fig. 6. A detail of the coffer palimpsest following the structural restoration and the cleaning intervention.

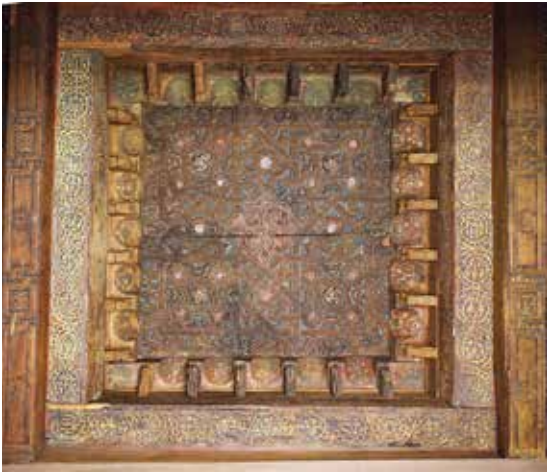
Fig. 7. A detail of the coffer palimpsest following the structural restoration and the cleaning intervention.

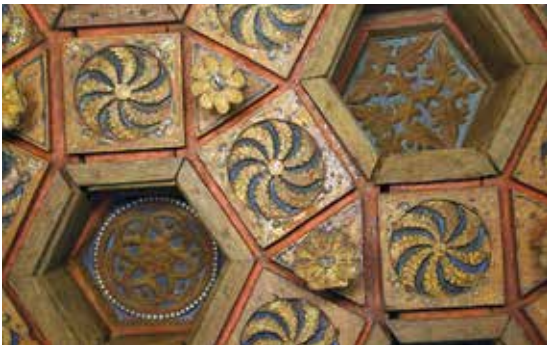
Fig. 8. Detail of one of the “end caps”.

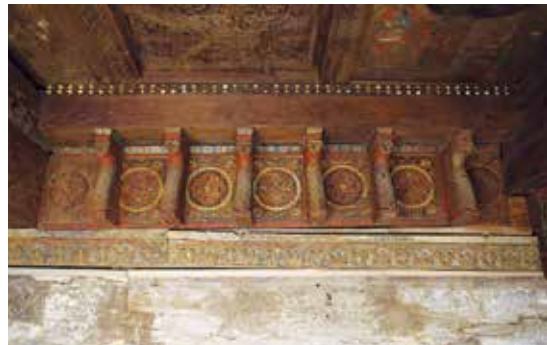
Fig. 9. Detail of a side decoration.

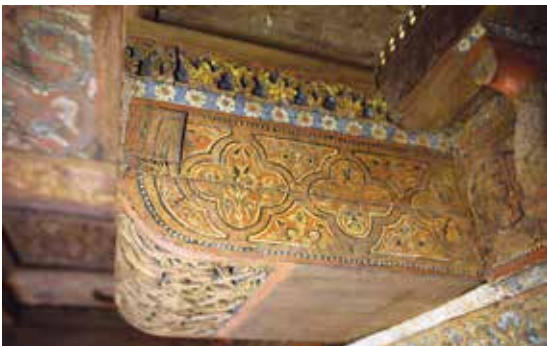
Fig. 10. Detail of what originally must have been a decorated and carved capital.

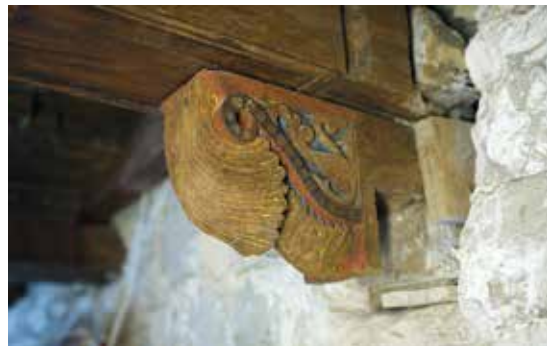
Fig. 11. Detail of a small decorative element placed under one of the secondary beams.

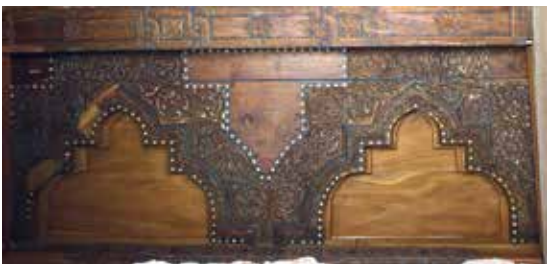
Fig. 12. Detail of a carved wooden window, here reused as a horizontal roofing element.

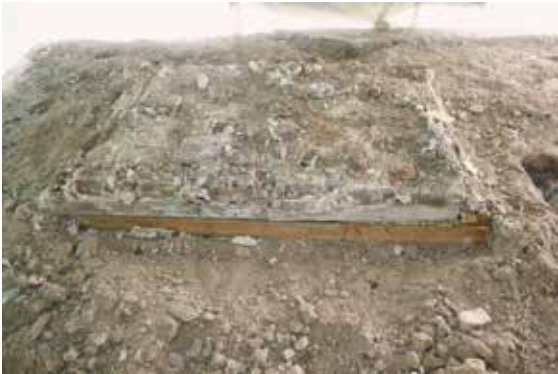
Fig. 17. Removal of the roof covering.

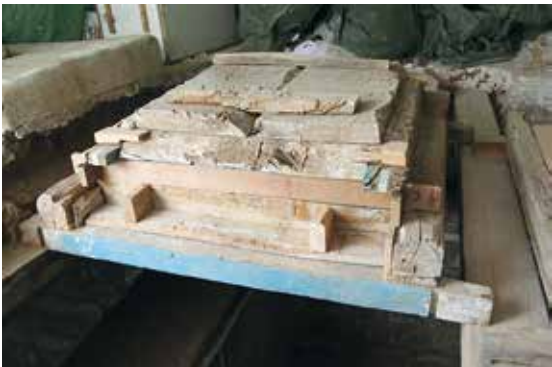
Fig. 18. Phase of the structural intervention in an intermediate stage of reassembly of the upper cap.

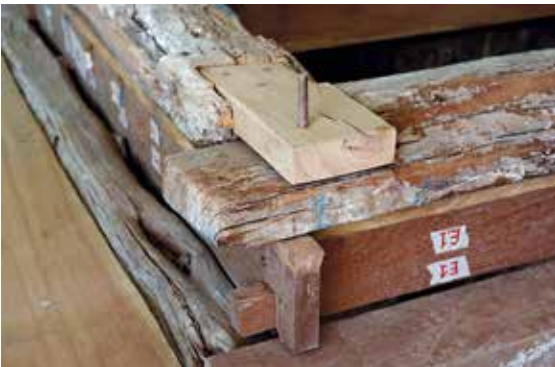
Fig. 19. Detail of the interlocking system of the renovation.

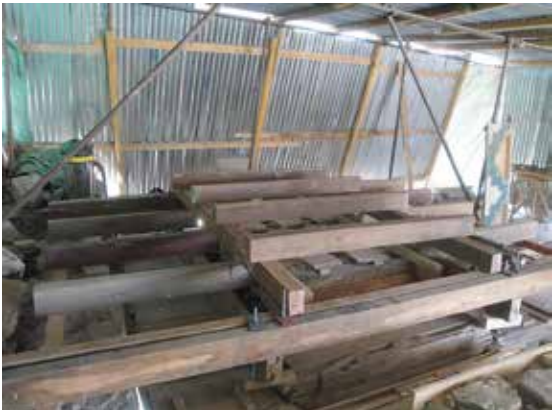
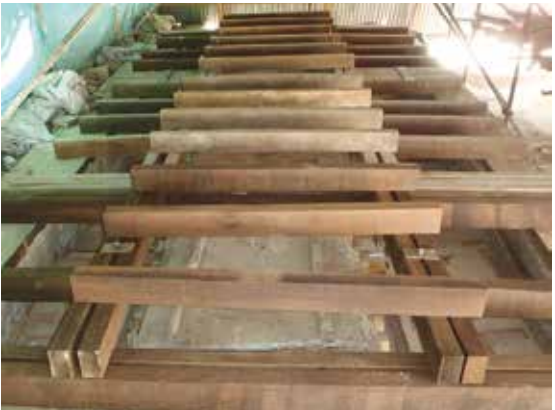
Figs 20 and 21. The pictures show the system of wooden beams supporting the wooden structure.

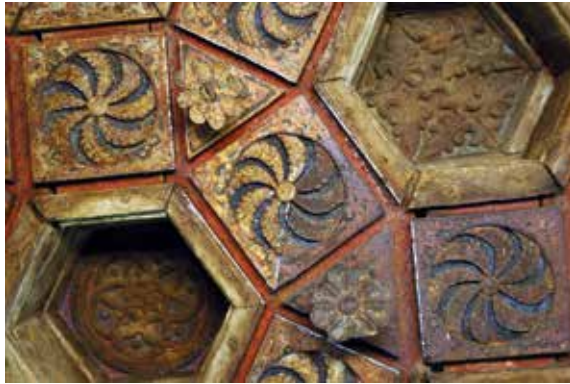
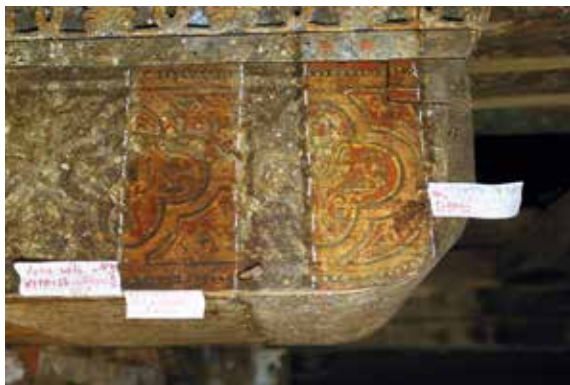
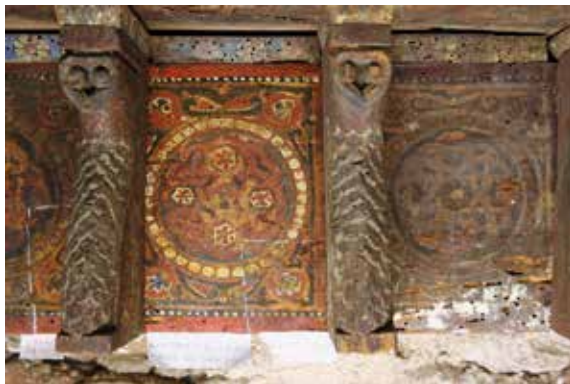
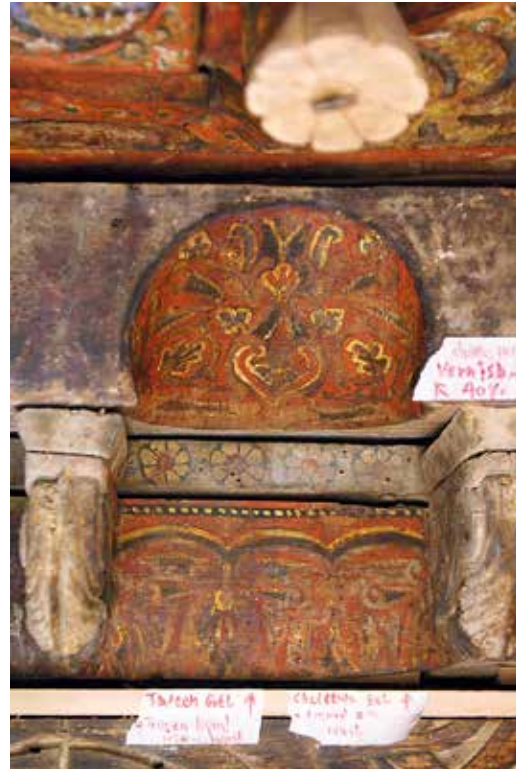
Figs 22, 23, 24 and 25. The photos show some cleaning blocks.

This operation essentially involved the use of surfactants. For the exposed wood areas, a solution with surfactants of the Tween 20 type gave excellent results. For the lower decorated areas the chelating solution at pH 7.5 was used. This same chelating solution was also used for cleaning the gold and for the hexagonal frames of the upper closing cap. Removal of the blue enamel overpainting present on the panels corresponding to the three northern sectors was done with solvengel in benzyl alcohol finished with a pH 9 chelating solution. The use of a pH 9 chelating agent ensured a better finishing in cleaning of the original decorations and wood parts which, otherwise, would have presented a slight blue halo created by the absorption of the wood of the repainting removed by the solvengel.

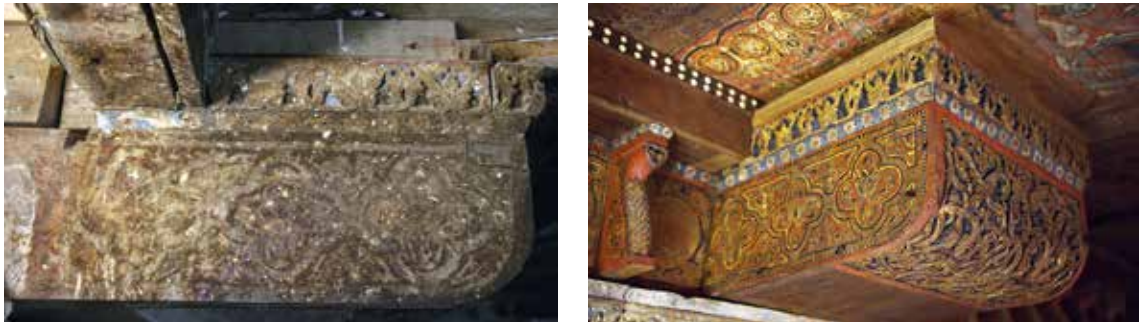
Figs 26 and 27. A comparison of photos before and after restoration.

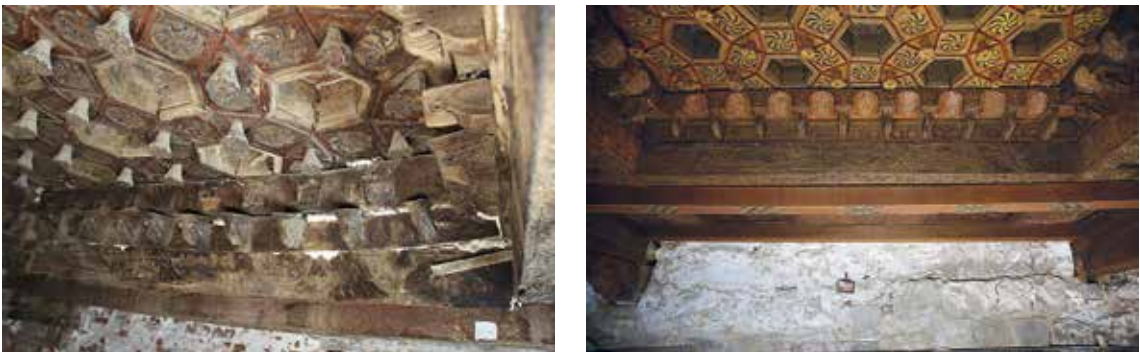
Figs 28 and 29. A comparison photos before and after restoration.

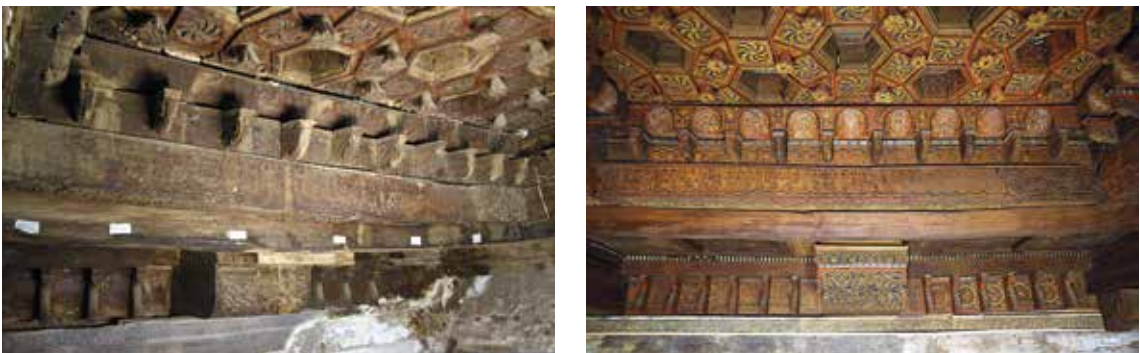
Figs 30 and 31. A comparison of photos before and after restoration.

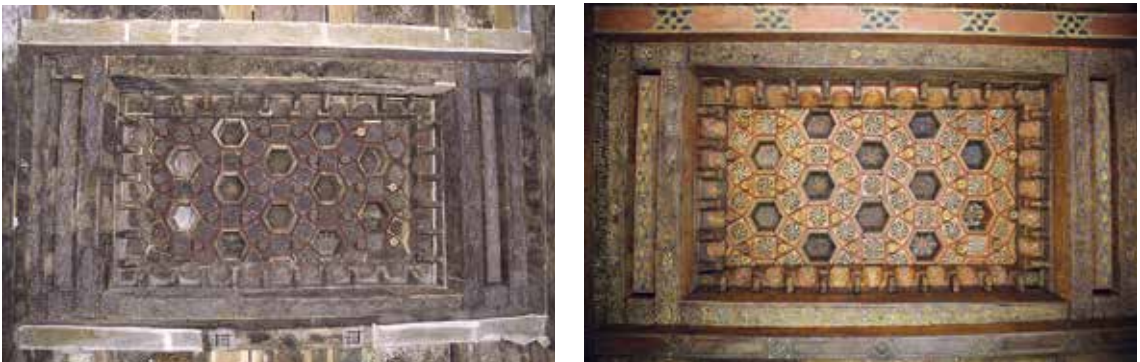
Figs 32 and 33. A comparison photos before and after restoration.

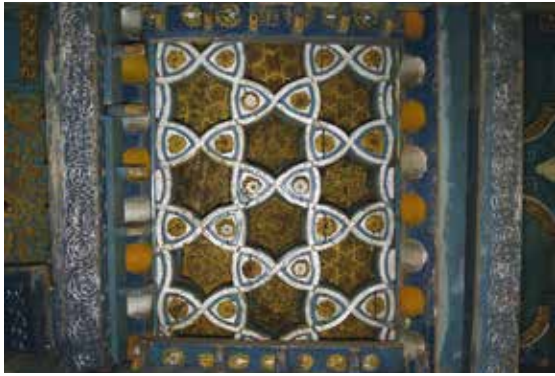
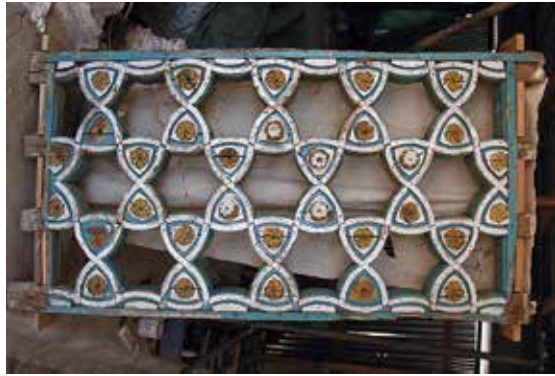
Figs 34 and 35. Top: one of the upper capping structures prior to restoration.
On the right, the same element which, once removed, reveals larger size than previously appeared.

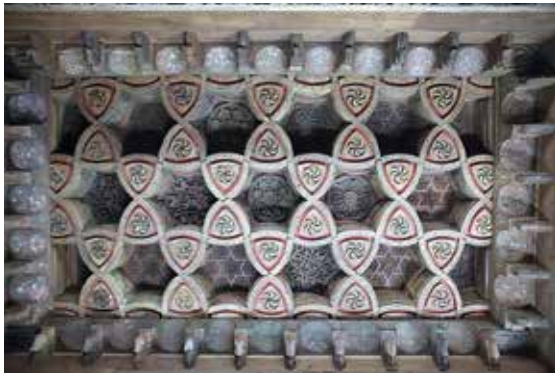
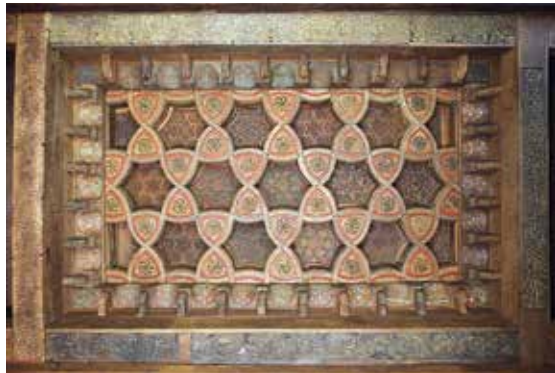
Figs 36 and 37. Top: the upper “capping structure” reassembled in the final structure.
On the right, the sector after restoration.

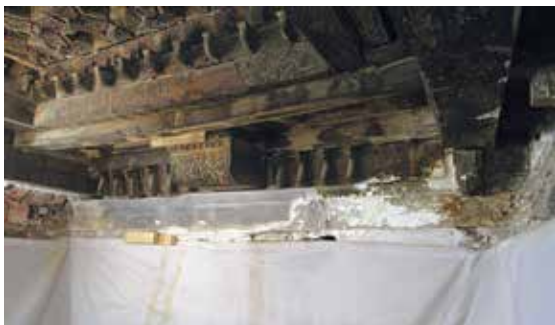
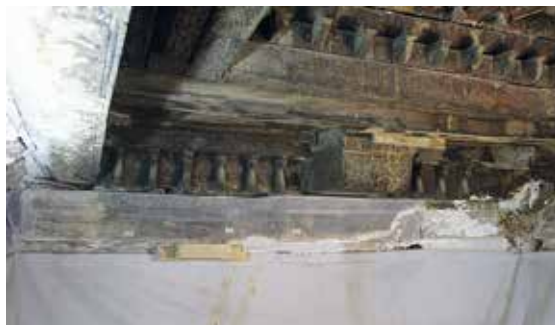
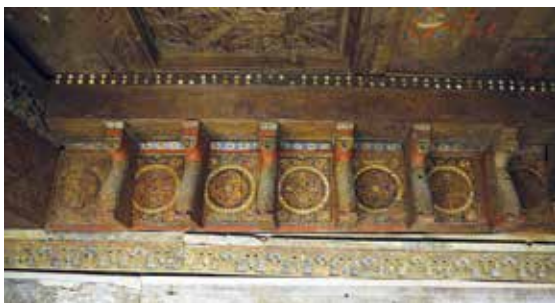
Figs 38, 39 and 40. Top: two details of the lateral decorations prior to restoration.
On the left a detail of the decoration after restoration.

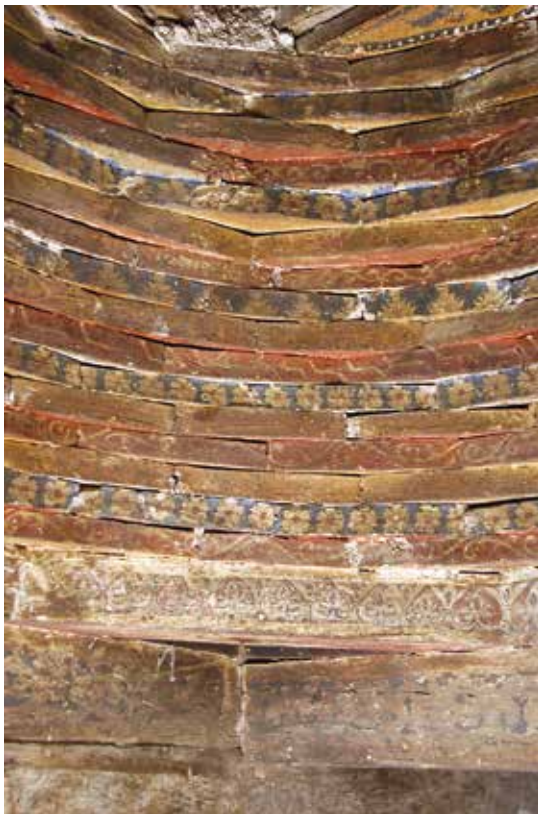
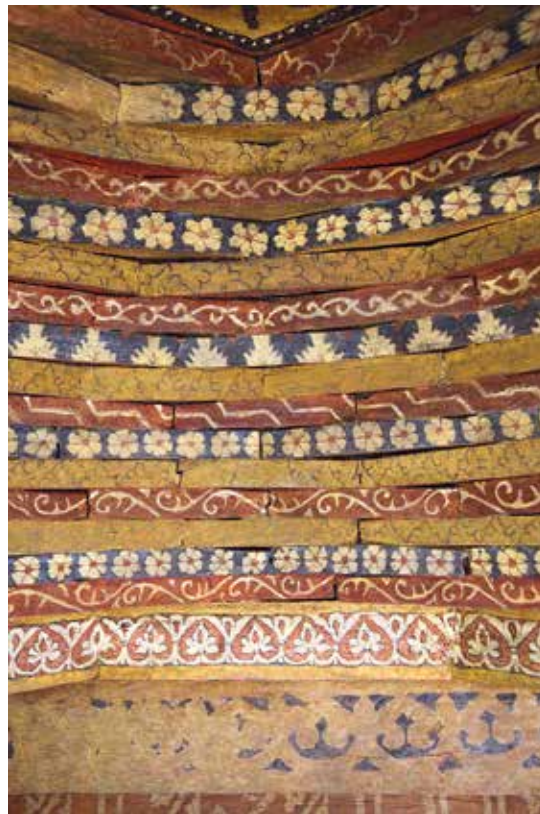
Figs 2 and 3. Detail of the wooden canopy, before and after restoration.

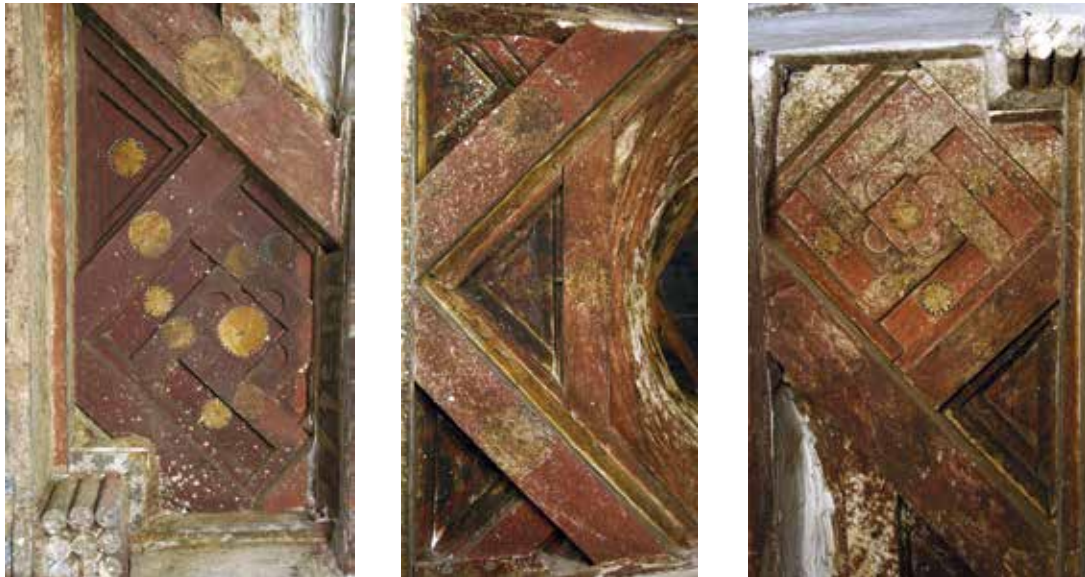
Figs 4, 5 and 6. Details of the under-beam system of the support surface.

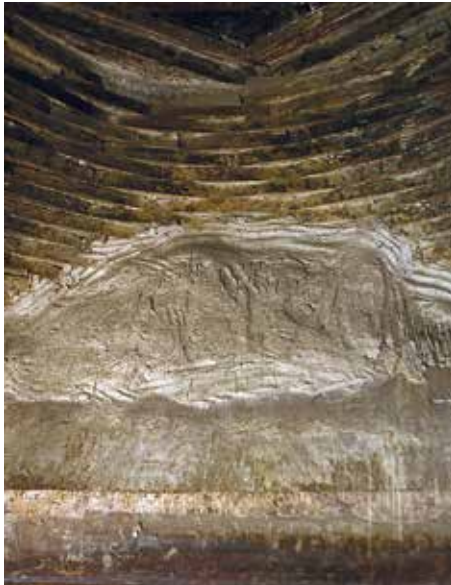
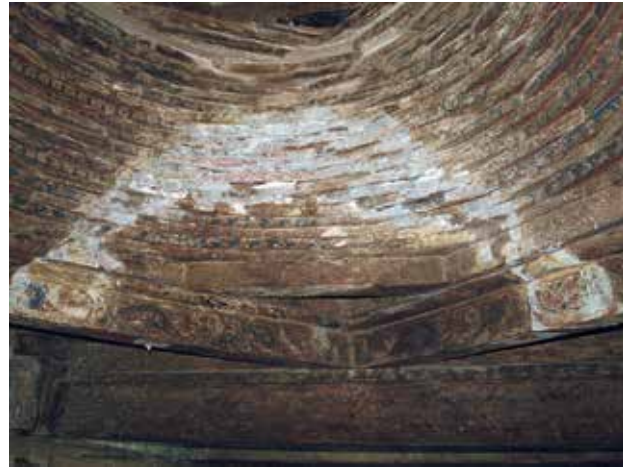
What was immediately striking was the damage created by a conservation intervention, during which two new load-bearing beams were inserted under the central dome, and a large quantity of lime, gypsum and sand-based mixture was used to plug the openings between the same beams of the central cap. This mixture was then widely used in various points to stem sagging of the concentric bands of the caps.

Figs 7 and 8. Details of the large plaster infill found in the central dome.

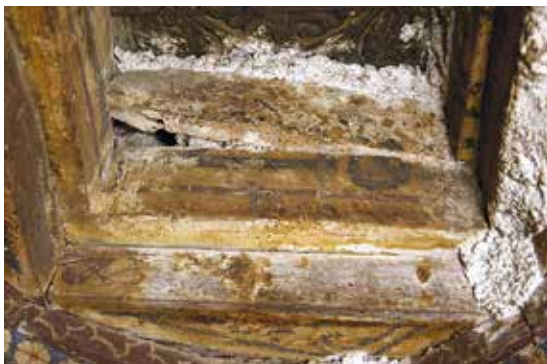
having been in bad condition for some time, had been remodeled and blocked with various buffers in an attempt to fasten the elements; precisely because of these clumsy attempts, however, some elements had been irretrievably lost. The northern right-side dome was devoid of the skylight altogether, and it had been replaced by a coarse and uneven layer of plaster which thus filled the gap.

Fig. 9. Details of the skylight of the NW dome which highlights the precarious state of conservation. The wooden boards showed serious disconnections and large plaster infills.

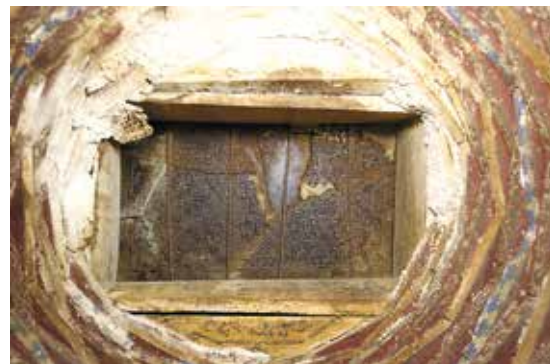
Fig. 10. Details of the skylight of the SW dome. Also in this case, in an attempt to restore the wooden structure, large plaster walls were built which over time which had become unsafe and at risk of collapsing.

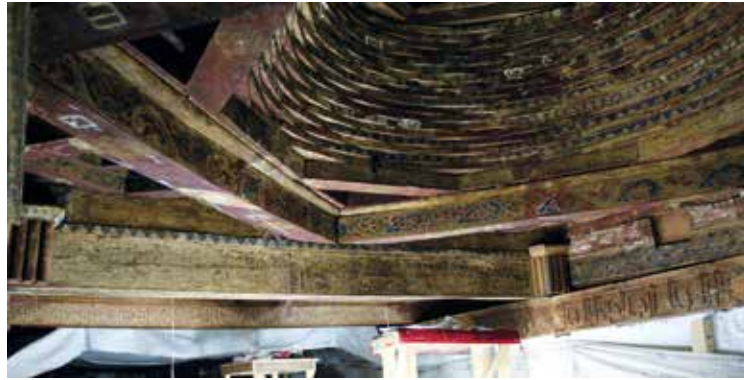
Fig. 11. General view of the central dome during restoration.

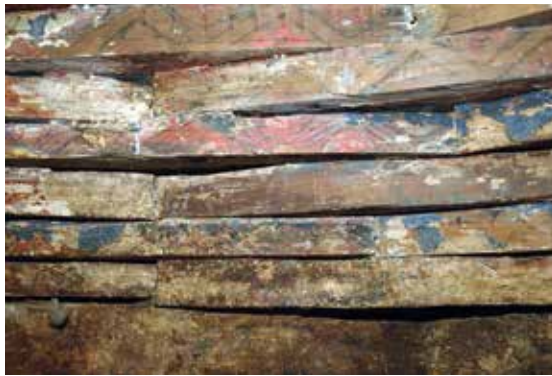
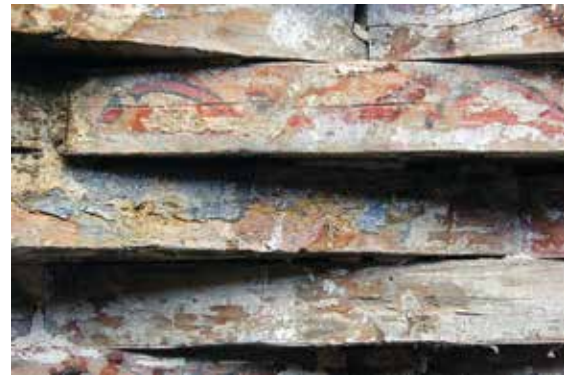
Figs 12 and 13. Detail of the elements that make up the wooden cap.

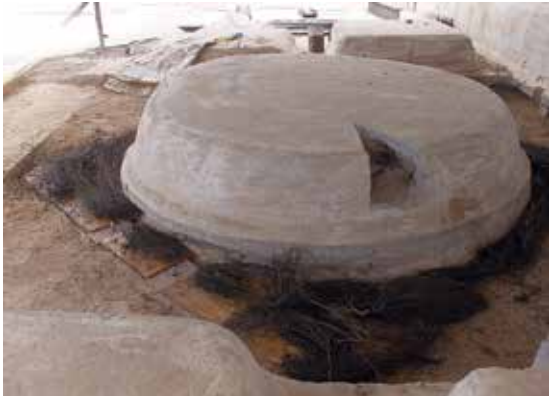
Fig. 17. Detail of the external structure of the central dome.

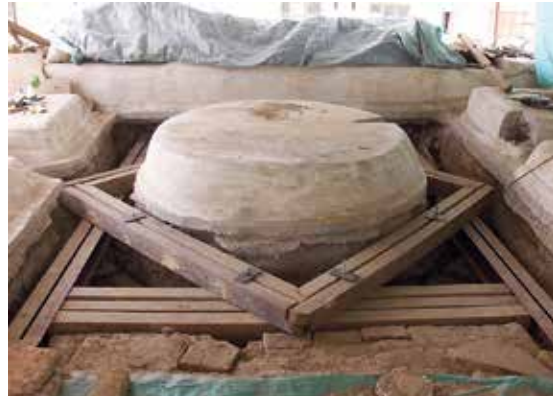
Fig. 18. Detail of part of the external wooden structure built to support the dome.

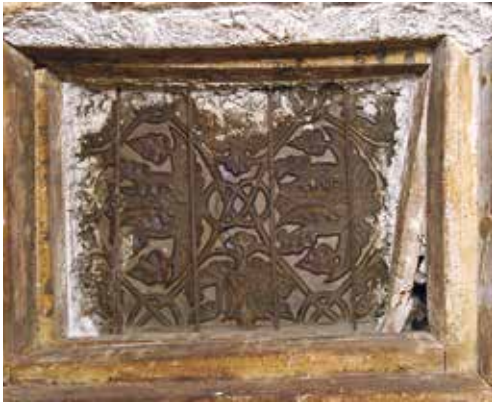
The slab of the north dome on the left side was fractured in the center. In the past, attempts had been made to repair this fracture by means of a plaster pad on the outside and the insertion of metal staples, which, having completely rusted, had become a further obstacle to conservation.

Fig. 19. Detail of the alabaster of the NW dome.

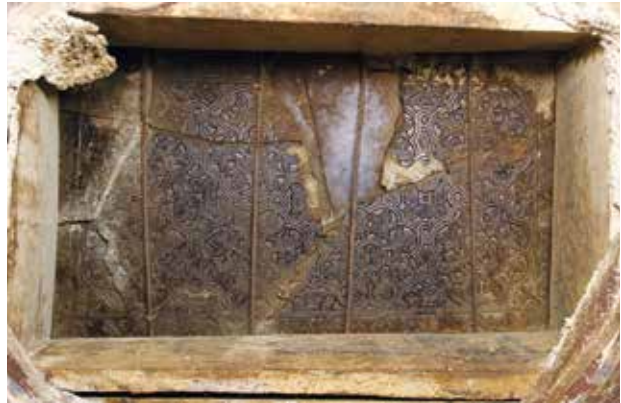
Fig. 20. Detail of the alabaster of the SW dome.

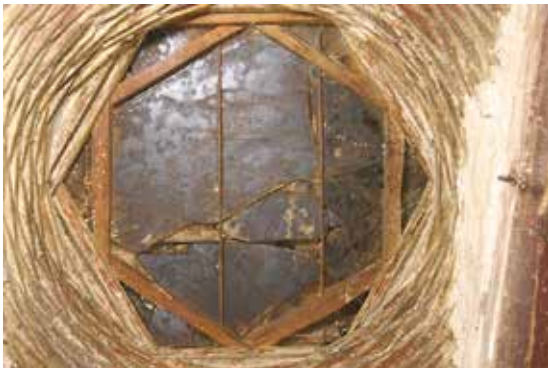
The slab of the central dome was the worst preserved. It was in fact divided into countless fragments of various sizes and dimensions, some of which are now lost.

Fig. 21. Detail of the alabaster of the central dome.

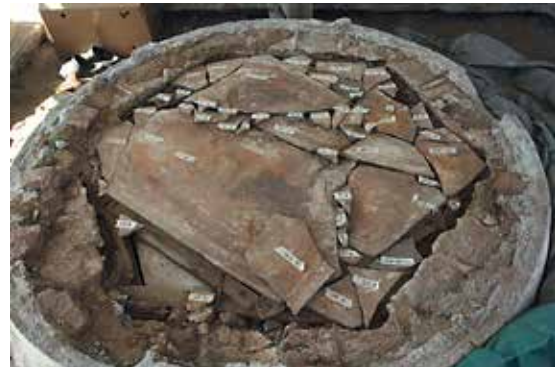
Fig. 22. External view of the alabaster of the central dome.

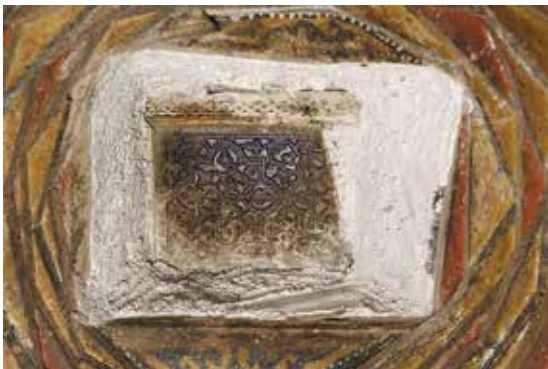
Fig. 23. Detail of the alabaster of the NE dome.

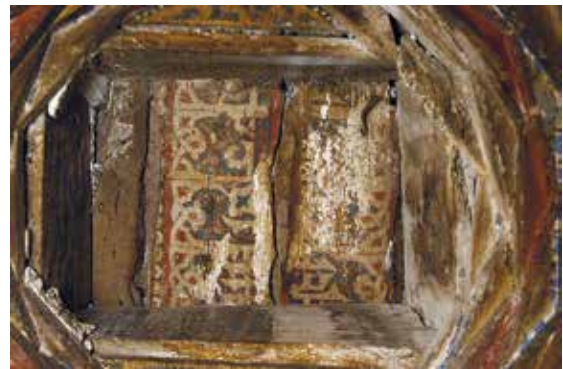
To close the skylights of the domes, alabaster plates were inserted in a simple wooden frame that secured them in their position. The only exception is the south dome on the right side which features two painted wooden panels to replace the original alabaster.

Fig. 24. Detail of the painted wooden board of the SE dome.

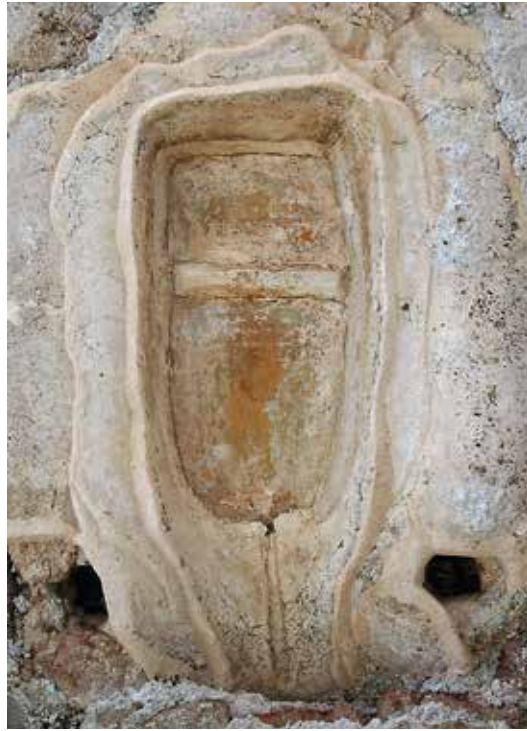
Fig. 25. In the image, the particular *qaḍāḍ* structure found during the excavation above one of the side domes.

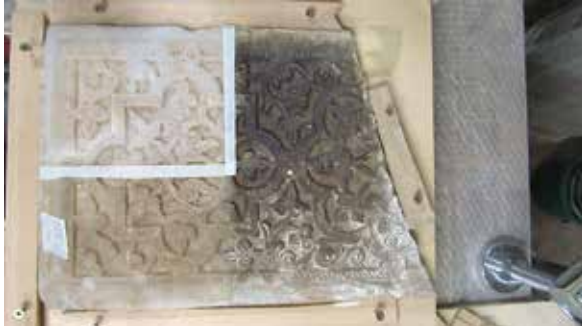
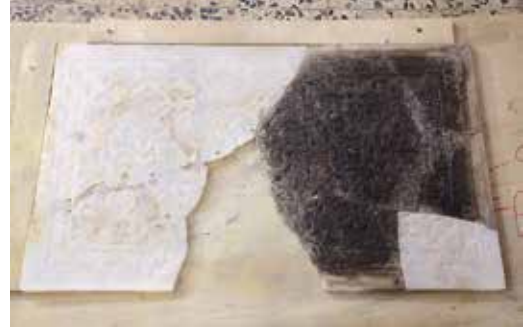
Figs 26 and 27. Detail of the alabaster strips during the intermediate cleaning phase.

- The result obtained by cleaning and by the effect of the ion exchange resins was surprising, as the slabs were restored to their original whiteness.

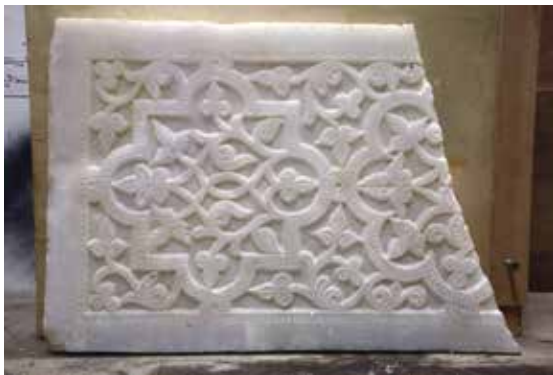
Fig. 28. Detail of one of the alabaster slabs after cleaning.

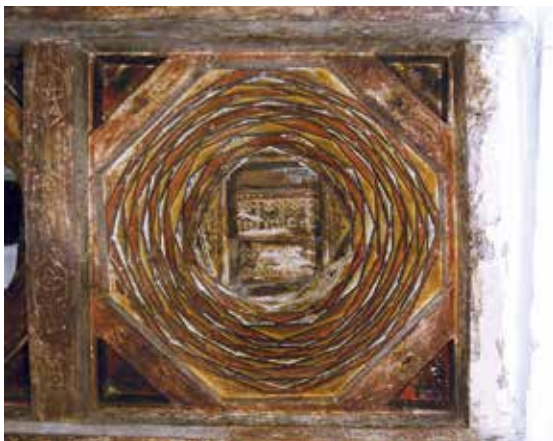
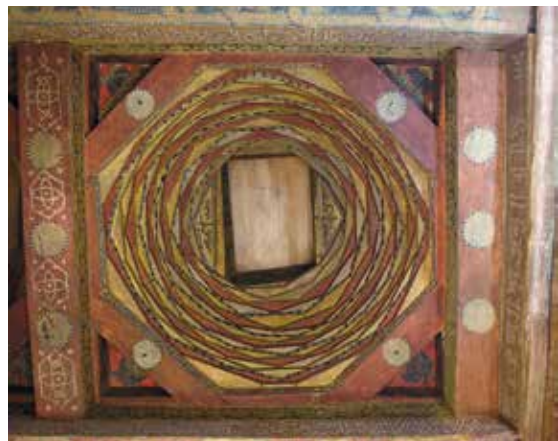
Figs 29 and 30. View of the NW dome before and after restoration.

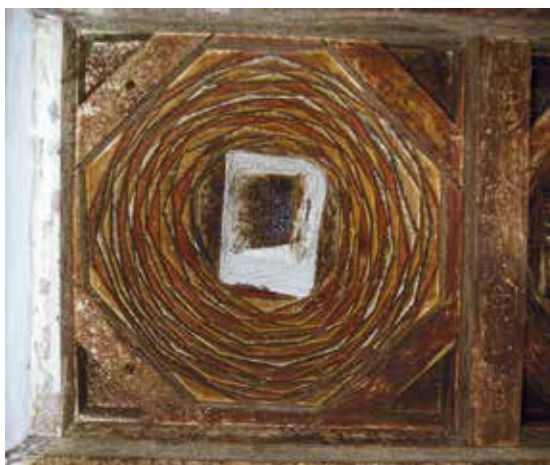
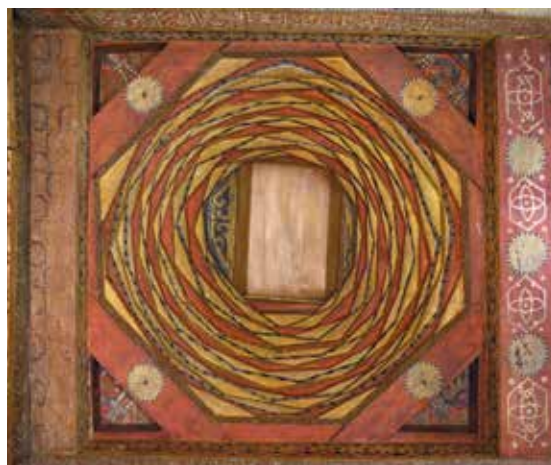
Figs 31 and 32. SW view of the dome before and after restoration.

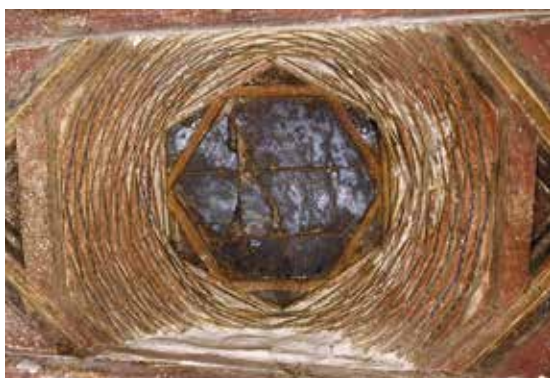
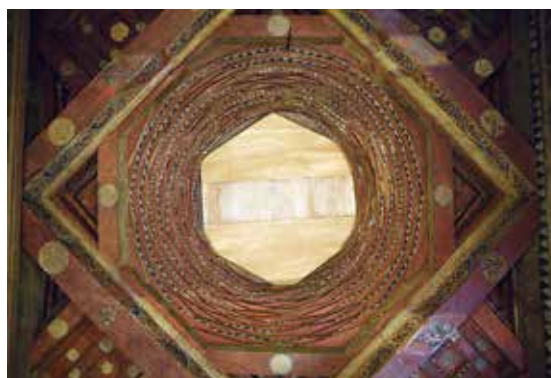
Figs 33 and 34. The central dome before and after restoration.

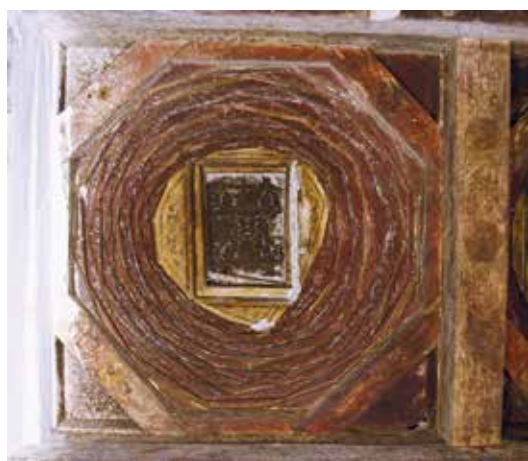
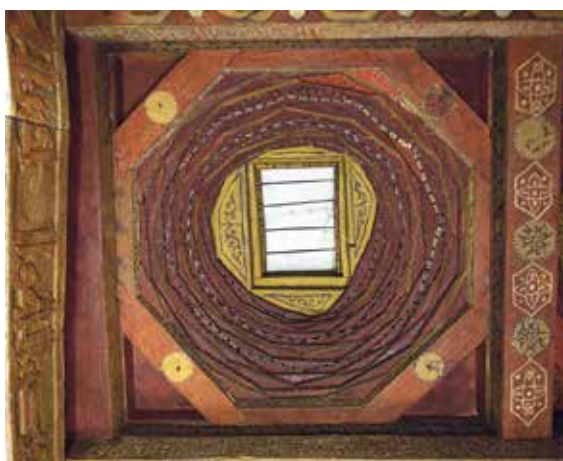
Fig. 35 and 36. View of NW dome before and after restoration.

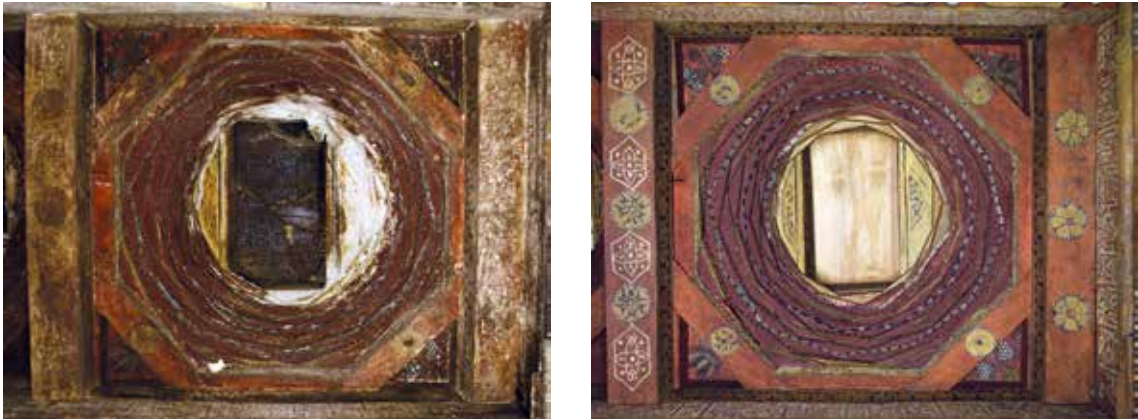
Fig. 37 and 38. View of the SE dome before and after restoration.

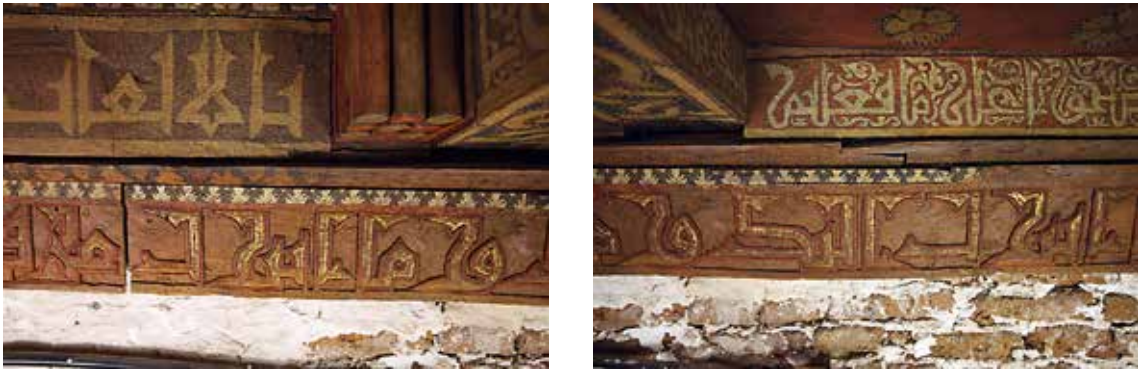
Figs 39 and 40. Detail of the Quranic inscription situated below the domes. This is a rare example of gilded letters.

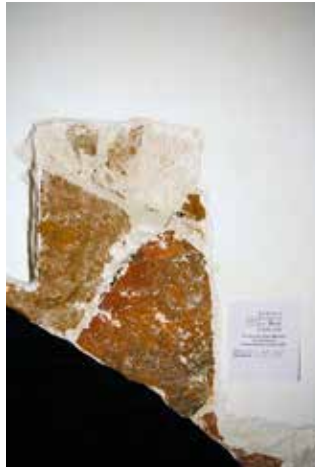
Fig. 10. S2SW0130

The profile of the arches was originally coated, in some cases, with very fine plaster, from 0 to 1 cm thick, and not painted under the industrial plaster (Fig. 10), while in other cases the base layer is from 1 to 3 cm thick, with three coats of lime and gypsum underneath the modern plaster surfacing.

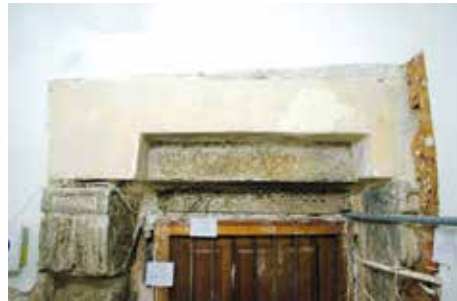
Fig. 11. S3WW0150-Door

The lintel on the outside of the entrance door on the west wall does not exhibit any traces of plaster under the industrial layer, from which we can deduce that it was left bare or only painted white (Fig. 11).
