THE GREAT MOSQUE OF ŞAN'Ā'

Conservation intervention

(2005-2015)

FOUNDATIONS OF THE GREAT MOSQUE IN ŞAN‘Ā’

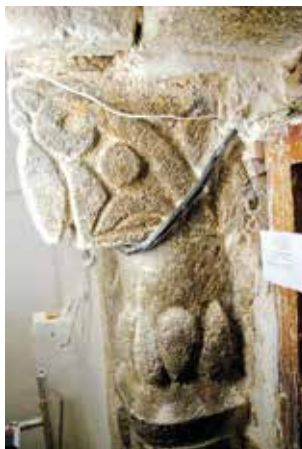
Fig. 12. S3WW0152-Door

Inside the doorway, the lintel was carved, while the basalt capitals were also plastered (Fig. 12).

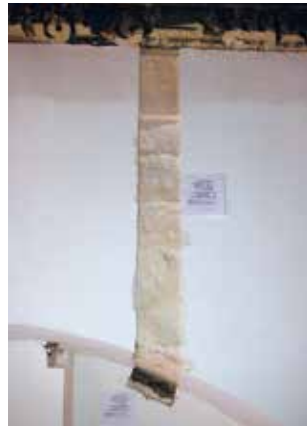
Fig. 20. W3EW0208

We discovered an arch in the inner courtyard (Fig. 20), that had been walled over, plastered and painted.

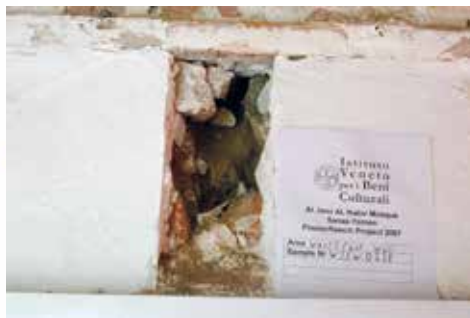
Fig. 21. W3EW0228

The rest of the wall repeats the masonry in bricks and white mortar of gypsum and lime with jutting steps toward the ceiling, painted in three coats of white lime underneath the industrial plaster. There was an uneven spot about halfway up the wall (Fig. 21) due to a crack or joint in the masonry.

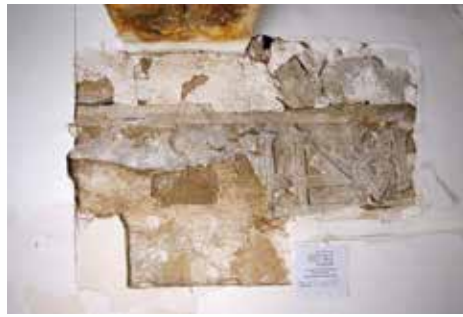
Fig. 22. N1NW0322

The perimetral wall on the north wing consists of sandstone blocks and basalt ashlar with white mortar, most of which was not plastered under the general modern surfacing. In the western corner where the walls meet, we discovered the system of positioning the ceiling beams, and the different composition of the two walls. The second layer of the western wall (which had been rebuilt) consisted of sandstone blocks plastered with industrial gypsum. Here we discovered a number of carved wooden planks inscribed with gilt lettering outlined in red on a black background. This had been plastered prior to application of the modern surfacing. In other areas (Fig. 22), an inscription on wood measuring 22 cm was found under the plaster.

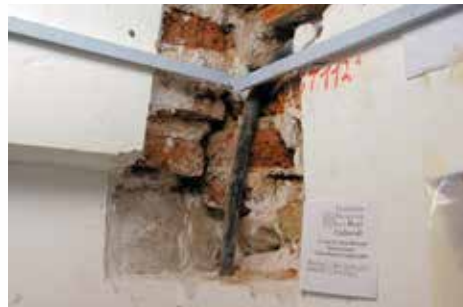
Fig. 23. E3ENW0423

In the entrance area, about halfway up the wall, there were more decorated wooden boards and a coat of white mortar. Beyond the door, toward the west, an inscription in plaster is visible, which had been painted red originally, then green and finally silver on a white background. The inscription was later covered over with acrylic and oil-based paints. Toward the east wing ashlar with inscriptions were found (Fig. 23). The perimetral wall in the sector bordering on the east wing contains three rows of progressively jutting bricks at the top (see E3ENW0423, E2ENW0415, E2WNW0416...)

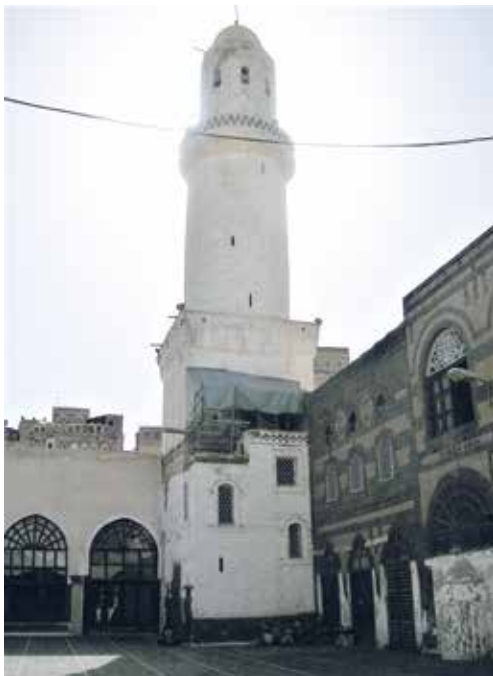
Fig. 36. Southeastern minaret prior to restoration, detail visible after collapse of the plaster applied over the decoration and inscription in the plaster.

The restoration project included a descialbo process to remove all the layers of mortar applied over plaster decorations and clean the surfaces, as well as structural consolidation of the plastering and plaster decoration, patching of gaps, chromatic color balancing of the surfaces and application of a protective coat of waterproofing.

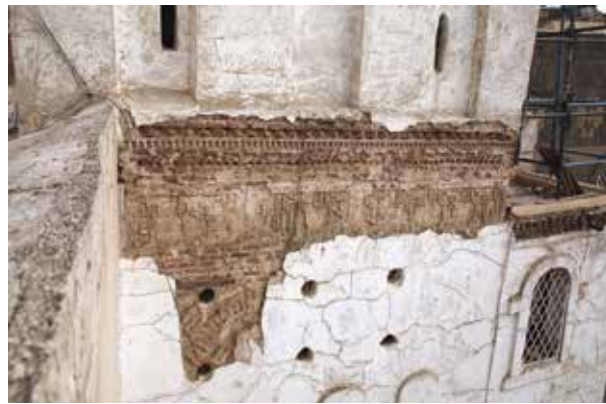
Fig. 35. Southeastern minaret prior to restoration.

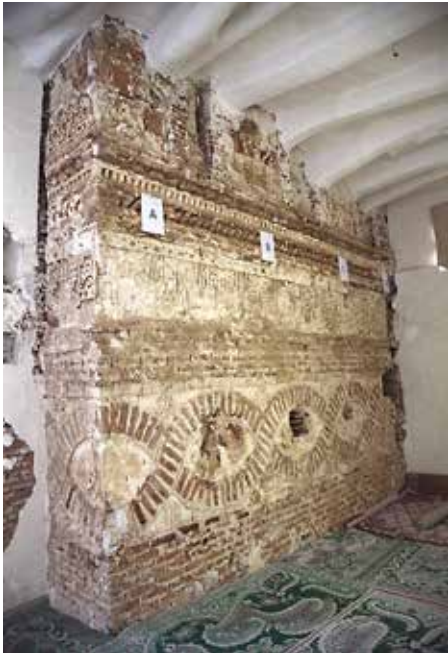
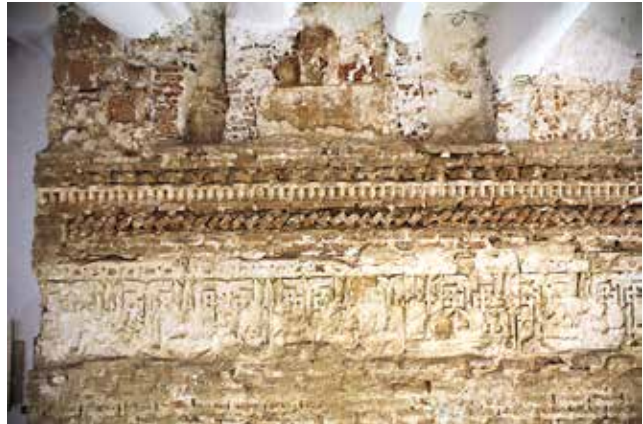
Figs 37, 38. Southeastern minaret prior to restoration. Detail of the plaster decoration incorporated into the library area.

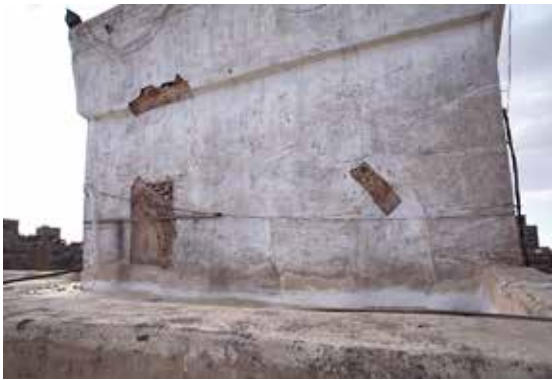
Fig. 39. Southeastern minaret prior to restoration. A number of stratigraphic assays were done for cleaning and investigation as to the position, type and condition of the original decorative plan.

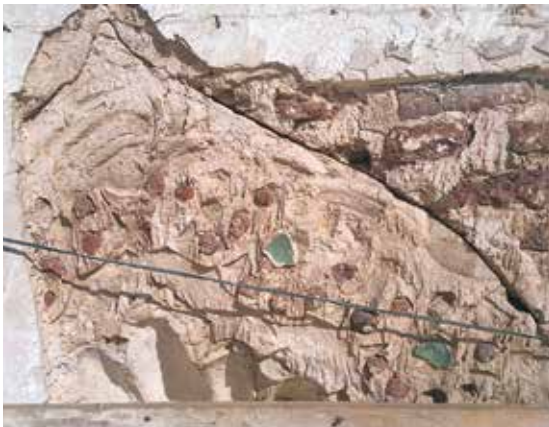
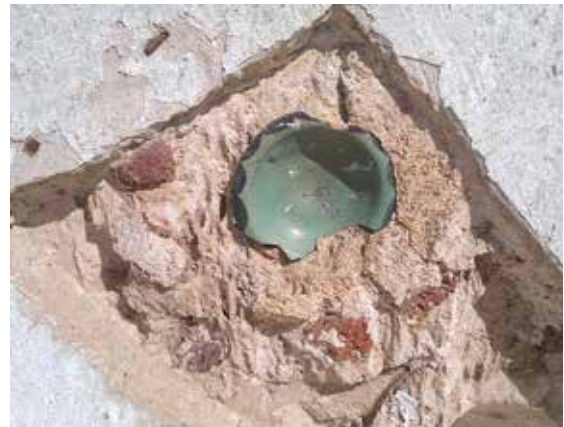
Figs 40, 41. Southeastern minaret prior to restoration. The illustrations show a few details of the cleaning assays in which the presence of inset elements in green ceramic can be seen.

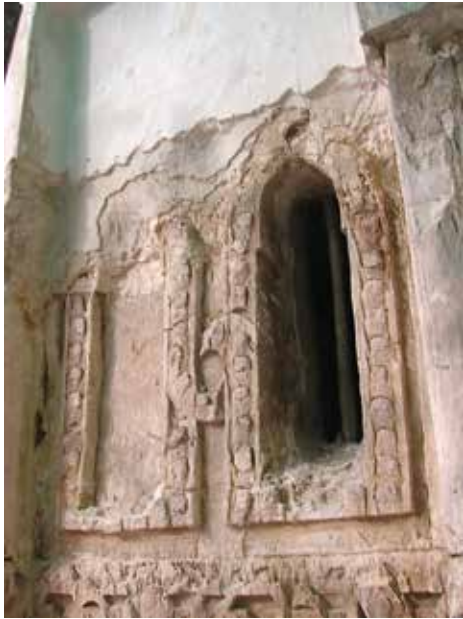
Fig. 42. Southeastern minaret, detail of the apertures on the western façade discovered after the first scrapings.

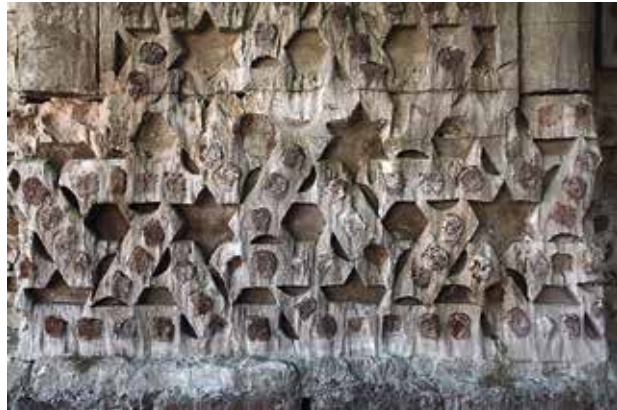
Fig. 43. Southeastern minaret, detail of the decoration uncovered on the western façade after the first scrapings.

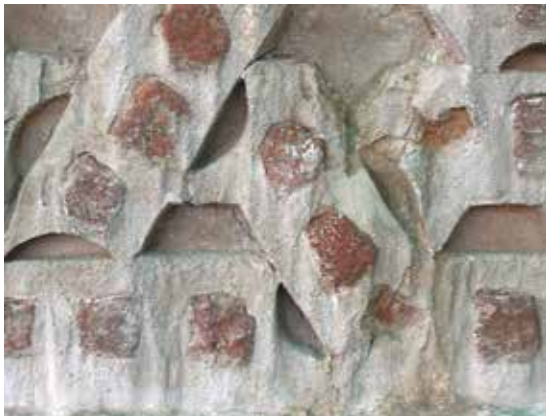
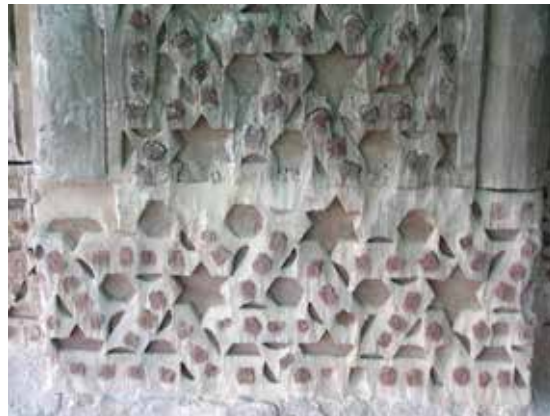
Figs 44, 45. Southeastern minaret, detail of the decorations on the west wall after cleaning and repointing the plaster.

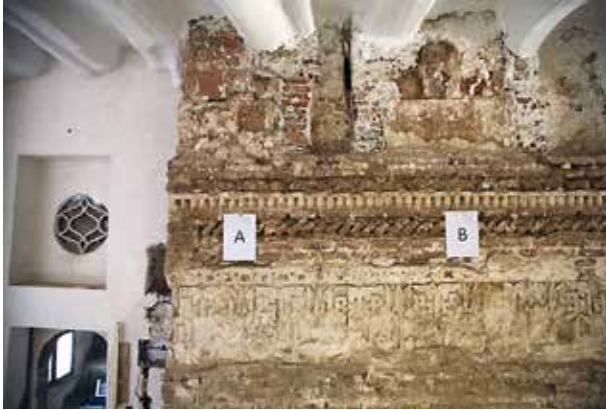
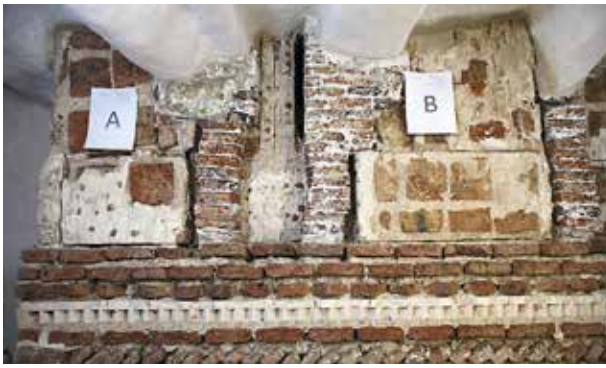
Figs 46, 47. Southeastern minaret, detail of the interior decoration before and after restoration.

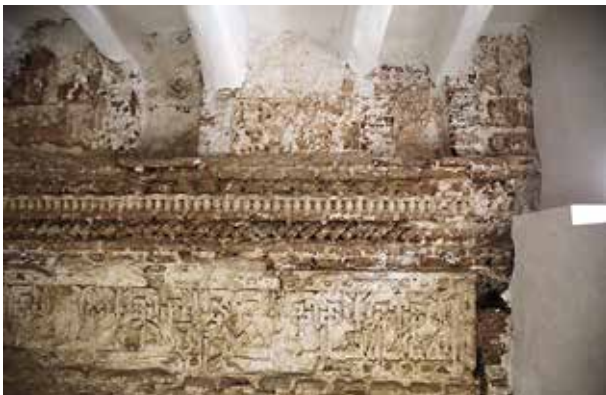
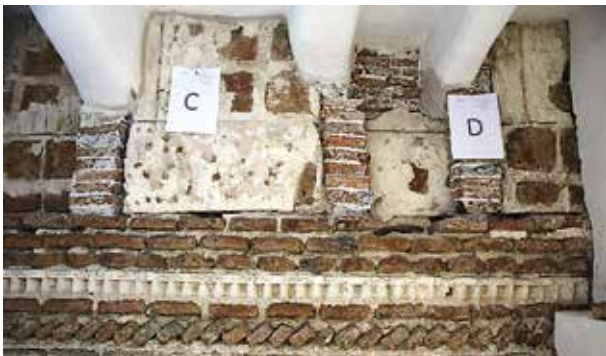
Figs 48, 49. Southeastern minaret, detail of the interior decoration before and after restoration.

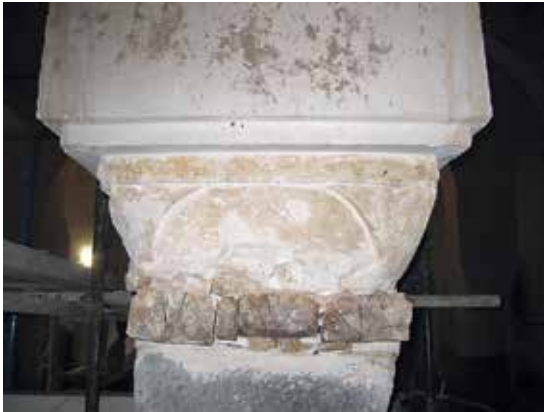
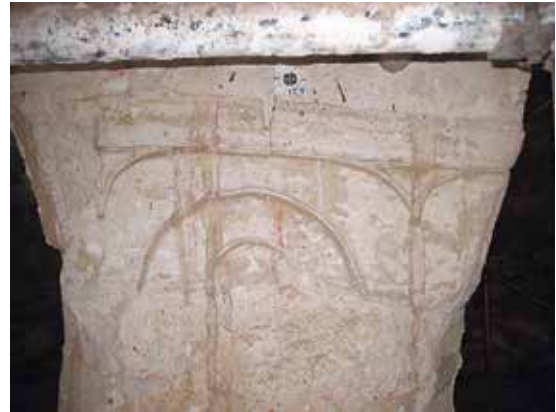
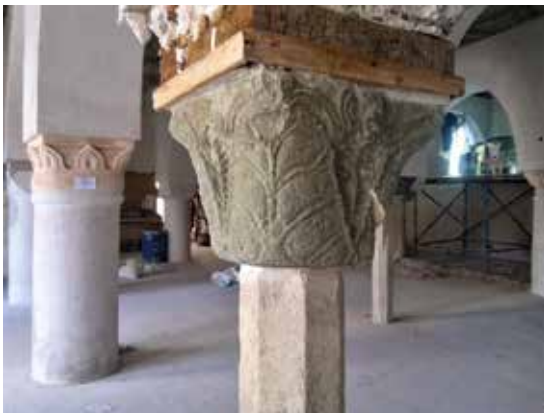
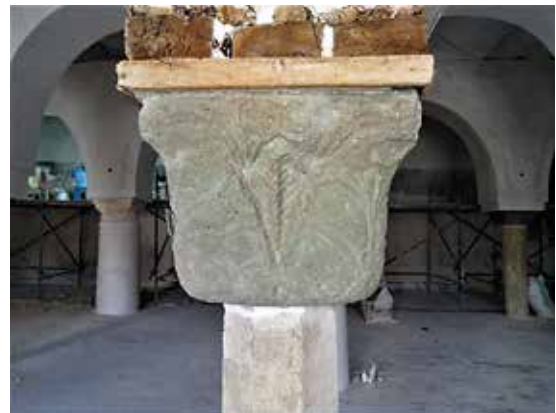
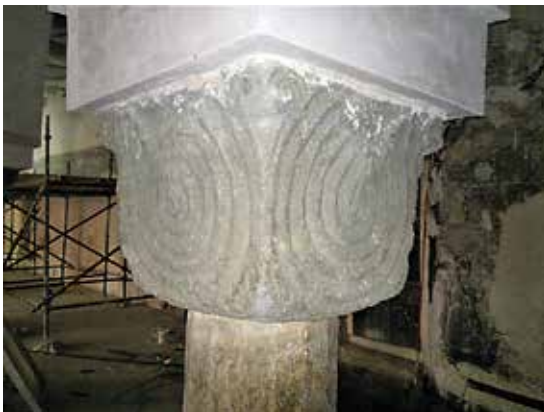
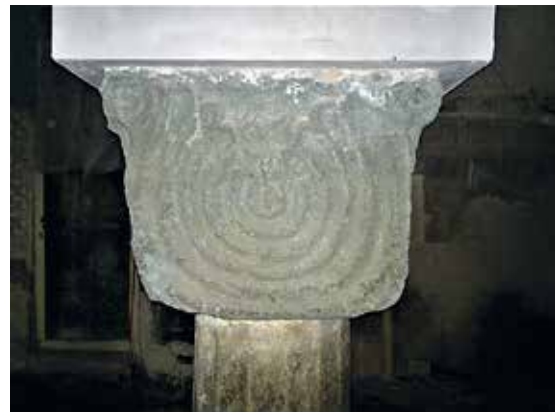
Figs 62 - 73. In the images some types of capitals.

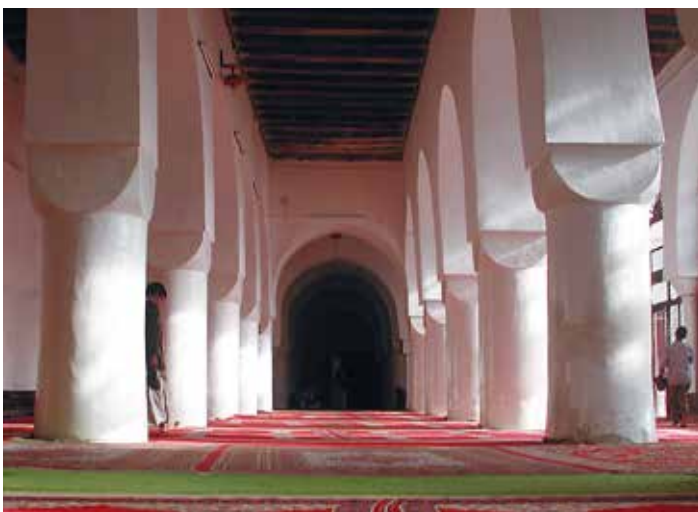
Fig. 74. In the image a shot of the south aisle of the Great Mosque with the characteristic columns made up of massive cylinders.

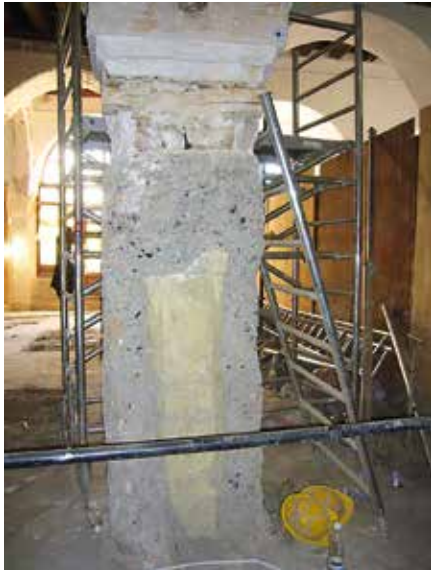
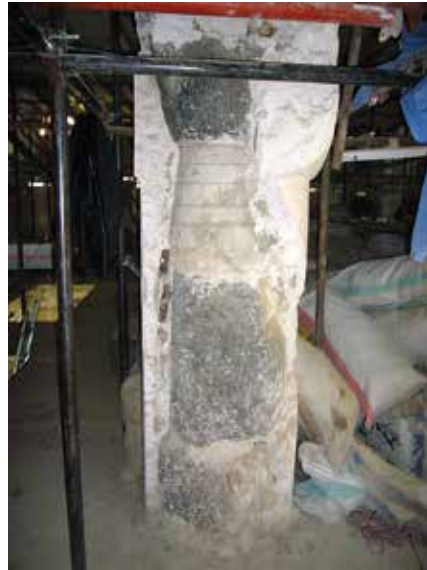
Figs 75, 76. In the images a phase of recovery of the ancient columns, freed from the thick layers of plaster and other materials.

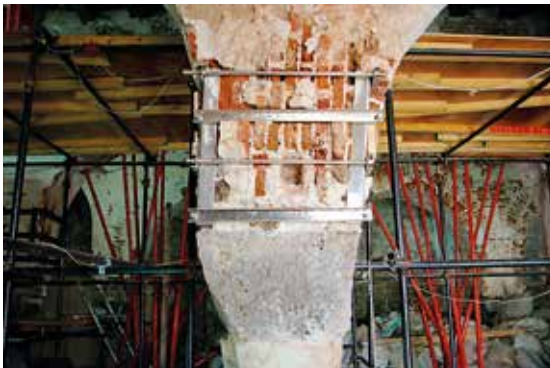
Fig. 77. Column no. 16 K north side.

Type of treatment: removal of old plaster and cleaning of surfaces. Structural repair with closure of large gaps using bricks and Lafarge hydraulic lime.

Application of a metal cage structure for containment.

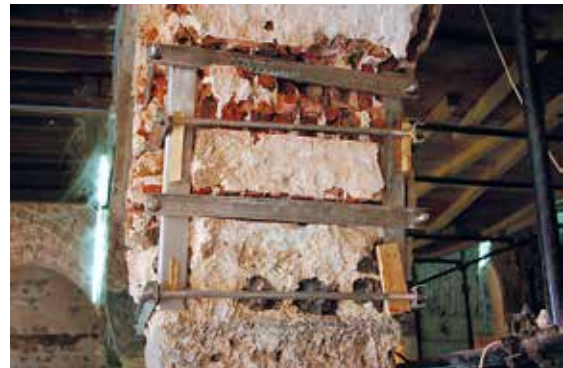
Fig. 78. Column no. 16 K west side.

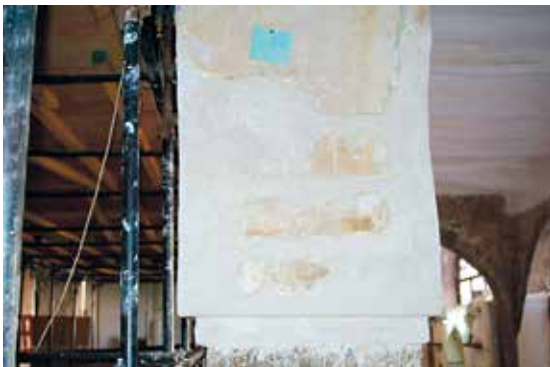
Fig. 79. Column no. 16 K, east side, application of plaster at the base before the final layer.

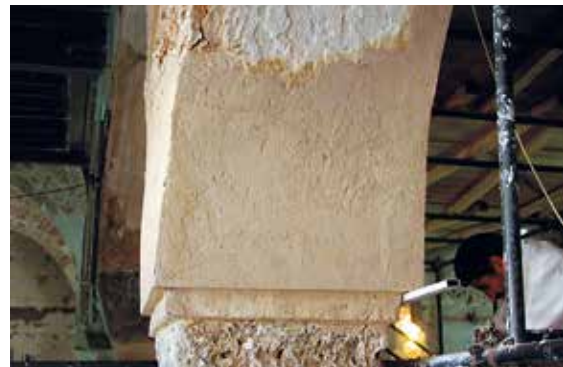
Fig. 80. Column no. 16 K, west side, application of base coat in preparation for final plastering.

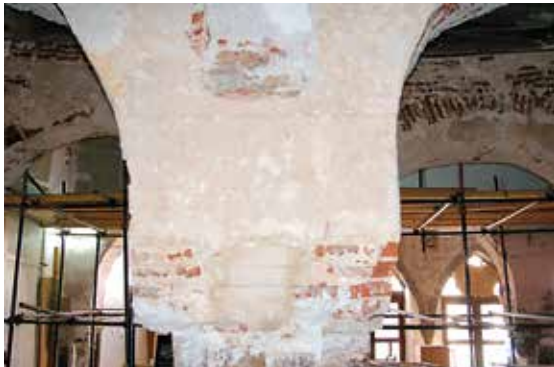
Fig. 81. Column no. 18 I, south side, cleaning and repointing of the surface.

Type of treatment: cleaning and consolidation for repair of the masonry structure in brick, closure and repointing of gaps with brings and Lafarge hydraulic lime. The surface was unified and repointed with hydraulic mortar. Application of a metal cage structure for containment.

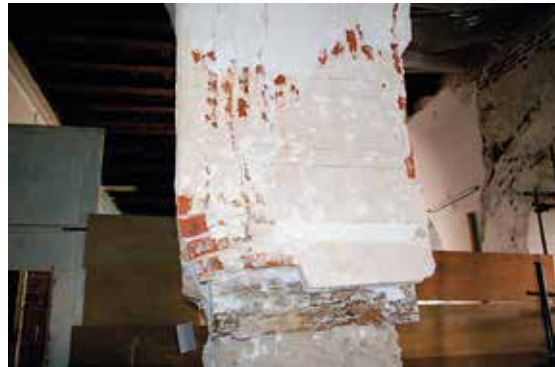
Fig. 82. Column no. 18 I, east side, cleaning and repointing of the surface.

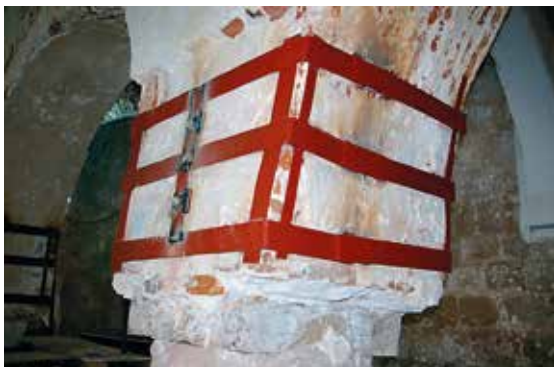
Fig. 83. Column no. 18 I, northwest side, application of metal cage.

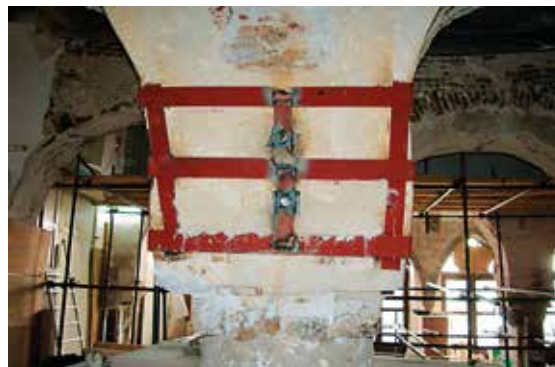
Fig. 84. Column no. 18 I, south side, cleaning and repointing of the surface.

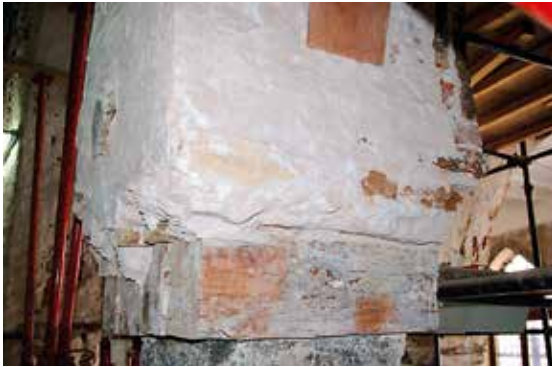
Fig. 85. Column no. 17 K, east side.

Type of treatment: cleaning and consolidation for repair of the masonry structure in brick, closure and patching of gaps with bricks and Lafarge hydraulic lime. The surface was unified and repointed with hydraulic mortar. Application of a metal cage structure for containment.

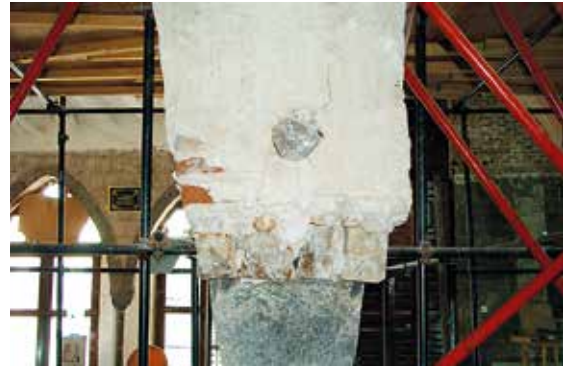
Fig. 86. Column no. 17 K, south side.

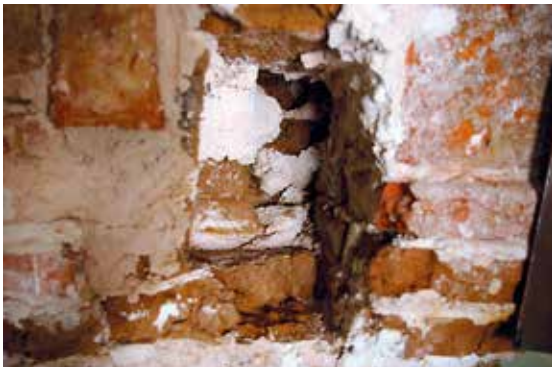
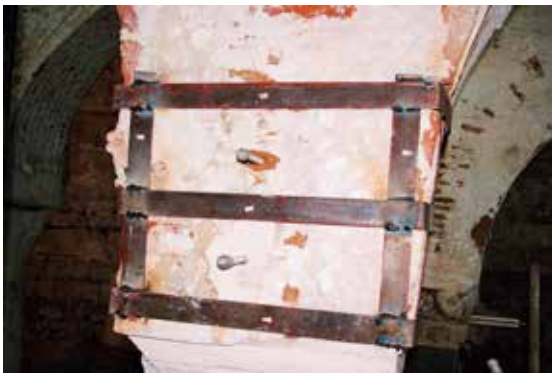
Figs. 87, 88. Column no. 17 K, north side, Example of gap and relative repointing with bricks and hydraulic lime.

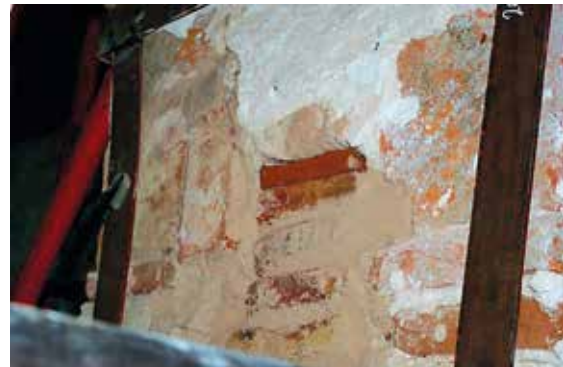
Fig. 89. Column no. 17 K, north side, patching of gaps with hydraulic lime and application of metal cage.

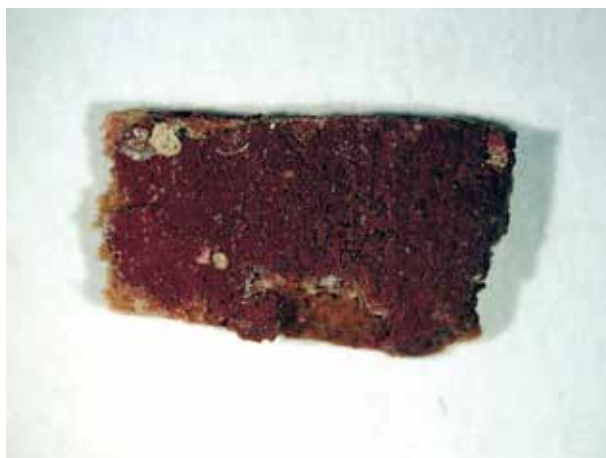
Below are some images relating to a fragment of red colored painting layer in which the presence of cinnabar and minium pigments has been identified, Figs 1-3.

Fig. 1. Stereomicroscope image of the red paint sample Y4, taken from the second aisle of the north wing of the al-Jāmi‘ al-Kabīr mosque in Şan‘ā’.

In the samples with red painting layers, the scientific investigations identified the cinnabar pigment (HgS), often in combination with minium (Pb_3O_4). In some samples, red earths (clays colored by anhydrous iron oxides) were also found, the latter also identified in some repainting layers.

In some samples including the wooden support, on top of the wooden surface were detected a thin layer containing protein-based materials, identified by specific microchemical tests. It is assumed that these layers were applied as ground layer '*imprimitura*' on the wooden surface before applying the paint layer, Figs 1-3 and Figs 35-37.

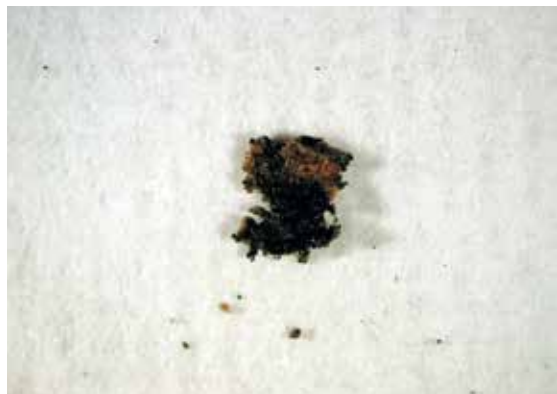
Fig. 8. Stereomicroscope image of the blue paint sample YSB, taken from the first aisle of the east wing of the al-Jāmi‘ al-Kabīr mosque in Şan‘ā’.

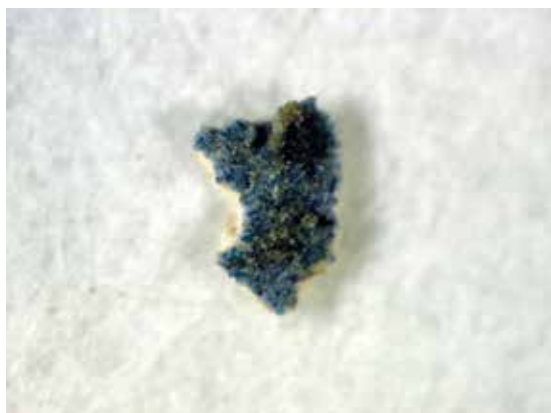
Fig. 11. Stereomicroscope image of the blue paint sample Y6, taken from the second aisle of the north wing (mezzanine) of the al-Jāmi‘ al-Kabīr mosque in Ṣan‘ā’.

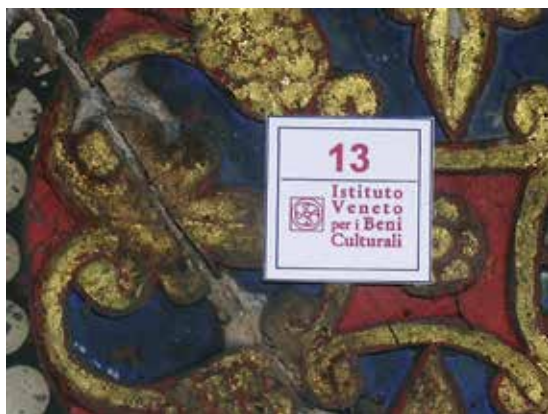
Fig. 14. Image of the sampling point of the blue paint sample Y-S1-13.

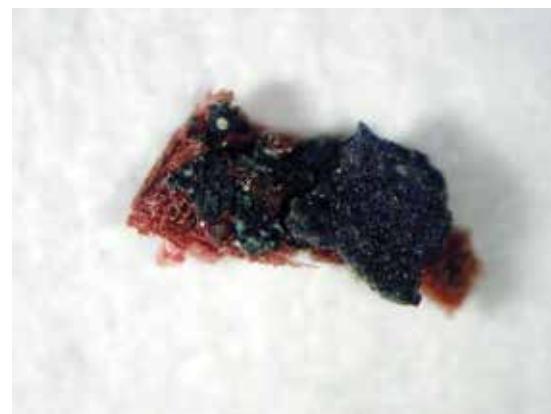
Fig. 15. Stereomicroscope image of the paint sample Y S1-13.

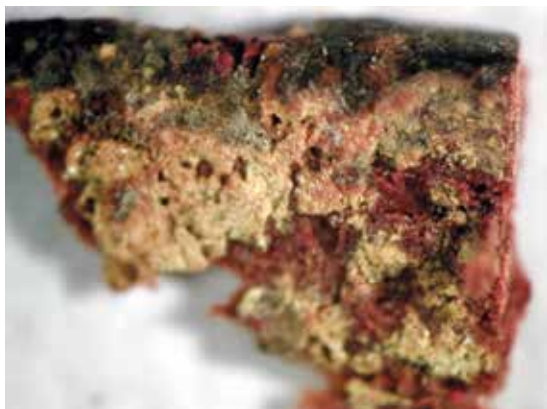
Fig. 18. Stereomicroscope image of the yellow paint sample YCG, taken from the fourth aisle of the south wing (sleeper) of the al-Jāmi‘ al-Kabīr mosque in Ṣan‘ā’.

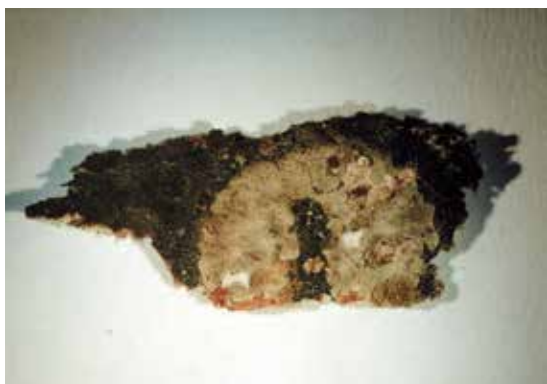
Fig. 22. Stereomicroscope image of the white/green paint sample Y1N, taken from the second aisle of the north wing (mezzanine: beam with panes) of the al-Jāmi‘ al-Kabīr mosque in Ṣan‘ā’.

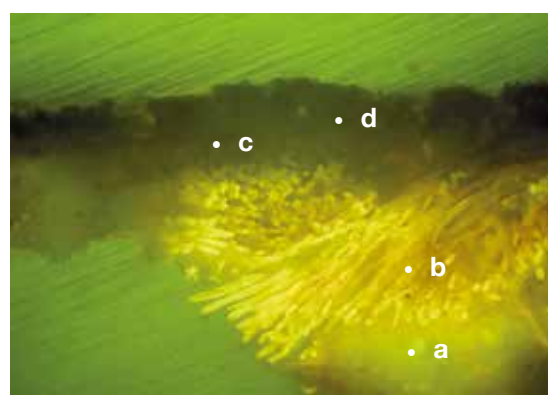
Fig. 24. Image at the Optical Microscope of the cross section of the paint sample Y1N viewed in ultraviolet radiation in order to highlight the presence of fluorescent materials.

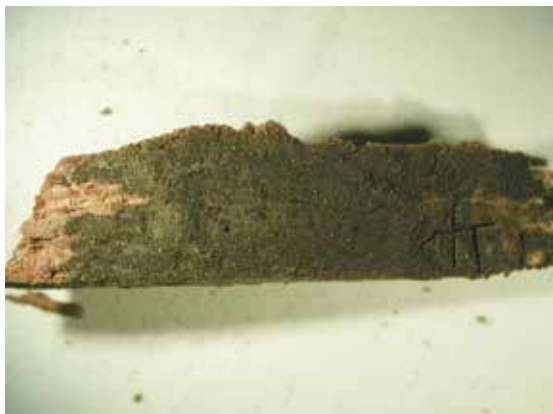
Fig. 27. Stereomicroscope image of the greenish paint sample 11 / E3C96B.

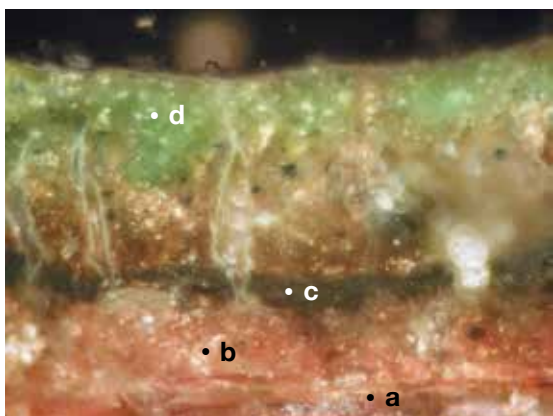
Fig. 28. Images at the optical microscope at different magnifications of the cross section of the paint sample 11 / E3C96B viewed in reflected visible light showing the wooden support (a), a layer of organic nature probably applied as a ground layer/‘*imprimitura*’ (b), a layer based on a black pigment of an organic nature (probably carbon black) (c) and a green layer in which blue grains are observed, identifiable with natural ultramarine blue (d). The innermost part of the green layer is chromatically changed from green to brown presumably by reaction with some components of the underlying layers, this alteration suggests the use of an organic green pigment in the creation of this layer.

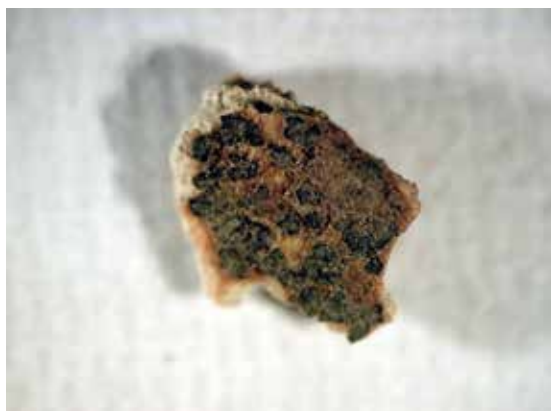
Fig. 35. Stereomicroscope image of the paint sample YTSBV, taken from the second aisle of the north wing of the al-Jāmi‘ al-Kabīr mosque in Şan‘ā’.
